Cause of Failure of the Lagoa do Pirocáua Dam at the Aurizona Mine on March 25, 2021, Maranhão State, Northeast Brazil

Steven H. Emerman, Malach Consulting, 785 N 200 W, Spanish Fork, Utah 84660, USA,
E-mail: SHEmerman@gmail.com, Tel: 1-801-921-1228

Report prepared at the request of Conselho Nacional de Direitos Humanos (CNDH)
Submitted on July 16, 2021

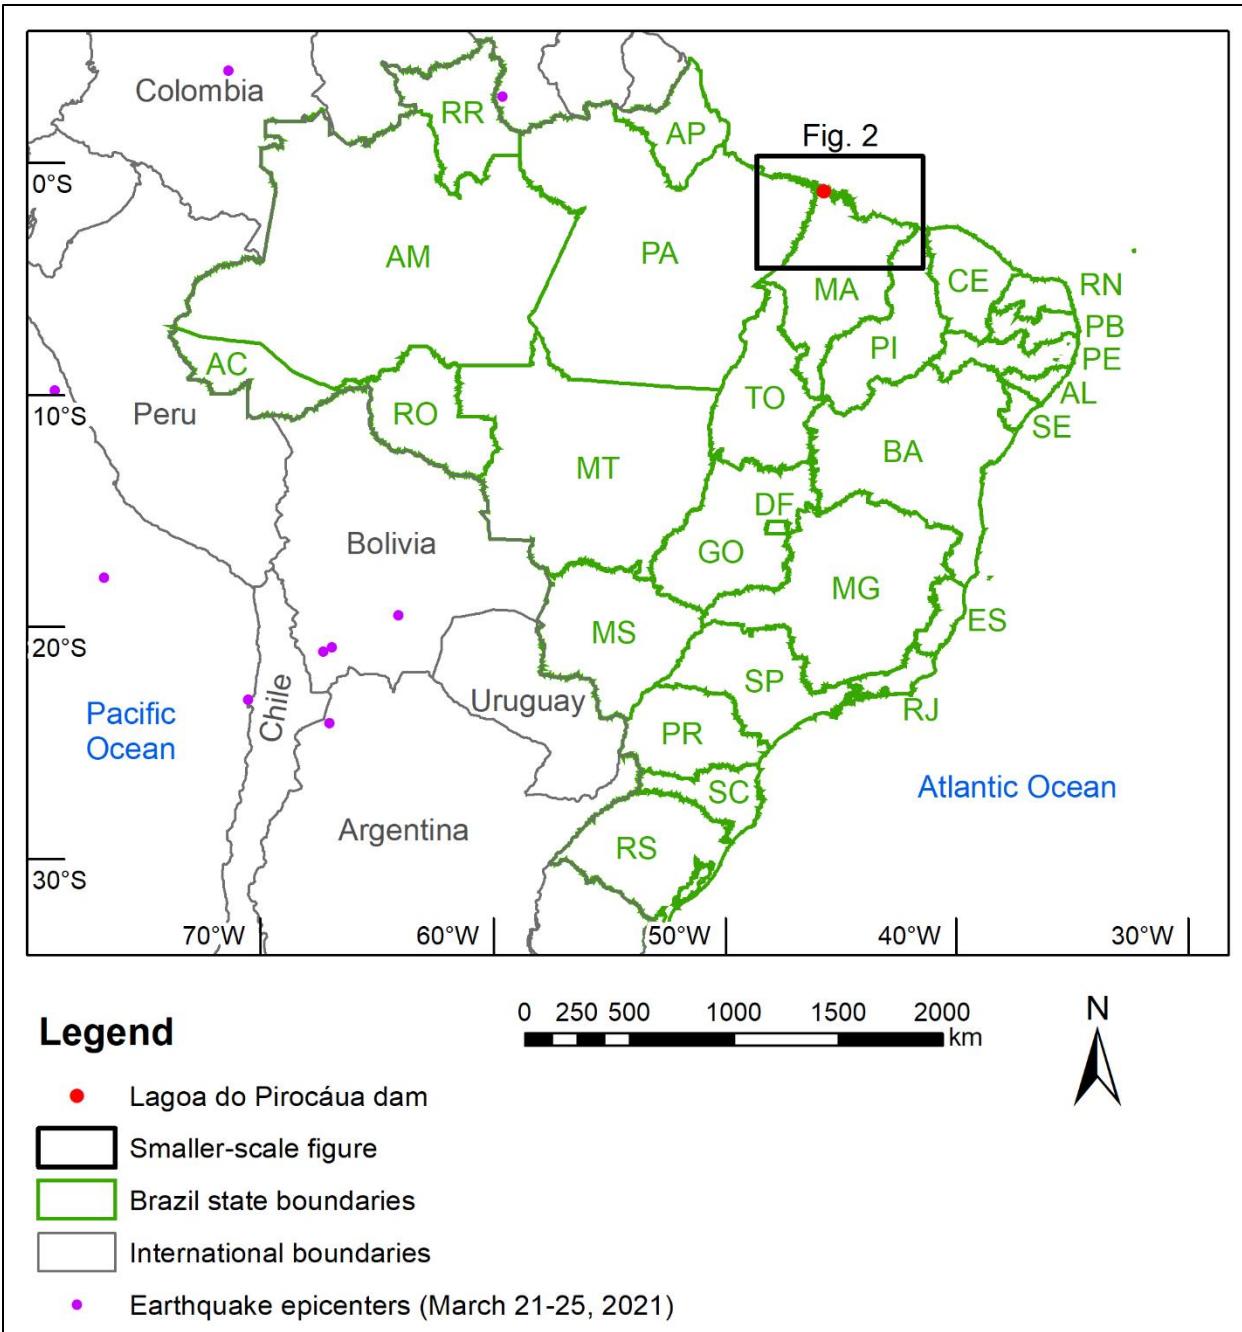
Figure 1. The failure of the Lagoa do Pirocáua dam at the Aurizona mine, owned by the Canadian mining company Equinox Gold, contaminated the water supply of the village of Aurizona. According to Equinox Gold and the National Mining Agency (ANM), the failure was caused by overtopping of the dam as a result of the 426 mm of rain that fell during March 23-24, 2021, which constituted a 10,000-year precipitation event (event with an annual exceedance probability of 0.01%).

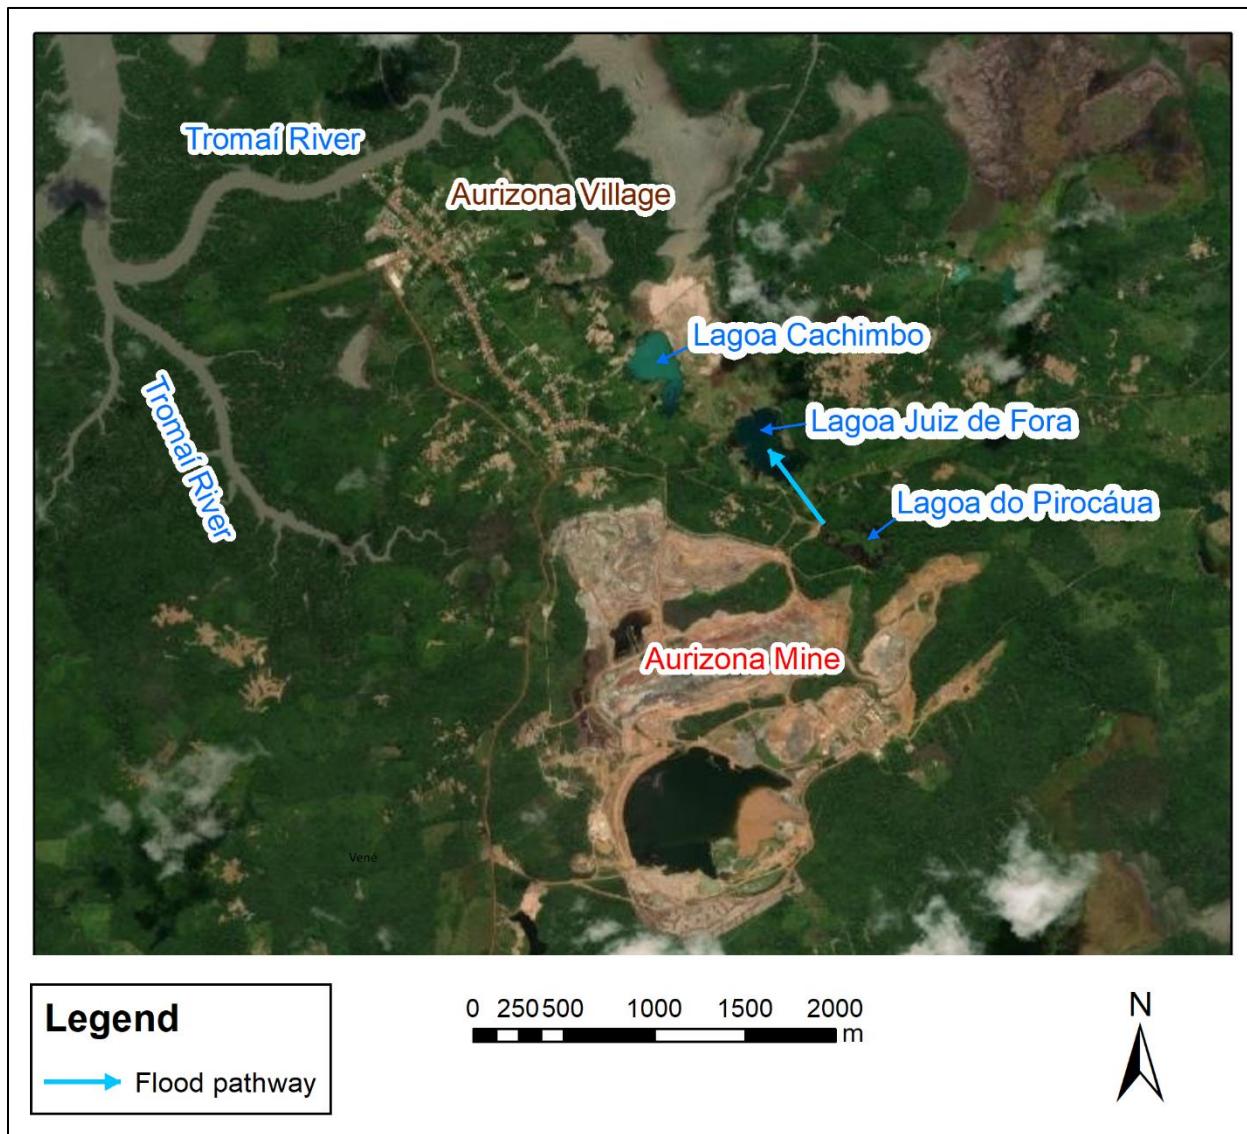
Figure 3. The failure of the Lagoa de Pirocáua dam resulted in contamination of Lagoa Juiz de Fora, which is the water supply for the 4000 inhabitants of the village of Aurizona.

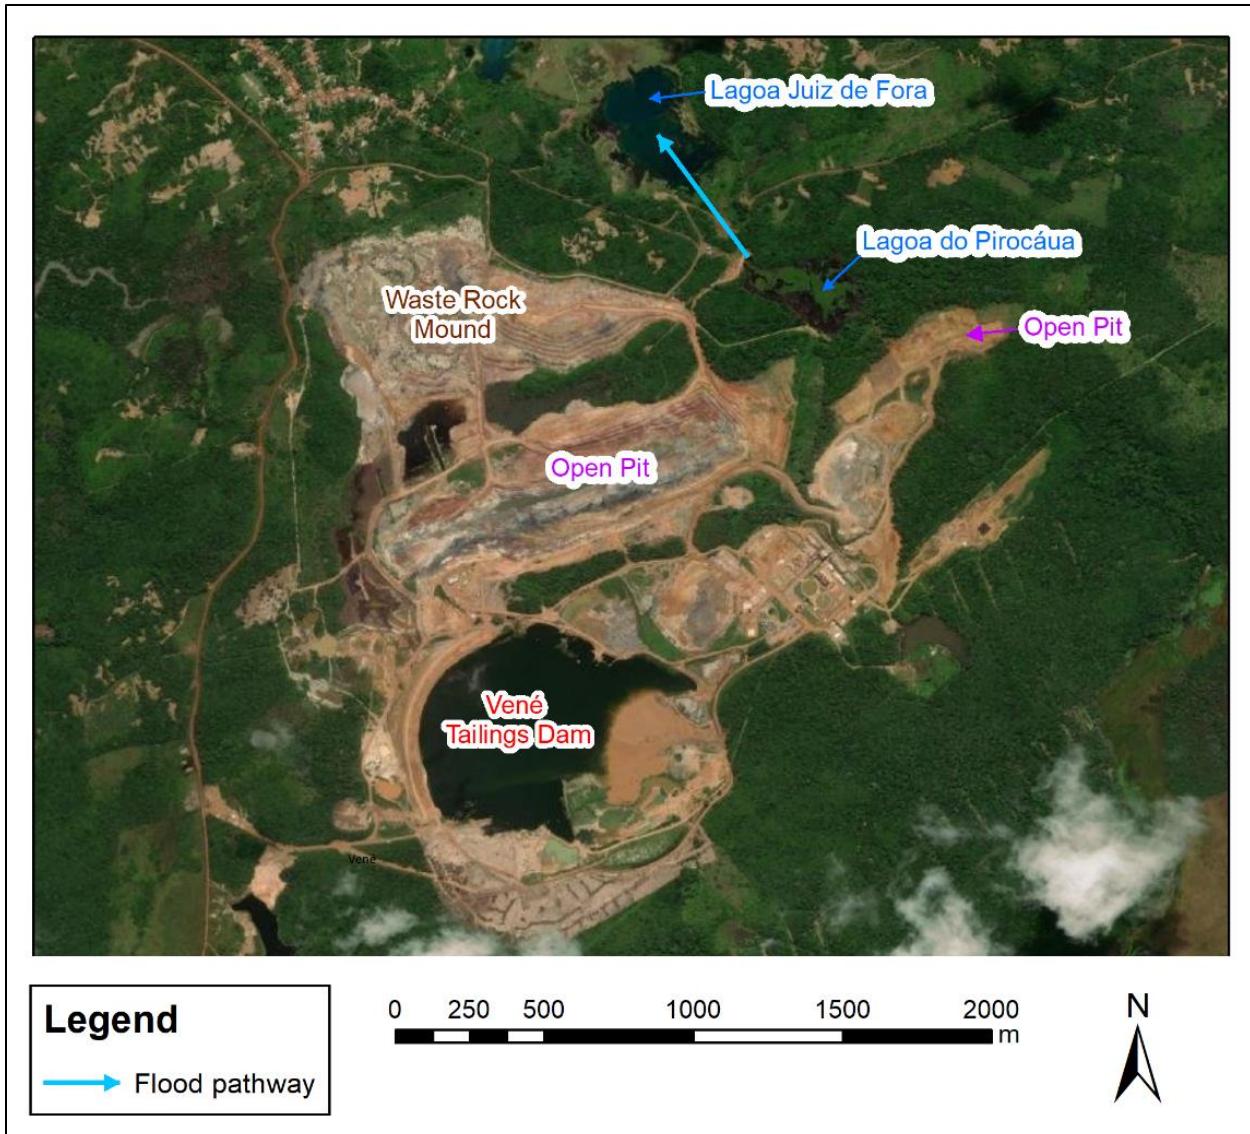
Figure 4. The failure of the Lagoa de Pirocáua dam resulted in contamination of Lagoa Juiz de Fora, which is the water supply for the 4000 inhabitants of the village of Aurizona. The Lagoa de Pirocáua dam was used to capture and store water for use in the mining operation and to capture sediment from the open pits. According to the State Secretariat for the Environment and Natural Resources (SEMA), the failure of the Lagoa de Pirocáua dam may have been caused not only by the heavy rain of the previous two days, but also by the collapse of an open pit that is above and to the east of Lagoa de Pirocáua.

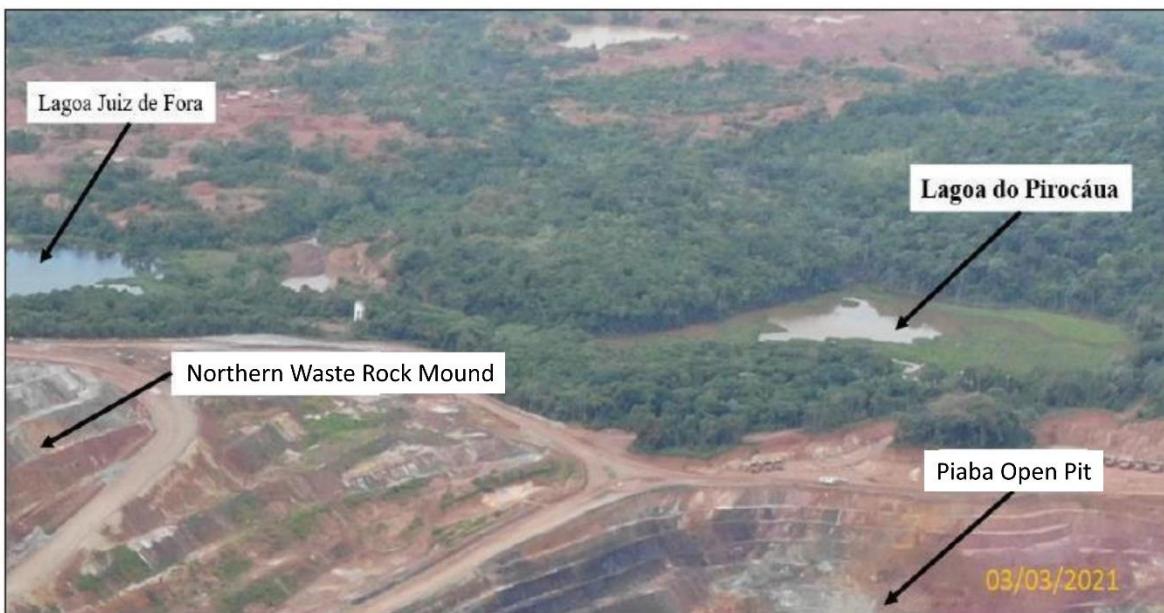
Figure 9: Overview of the area of Lagoa do Pirocáua

Figure 5. According to the State Secretariat for the Environment and Natural Resources (SEMA), the failure of the Lagoa de Pirocáua dam may have been caused not only by the heavy rain of the previous two days, but by the collapse of an open pit that is above and to the east of Lagoa de Pirocáua (off the photo to the right). View of aerial photo is to the northeast. Labeled photo from ANM (2021a) with overlay of English labels.

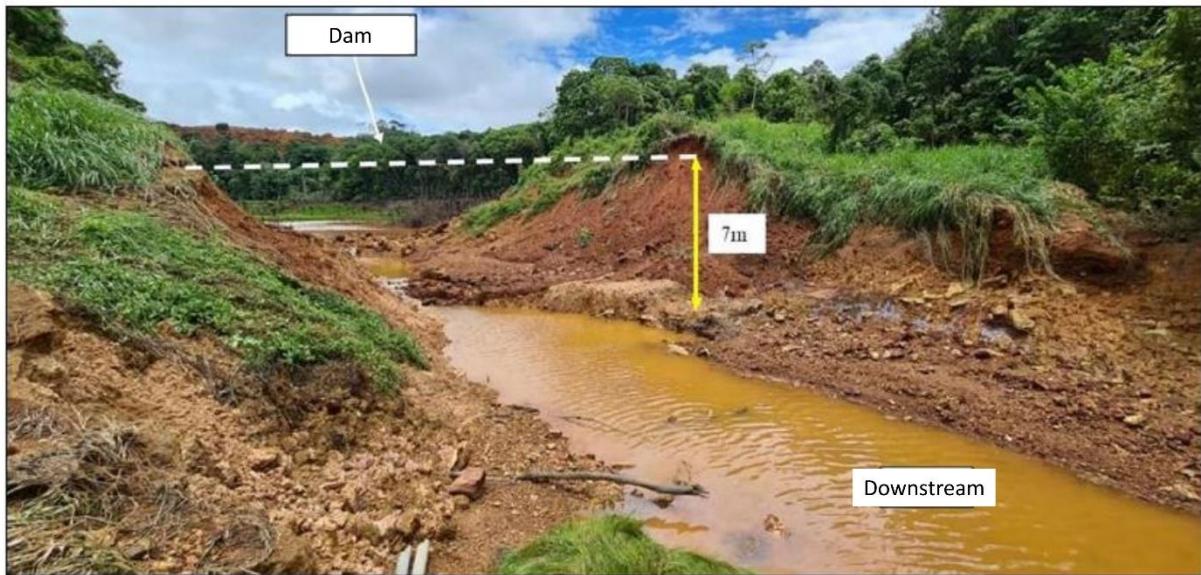
Figure 11: Situation of the dam after the overtopping

Figure 6. According to ANM (2021a), the 7-meter high Lagoa do Pirocáua dam failed by overtopping, which caused a breach in the dam. ANM (2021a) did not offer any evidence to support the overtopping hypothesis, aside from the assumption that 426 mm of rain fell over the previous two days. View of ground photo is to the southeast. Labeled photo from ANM (2021a) with overlay of English labels.

ANM (2021a) further argued that the extreme precipitation event resulted in an overtopping and failure of the embankment dam (see Fig. 6). An embankment dam is any dam constructed out of unconsolidated materials, such as soil, sand, clay, rock fill, or mine tailings. Often, the overtopping of an embankment dam results in the erosion and breach of the dam (see Fig. 7). According to ANM (2021a), “*Este evento de chuva atípico causou a rápida elevação no nível do lago e resultou no transbordamento, ou galgamento (figura 10), da estrutura, o que, por sua vez, gerou um processo de brecha do maciço, resultando em sua ruptura e liberação de parte do volume de água armazenada*” [This atypical rain event caused the rapid rise in the lake level and resulted in the overflowing, or overtopping … of the structure, which, in turn, generated a process of breach of the mass, resulting in its rupture and the release of part of the volume of stored water]. A dam failure refers to an uncontrolled release of water or other

materials that were stored behind the dam without necessarily implying the collapse or loss of structural integrity of the dam itself (Fell et al., 2015). Equinox Gold (2021a-c) repeatedly refers to the failure of the Lagoa do Pirocáua dam as an “overflow,” which could imply a simple loss of water with no impact on the dam. However, the explanation and photos by ANM (2021a) clarify that the dam was breached along its entire height of 7 meters (see Fig. 6).

The problem with determining the proximal cause of dam failure from only a post-failure ground photo (see Fig. 6) with no monitoring or inspection records, no ground photos during the failure, and no eyewitness accounts, is that the dam failure was so complete. A dam breach due to overtopping tends to initiate at the top of the dam, so that the breach might have a triangular or trapezoidal shape with the wider side at the top. A dam breach due to internal erosion tends to initiate at the site of emergence of the seepage and then propagate upwards, so that a partial breach might leave intact portions of the dam crest. A dam failure due to slope instability will initiate at the point on the failure surface with the lowest ratio of shear strength to shear stress and then propagate both up and down the failure surface. However, when the dam breach is total, with the dam rent from top to bottom (see Fig. 6), there is no remaining evidence of the process of dam breaching. In summary, the proximal cause of dam failure is unknown. The root cause of dam failure is known and will be addressed in the Discussion section.

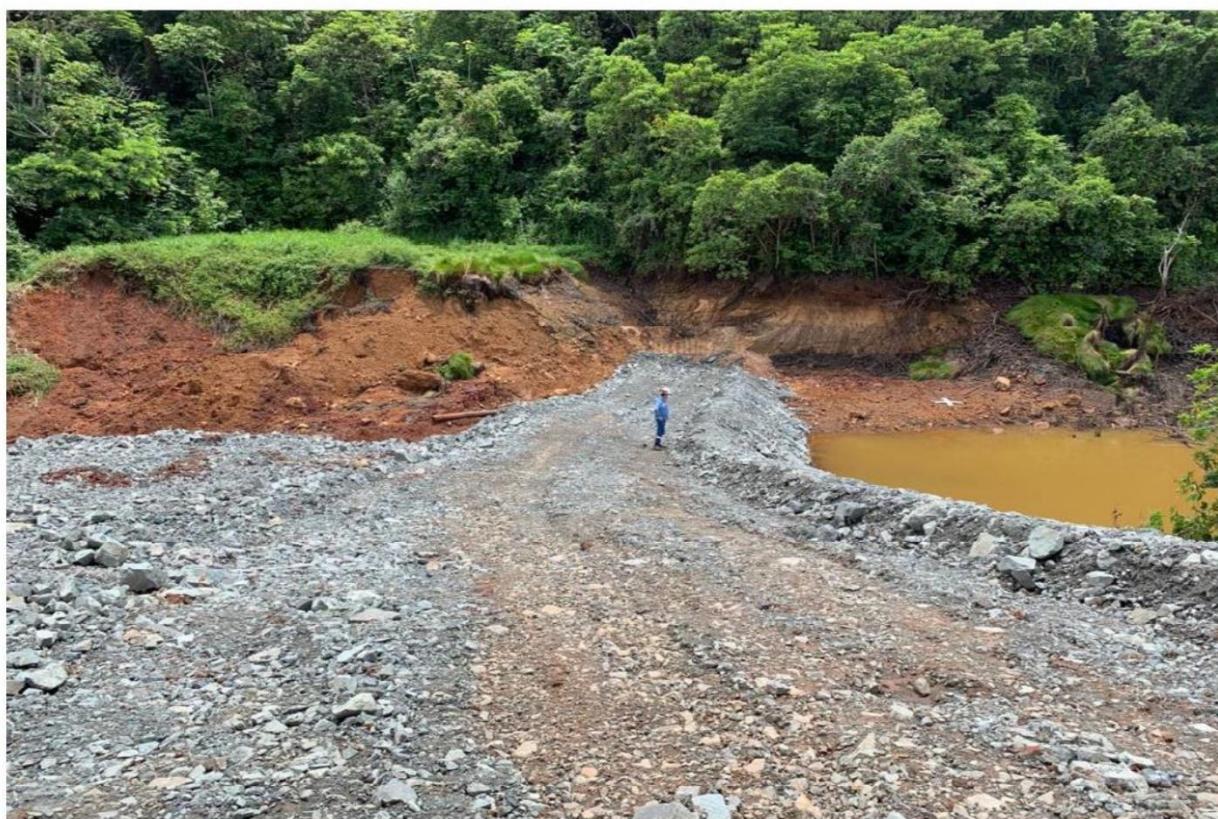
Figure 12: Emergency reconstruction of the ruptured dam.

Following the dam failure, an emergency dam was constructed at the site of the failed dam (ANM, 2021a; see Fig. 16). Based on the 7-meter height of the failed dam (see Fig. 6) and the person in the photo (see Fig. 16), the reconstructed dam is about two meters high, thus, considerably lower than the failed dam. According to the ANM (2021b) web site, all of the problems that led to the failure of the initial dam still remain as of this writing. In particular, the following problems still remain with respect to the reconstructed dam:

- 1) The return period of the design flood for the dam is either less than 500 years or unknown.

- 2) There are identified problems with the overflow structures and no corrective measures are being carried out.
- 3) The instrumentation is inappropriate and there is no plan to install new instruments.
- 4) There is no backup dam.
- 5) There are no design documents.
- 6) There are no manuals or formal procedures for monitoring and inspection.
- 7) There is no emergency action plan,
- 8) There has been no submission of inspection and monitoring reports or safety analyses.
- 9) There has been no submission of a Declaration of Condition of Stability.

Figure 16. Following the dam failure, an emergency dam was constructed at the site of the failed dam (compare with Fig. 6). According to information on the ANM web site, all of the problems that existed with the failed dam are still present in the reconstructed dam. Since the reconstructed dam is considerably lower than the failed dam, it should be assumed that the risk of failure is even greater at the present time than it was when the dam initially failed.
