Causes and Consequences of the Failure of the Tailings Dam at the Agroindustrial El Corazón Gold Mine on November 4, 2023, Imbabura Province, Northern Ecuador

Steven H. Emerman, Malach Consulting, 785 N 200 W, Spanish Fork, Utah 84660, USA,
E-mail: SHEmerman@gmail.com, Tel: 1-801-921-1228

Report prepared at the request of Asociación de Propietarios de Tierras Rurales del Norte
[Association of Northern Rural Landowners] and Frente Antiminero [Antimining Front]
Submitted June 10, 2024

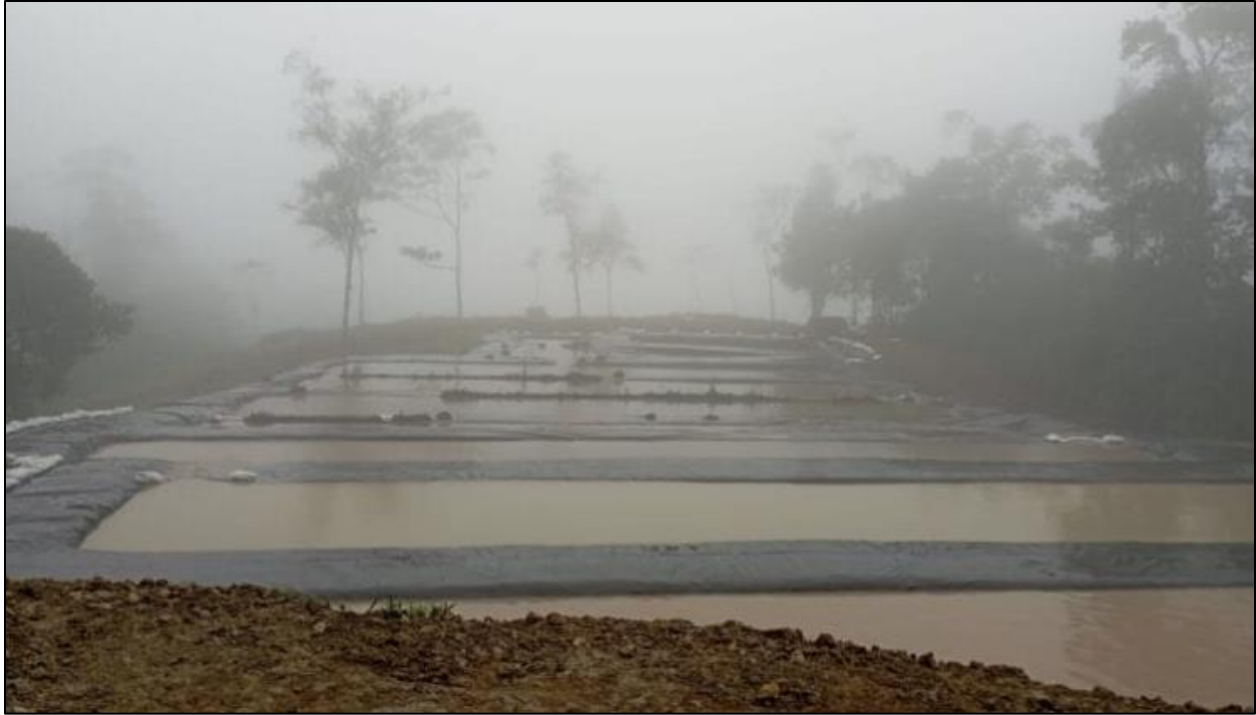
Figure 5. The wet tailings remaining from the processing of gold ore using cyanide at the El Corazón mine are stored in a succession of tailings ponds (see Fig. 4). There is no indication that the cyanide is destroyed (oxidized) prior to deposition in the tailings ponds, so that it should be assumed that the water in the tailings ponds is enriched in cyanide. Photo from Agencia de Prensa Minera (2023).

According to the report in Agencia de Prensa Minera (2023), the tailings pond “*explotó*” [exploded]. Agroindustrial El Corazón S.A. (2023c) described the story in Agencia de Prensa Minera (2023) as “*sensacionalista*” [sensationalist] and the word “*fuga*” [leak] was preferred in reports by Agroindustrial El Corazón S.A. (2023a), as well as by MAATE (2023a-b) and MEM (2023b). The Municipio de Cotacachi (2023, 2024) preferred the term “*filtración*” [seepage], which was also occasionally used in the reports by Agroindustrial El Corazón S.A. (2023a), MAATE (2023a-b) and MEM (2023). Although leaks and seepages did occur, the technical term in the dam safety literature for the incident is “failure,” and the November 4 incident will be referred to as a “tailings dam failure” throughout the rest of this report.

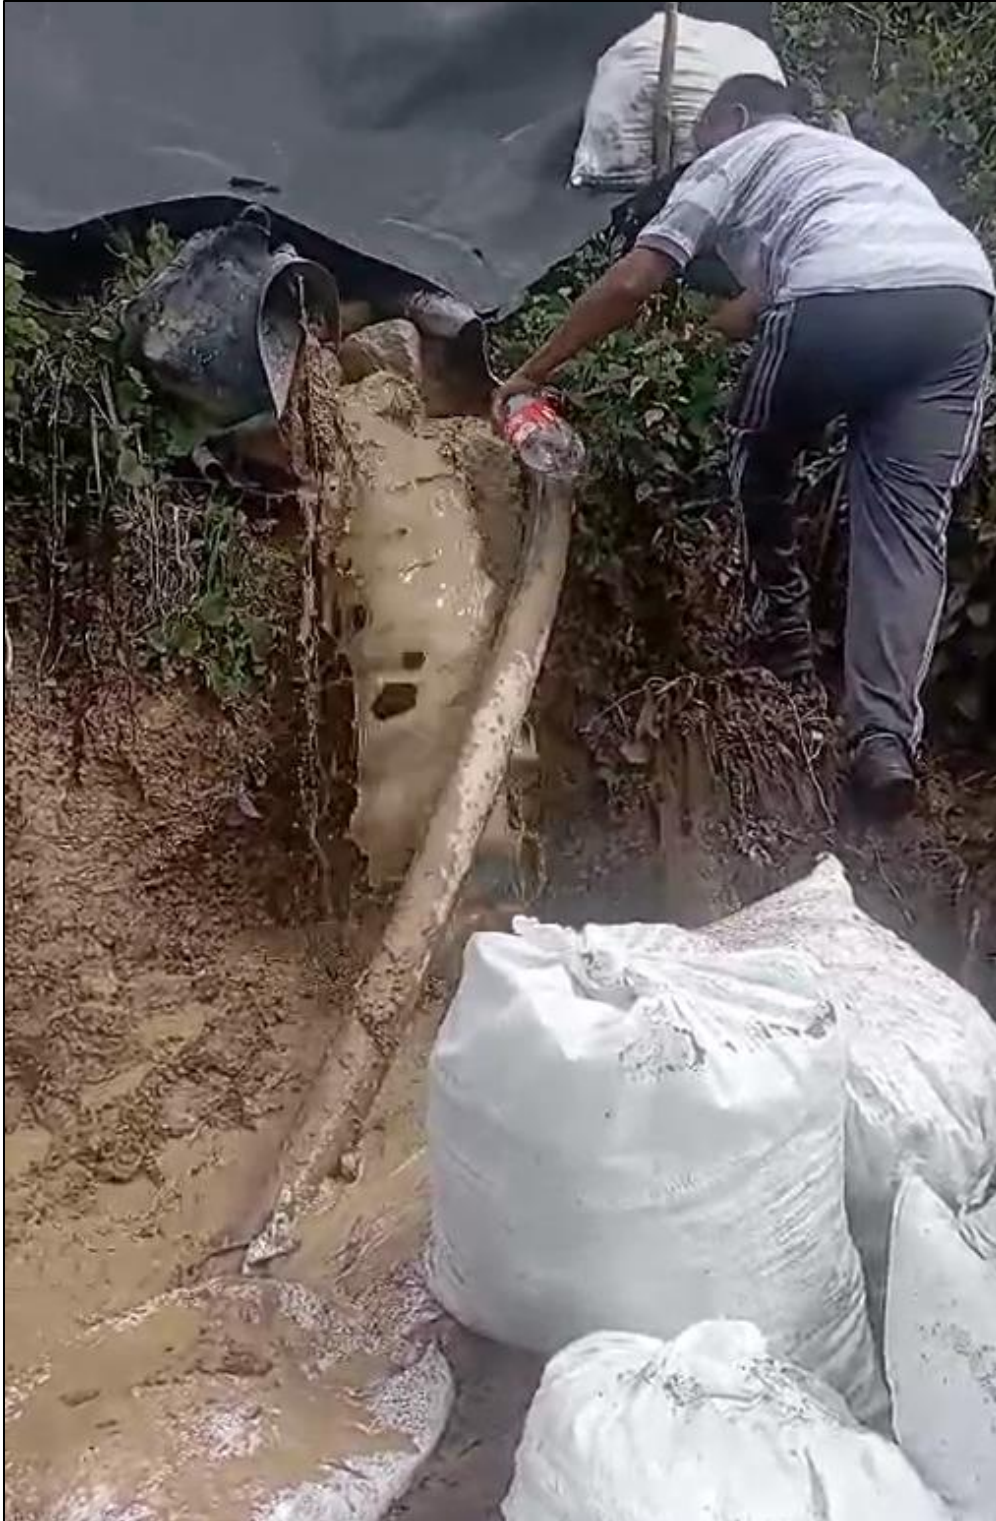
On the morning of November 4, 2023, a local resident collected a sample from the water and tailings that were flowing through the failed dam (see Fig. 6). The sample was delivered to Laboratorio Anncy for analysis on November 22 and the analysis was complete on December 4 (Laboratorio Anncy, 2023). The analysis showed a total cyanide concentration of 60.8 mg/L, which is over 600 times the maximum permissible limit for freshwater bodies in Ecuador of 0.1 mg/L (see Table 1). Other exceedances included arsenic concentration of 0.750 mg/L, copper concentration of 1.88 mg/L, iron concentration of 136 mg/L, manganese concentration of 4.20 mg/L, and mercury concentration of 0.034 mg/L, which are 7.5 times, 1.88 times, 13.6 times, 2.1 times, and 6.8 times the respective Ecuadorian maximum permissible limits (see Table 1).

Figure 6. On the day of the tailings dam failure (November 4, 2023), a local resident struggles to gain footing on the steep embankment to collect a water sample from the leaking dam (see results of water analysis by Laboratorio Anncy (2023) in Table 1). The steepness of the embankment is further indicated by the steepness of the pipe, the exposed plant roots, and the near vertical fall of contaminated water from the tailings pond. Still photo at 0:04 of video provided by Asociación de Propietarios de Tierras Rurales del Norte and Frente Antiminero (labeled Video 1 by author). Another still photo from the same video is available in Municipio de Cotacachi (2023a).

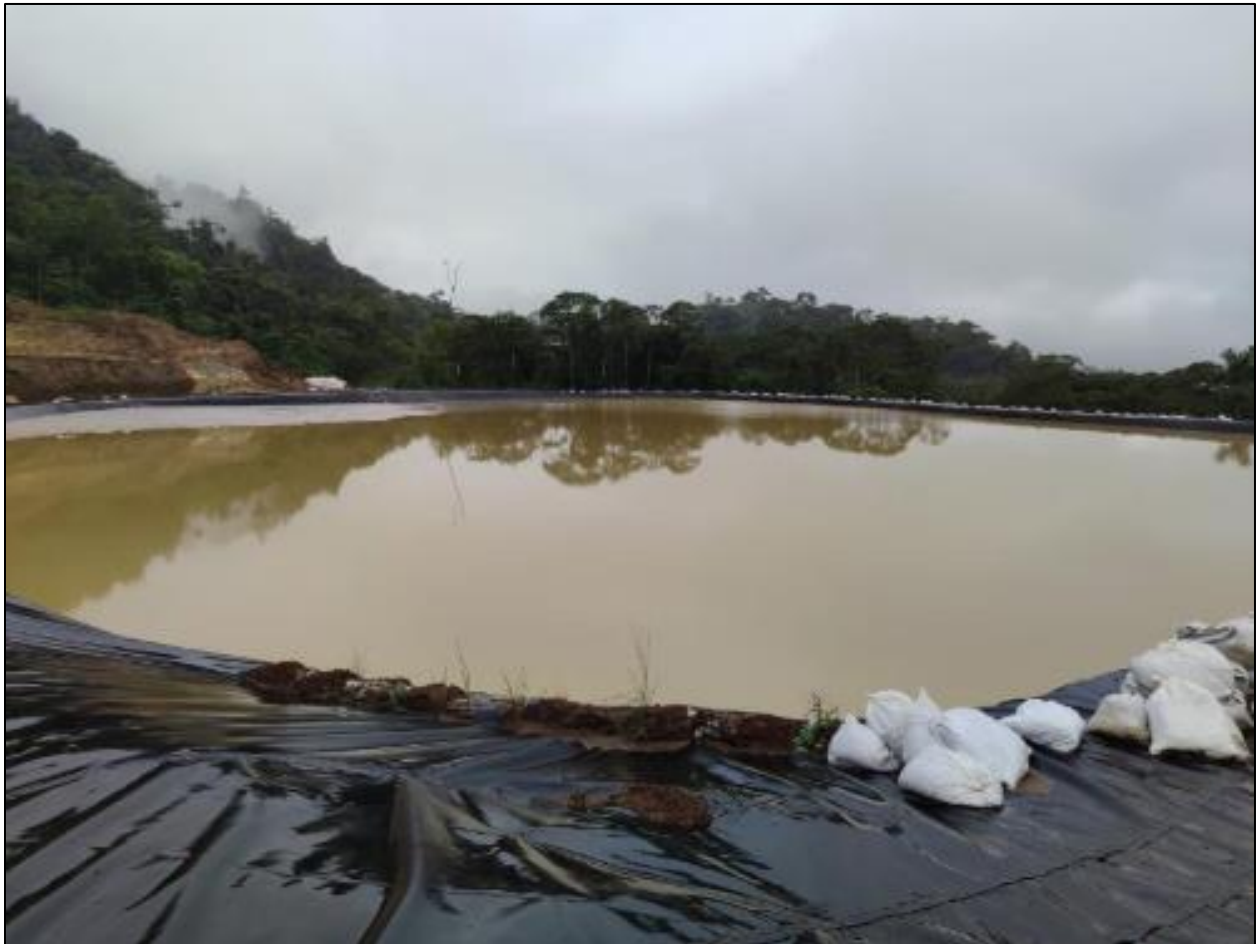
Figure 13. Pond No. 15 at the El Corazón mine contained about 50,000 cubic meters of water and tailings prior to the failure of the tailings dam on November 4, 2023. Photo from Municipio de Cotacachi (2023a).

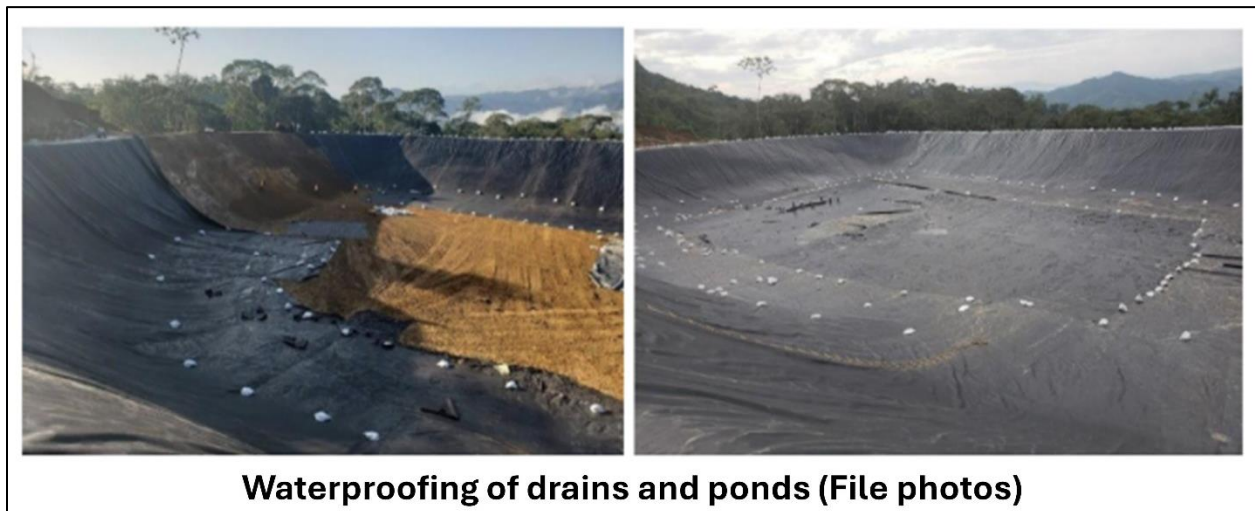
The root cause of the tailings dam failure was improper design because a waterproof geomembrane should not be the sole line of defense against failure. The first element of improper design is that the slope of the outer embankment should have been much lower in order to lengthen the hydraulic pathway and decrease the speed of water flow through the embankment. Photos show the slopes of the embankments surrounding Pond No. 15 to be approximately 1V:1H (1 meter vertical for 1 meter horizontal) or 45° from the horizontal. By contrast, many guidance documents, such as those of the U.S. Army Corps of Engineers, recommend slopes no steeper than 1V:5H (11° from the horizontal) in order to avoid failure by internal erosion. In fact, a slope of 1V:1H is regarded as the maximum critical angle to avoid internal erosion, so that the tailings dams at the El Corazón mine have always been on the cusp of failure. A maximum slope of 1V:3H (18° from the horizontal) is also regarded as a maximum angle to ensure slope stability and to prevent surface erosion. The second element of improper design is that the outer embankment should include a combination of a vertical drain and a

The water and tailings in Pond No. 15 were deposited on top of a waterproof geomembrane with a thickness of 0.7 millimeters (see Fig. 14). The waterproof geomembrane was placed on top of a drainage system that was constructed to prevent rainwater from ponding

Figure 14. Wet gold tailings from the El Corazón mine are deposited onto a waterproof geomembrane. The fundamental problem with the design is that a geomembrane should not be the sole mechanism of defense against failure of the tailings pond. Based on the current design, any tear in the geomembrane will lead to the release of tailings and water laden with cyanide. Photo from Agroindustrial El Corazón S.A. (2023a) with overlay of English label.

horizontal drain to force any seepage to exit at the toe of the dam. By contrast, the flow through the tailings dam on November 4 appeared high on the face of the embankment. Finally, in order to minimize the consequences of failure, no cyanide should be present in the tailings pond, meaning that all cyanide should be destroyed before the wet tailings are deposited in the tailings pond.

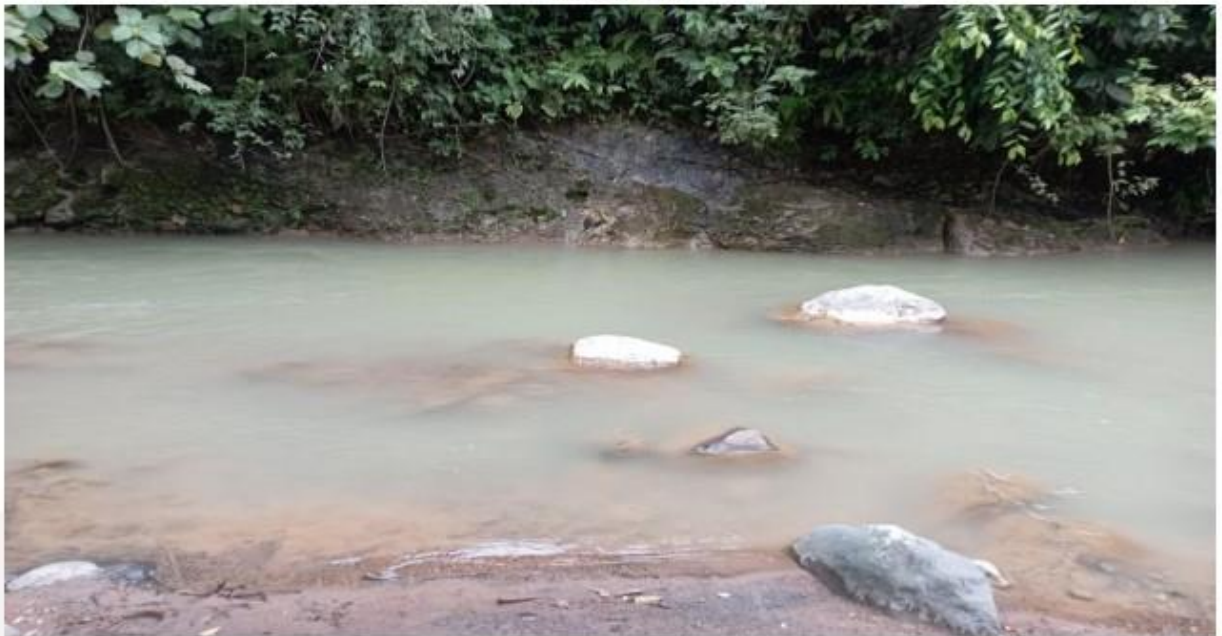
Figure 15a. On June 11, 2023, a grayish-green color was observed in the Manduriaco Chico river (see Fig. 3), which had appeared suddenly two days previously. Grayish colors are typically associated with fine particulate matter, such as fine-grained tailings. Based on available stream maps, aerial photos and satellite images, the pathway from one of the tailings ponds to the Manduriaco Chico river is not clear (see Figs. 3-4). Photos from Municipio de Cotacachi (2023b).

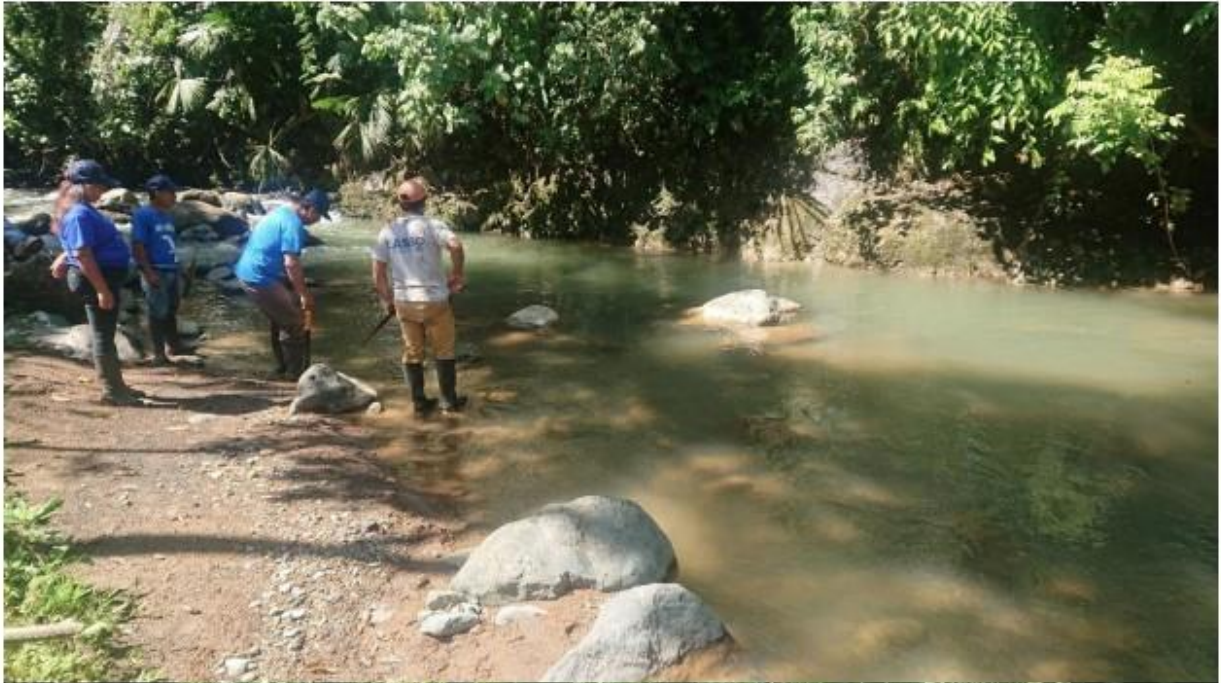
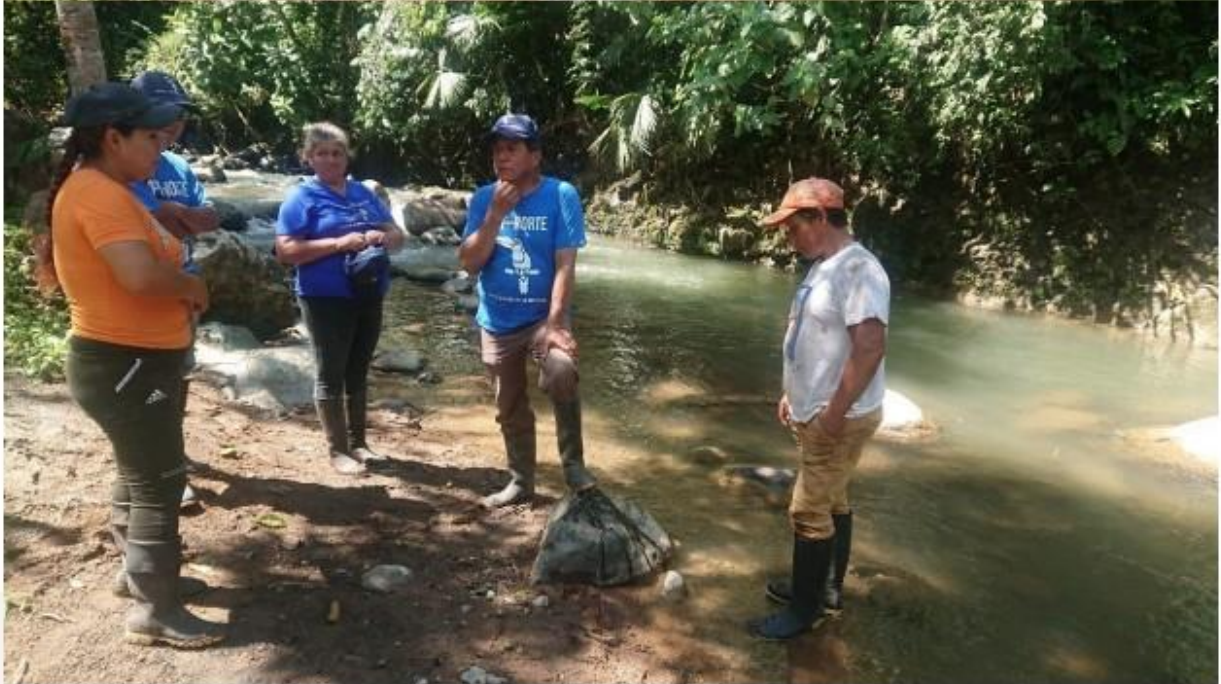
Figure 15b. On June 11, 2023, a grayish-green color was observed in the Manduriaco Chico river (see Fig. 3), which had appeared suddenly two days previously. Grayish colors are typically associated with fine particulate matter, such as fine-grained tailings. Based on available stream maps, aerial photos and satellite images, the pathway from one of the tailings ponds to the Manduriaco Chico river is not clear (see Figs. 3-4). Photos from Municipio de Cotacachi (2023b).

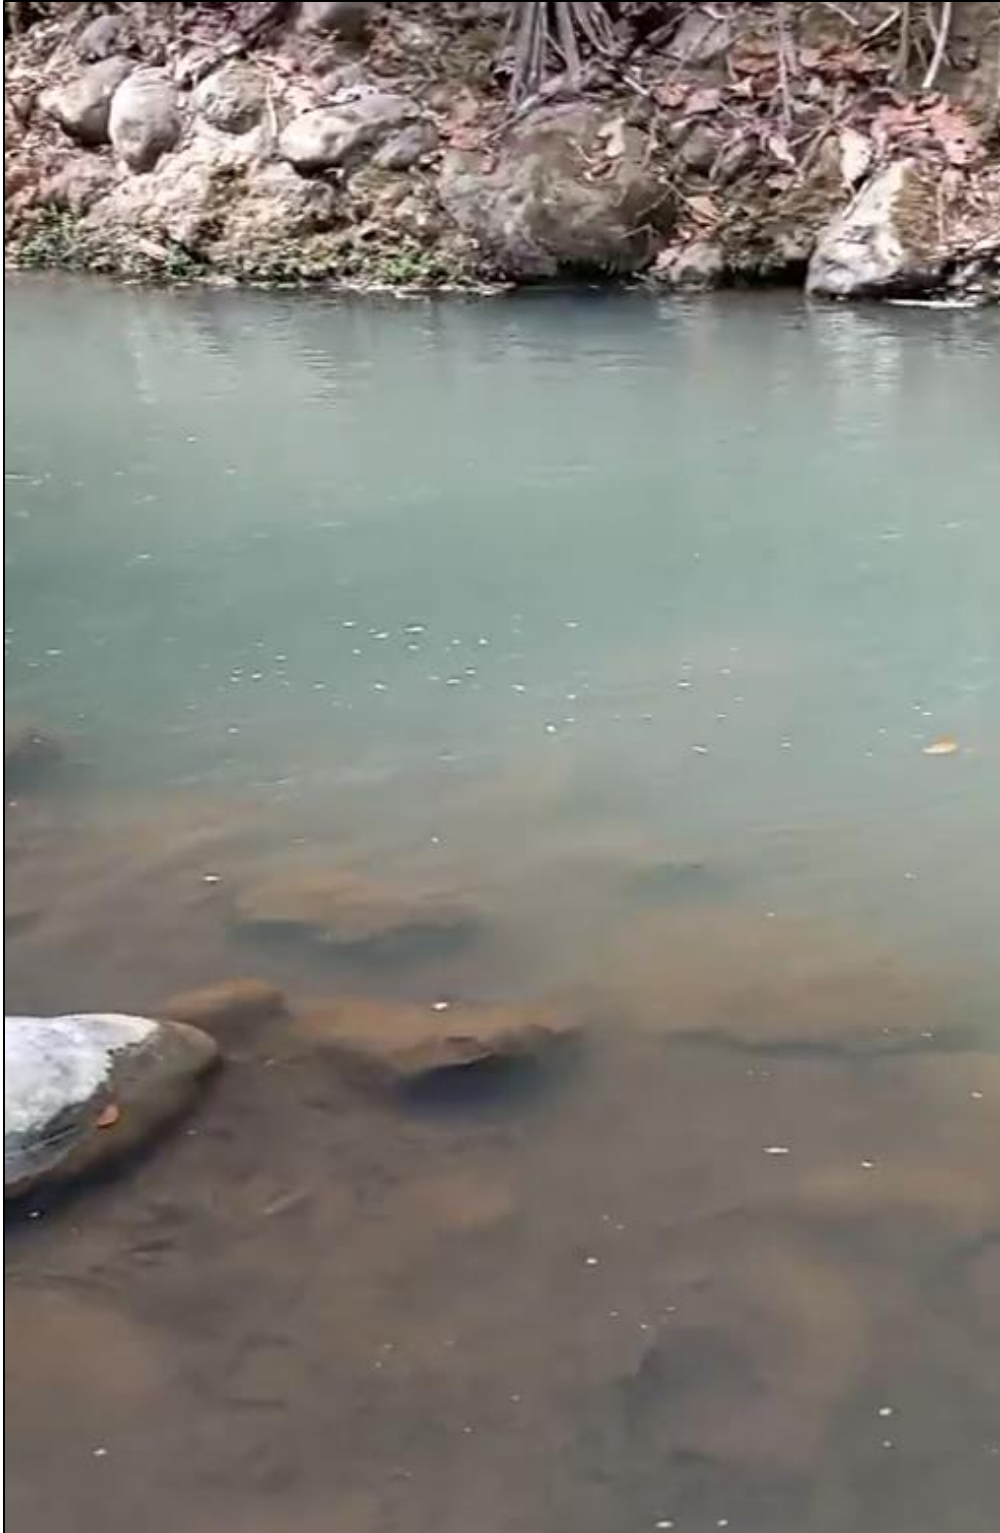
Figure 16. On November 4, 2023, the same grayish-green color appeared in the Manduriaco Chico river (compare with Figs. 16a-b) following the failure of the tailings dam at the El Corazón mine. Grayish colors are typically associated with fine particulate matter, such as fine-grained tailings. Based on available stream maps, aerial photos and satellite images, the pathway from Pond 15 to the Manduriaco Chico river is not clear (see Figs. 3-4). Still photo at 0:30 of video provided by Asociación de Proprietarios de Tierras Rurales del Norte and Frente Antiminero (labeled Video 3 by author).

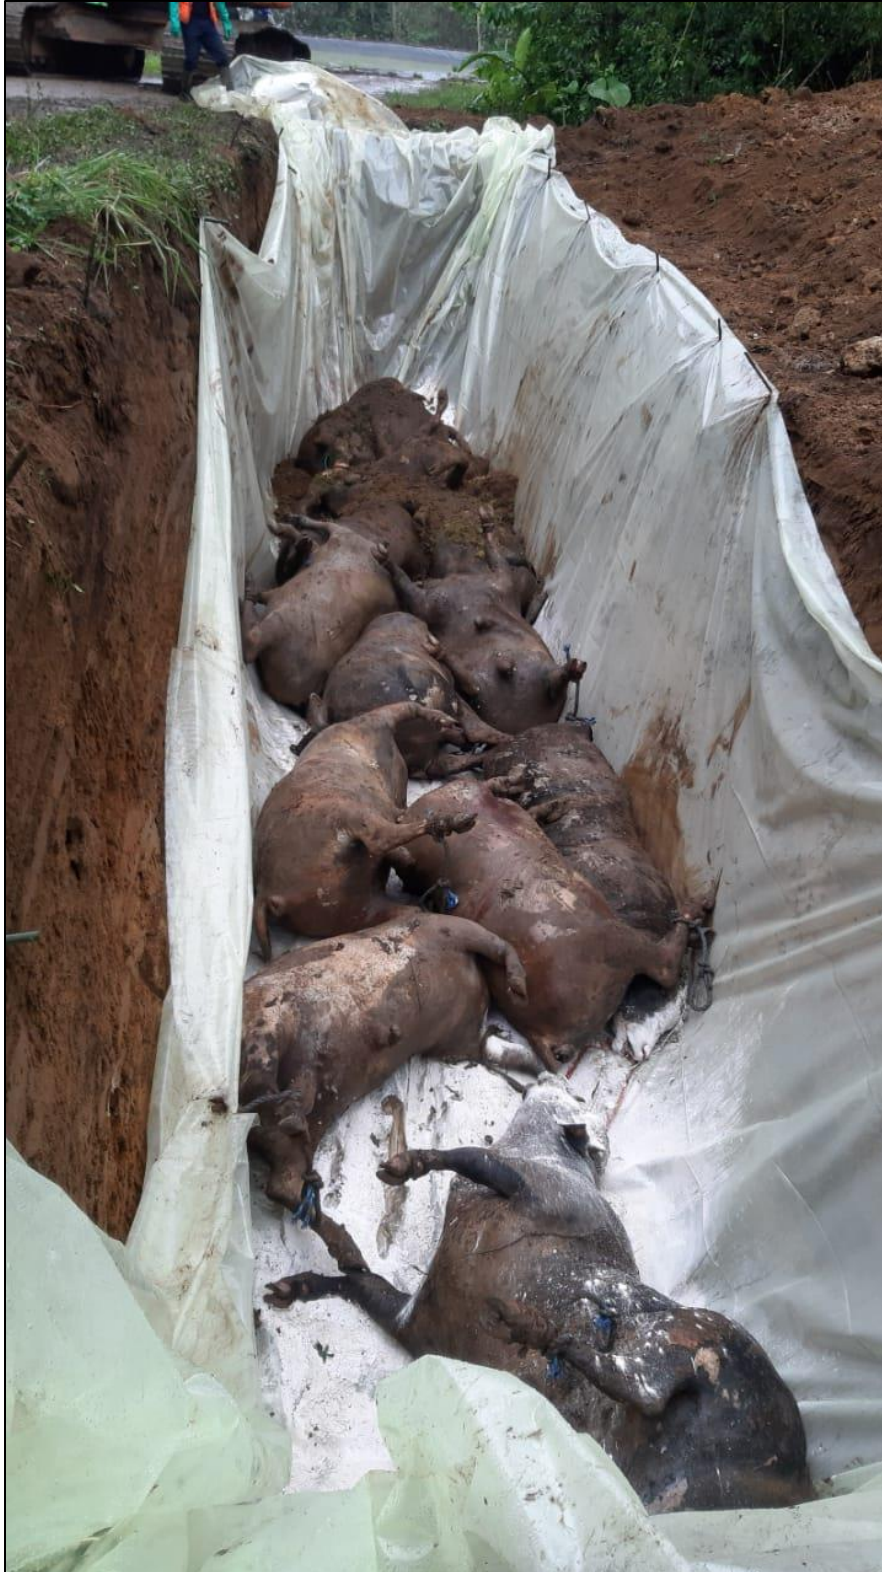
Figure 17. A death of 13 cattle occurred downstream from the El Corazón mine in 2020. It is believed that the cattle died from cyanide poisoning following a tailings dam failure. Photo provided by Asociación de Proprietarios de Tierras Rurales del Norte and Frente Antiminero. A lower-resolution version of the photo is also available in Asamblea de Unidad—Cantonal de Cotacachi [Assembly of Unity—Canton of Cotacachi] (2023).

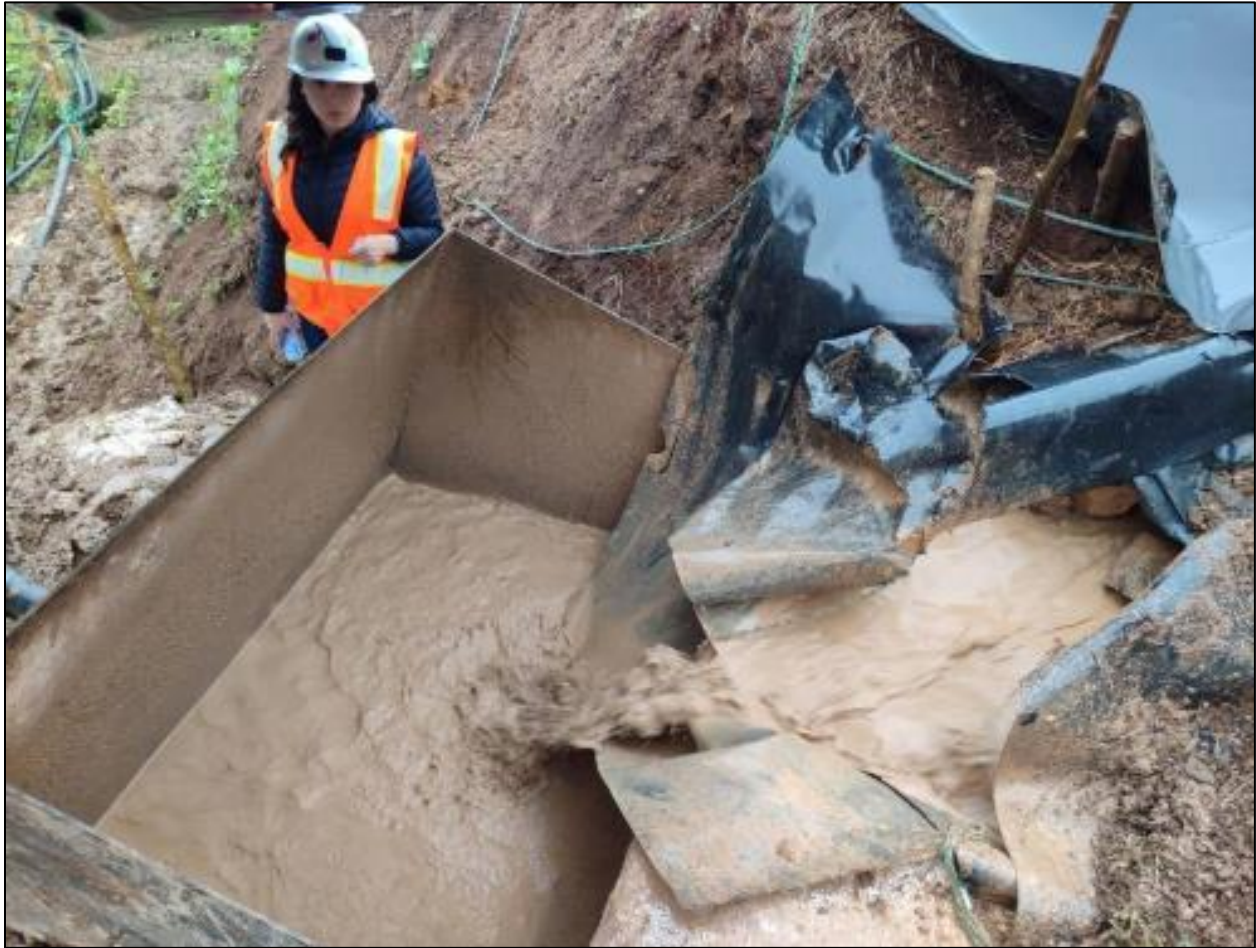
Figure 18. The water and tailings that were discharged from Pond No. 15 were collected in a metal container and then transferred to Pond No. 9 (see Fig. 4). Photo from Municipio de Cotacachi (2023a).

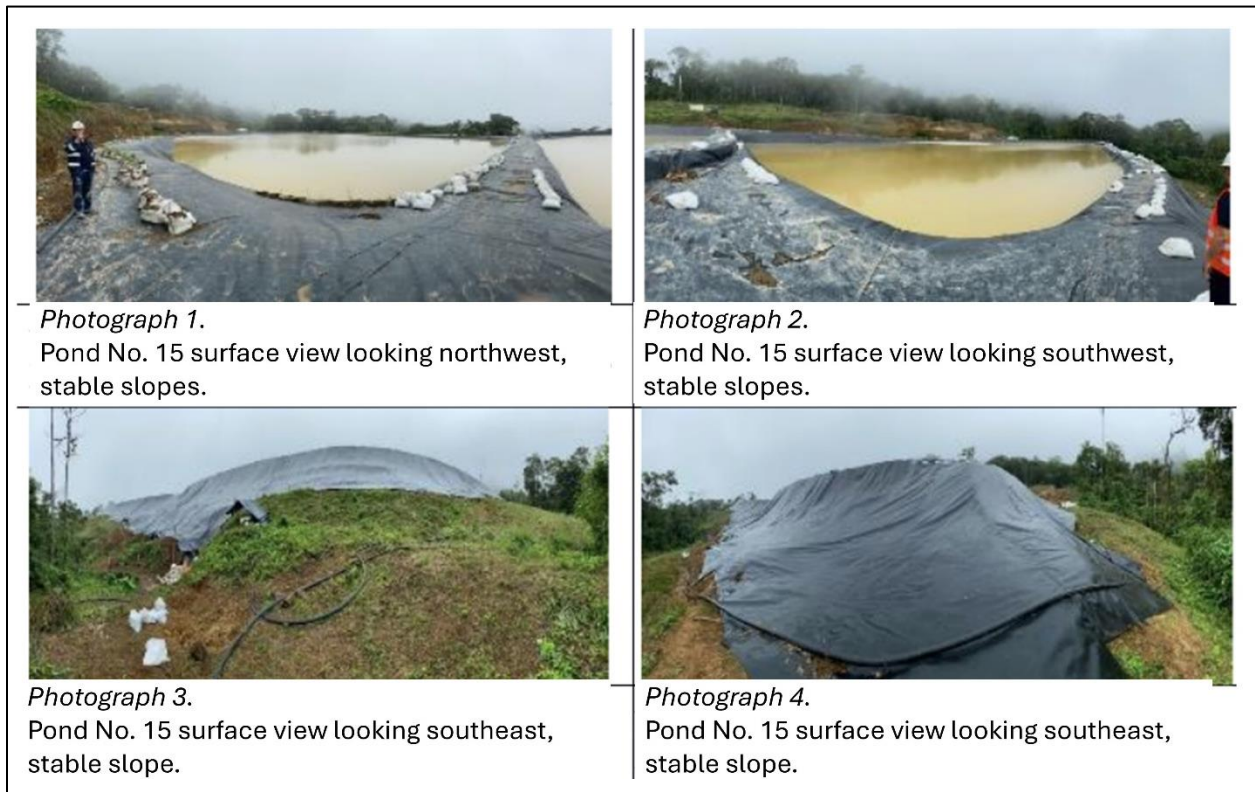
Figure 24. MAATE (2023b) states that the slopes of Pond No. 15 are stable without giving any evidence or explaining how the word “stable” is to be understood. The photos (especially the upper right) clarify that the embankments are very steep and on the order of 1V:1H (45°), which is the maximum critical angle necessary to avoid failure by internal erosion. By contrast, the U.S. Army Corps of Engineers requires slope angles no greater than 1V:5H (11° from the horizontal) to avoid failure by internal erosion (USACE, 2000). Since there are two views to the southeast and no view to the northeast, the directions might be mislabeled. Figure from MAATE (2023b) with overlay of English labels.

embankment be no steeper than 1V:5H (11° from the horizontal). By contrast, the photos in MAATE (2023b) clarify that the slopes of the embankments are about 1V:1H (45°), which is far too steep (see Fig. 24). In fact, a slope of 1V:1H is regarded as the maximum critical angle for the prevention of internal erosion (Holtz et al., 2000), which implies that the embankments of Pond No. 15 have always existed on the cusp of failure. Therefore, once the geomembrane tore, the water from the tailings pond was flowing so fast through the tear and then across the embankment that it was able to entrain solid particles. The steepness of the embankment is also evident in the way that the local resident struggled to gain footing to collect a water sample from the leaking tailings dam (see Fig. 6). The steepness of the embankment is further indicated by the steepness of the pipe, the exposed plant roots, and the near vertical fall of contaminated water from the tailings pond (see Fig. 6).

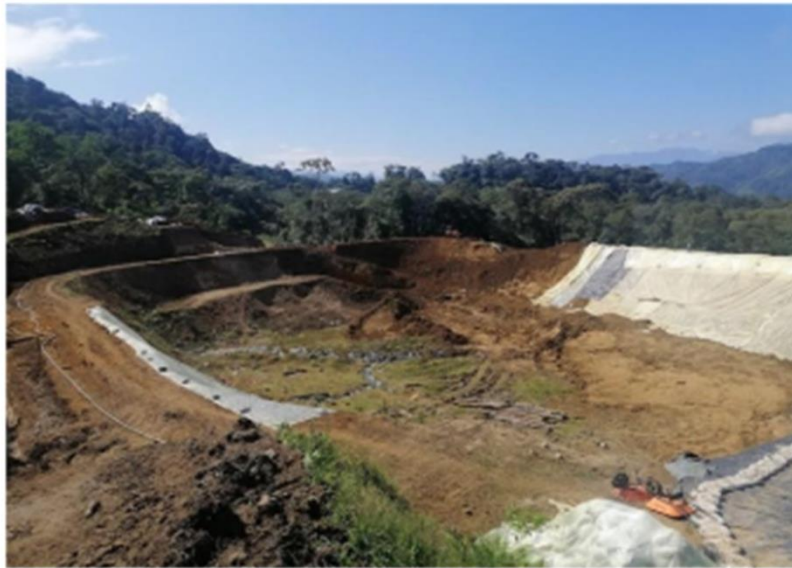
Construction of drains in the foundation of the tailings pond (file photo)

Figure 25. Drains were constructed in the foundations of the tailings ponds underneath the geomembrane. However, there are no drains that would force water and tailings that escape from the geomembrane and flow against the tailings dam to exit the tailings dam at the toe (compare with Figs. 10-11). Photo from Agroindustrial El Corazón S.A. (2023a) with overlay of English label.
