The Track Record of Environmental
Impacts Resulting from Pipeline Spills,
Accidental Releases and Failure to
Capture and Treat Mine Impacted Water

U.S. Gold Mines Spills & Failures Report

JULY 2017

BY BONNIE GESTRING AND JOHN HADDER

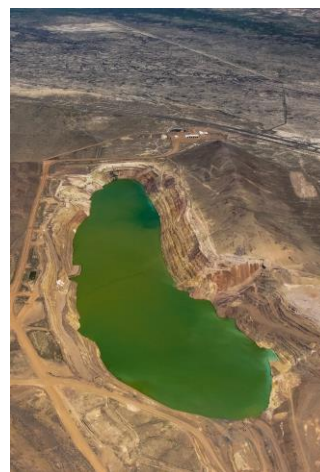
Lone Tree Mine pit lake.
