Filtered Tailings in Indonesia

The Catastrophic Failure of a Disruptive Technology

Technical Report: Steven H. Emerman, PhD, Malach Consulting

March, 2026

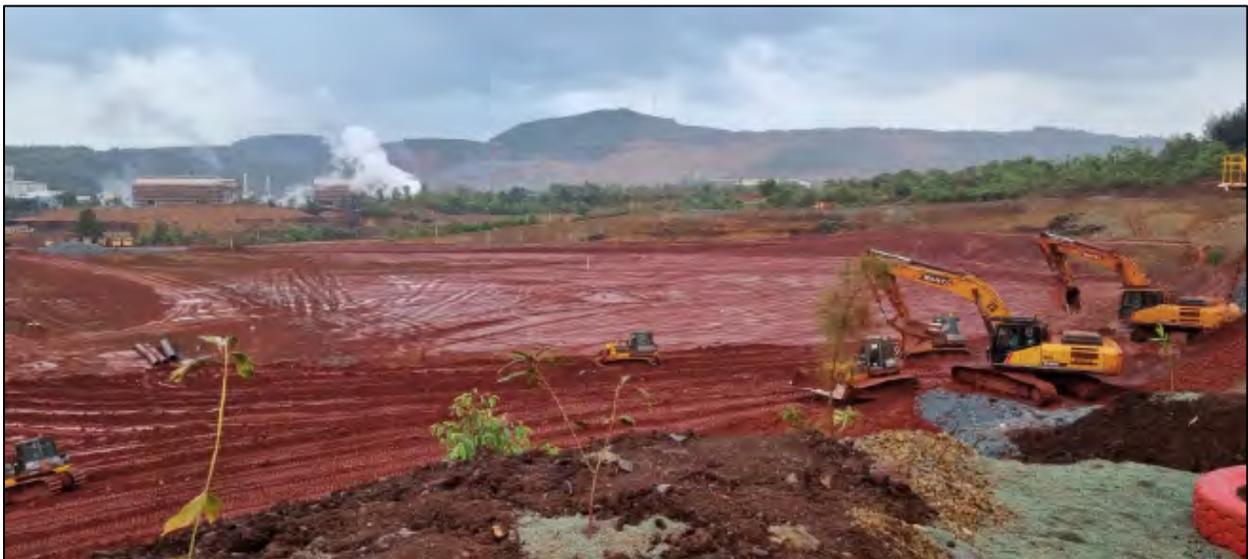
Figure 4. Panoramic view of filtered tailings storage facility in Indonesia. The precise location is not stated. Photo from Fisher and Grossl (2023).

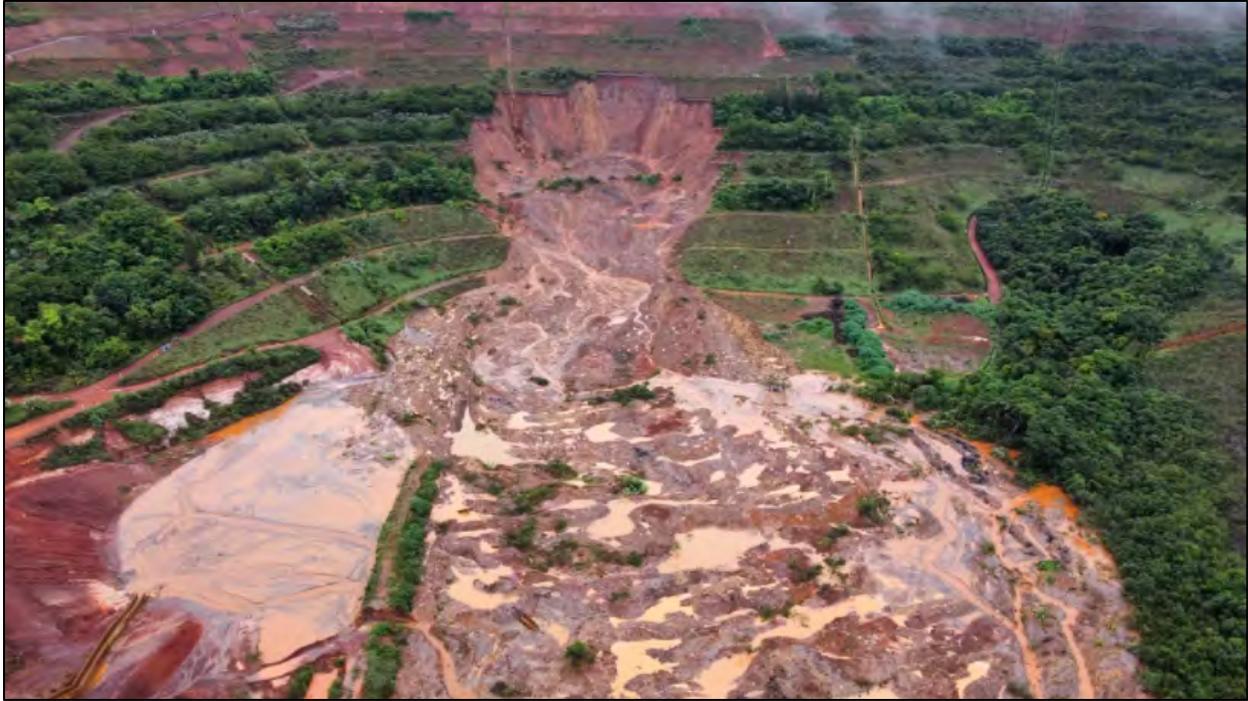
Figure 14. A 48-meter-high filtered tailings stack collapsed at the Pau Branco iron-ore mine in Brazil on January 8, 2022. Although filtered tailings are regarded as the Best Available Technology at the present time (Independent Expert Engineering Investigation and Review Panel, 2015; Morrill et al., 2022), the use of filtered tailings technology is not a license to ignore every other aspect of safety. Photo from Angelo (2022).

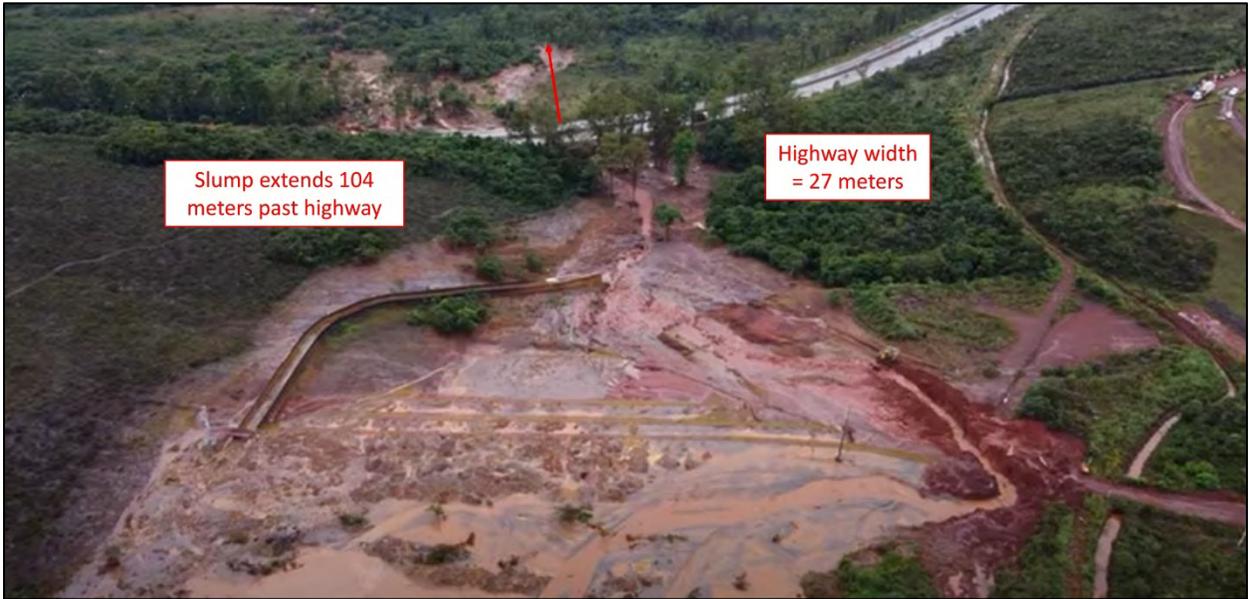
Figure 15a. Based on the highway width of 27 meters, the slump at the filtered tailings storage facility at the Pau Branco mine in Brazil on January 8, 2022 (see Fig. 14), extended for 104 meters past Highway BR-40. Highway width was measured from Google Earth image from June 29, 2022 (see Fig. 15b). Still image at 0:38 of drone video (Observatório da Mineração [Mining Observatory], 2022).

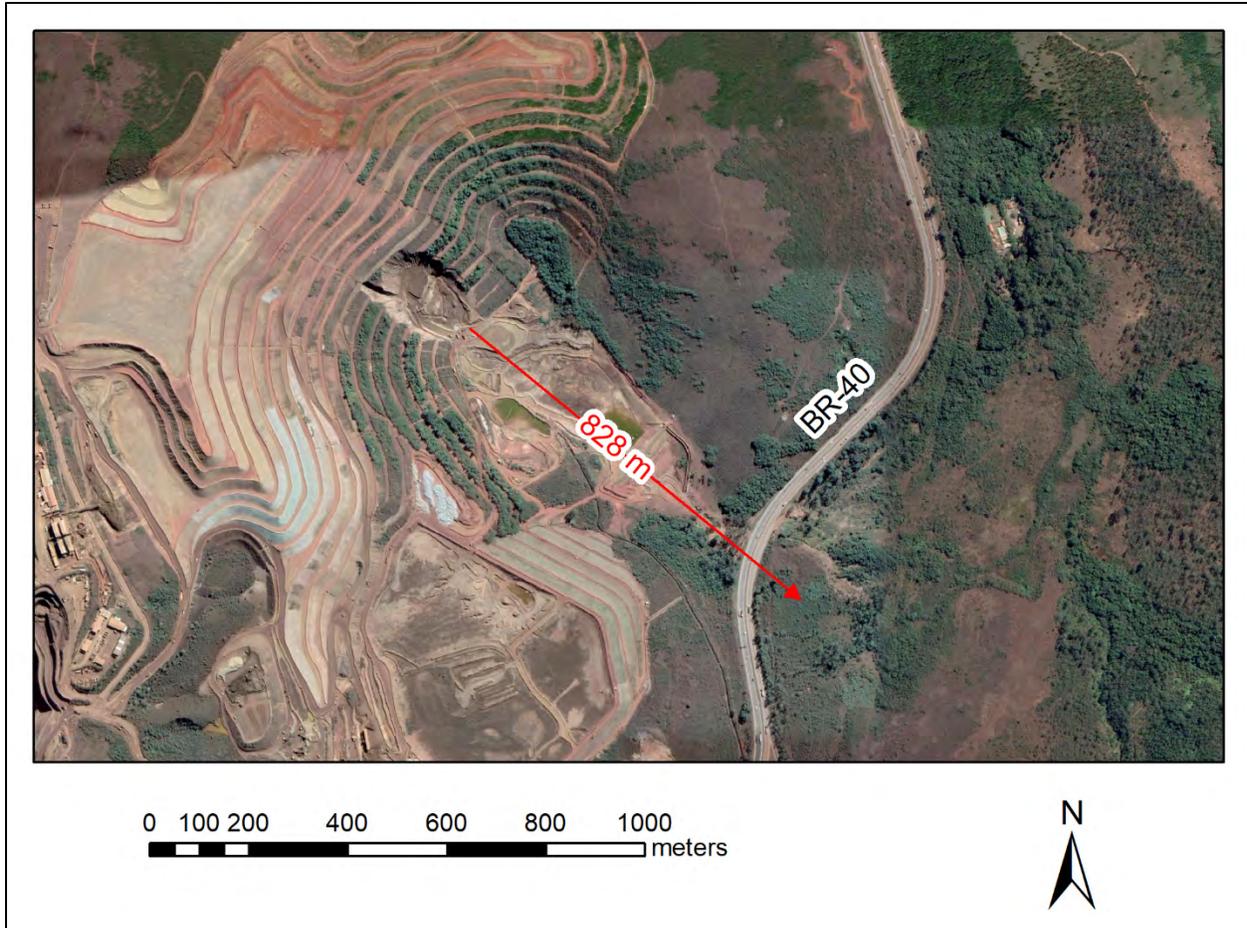
Figure 15b. The slump of the filtered tailings storage facility at the Pau Branco mine in Brazil on January 8, 2022 (see Fig. 14), extended for 828 meters past the toe of the facility or 17.25 times the height of the filtered tailings storage facility of 48 meters (Agência Nacional de Mineração [National Mining Agency], 2025). Background is Google Earth image from June 29, 2022.

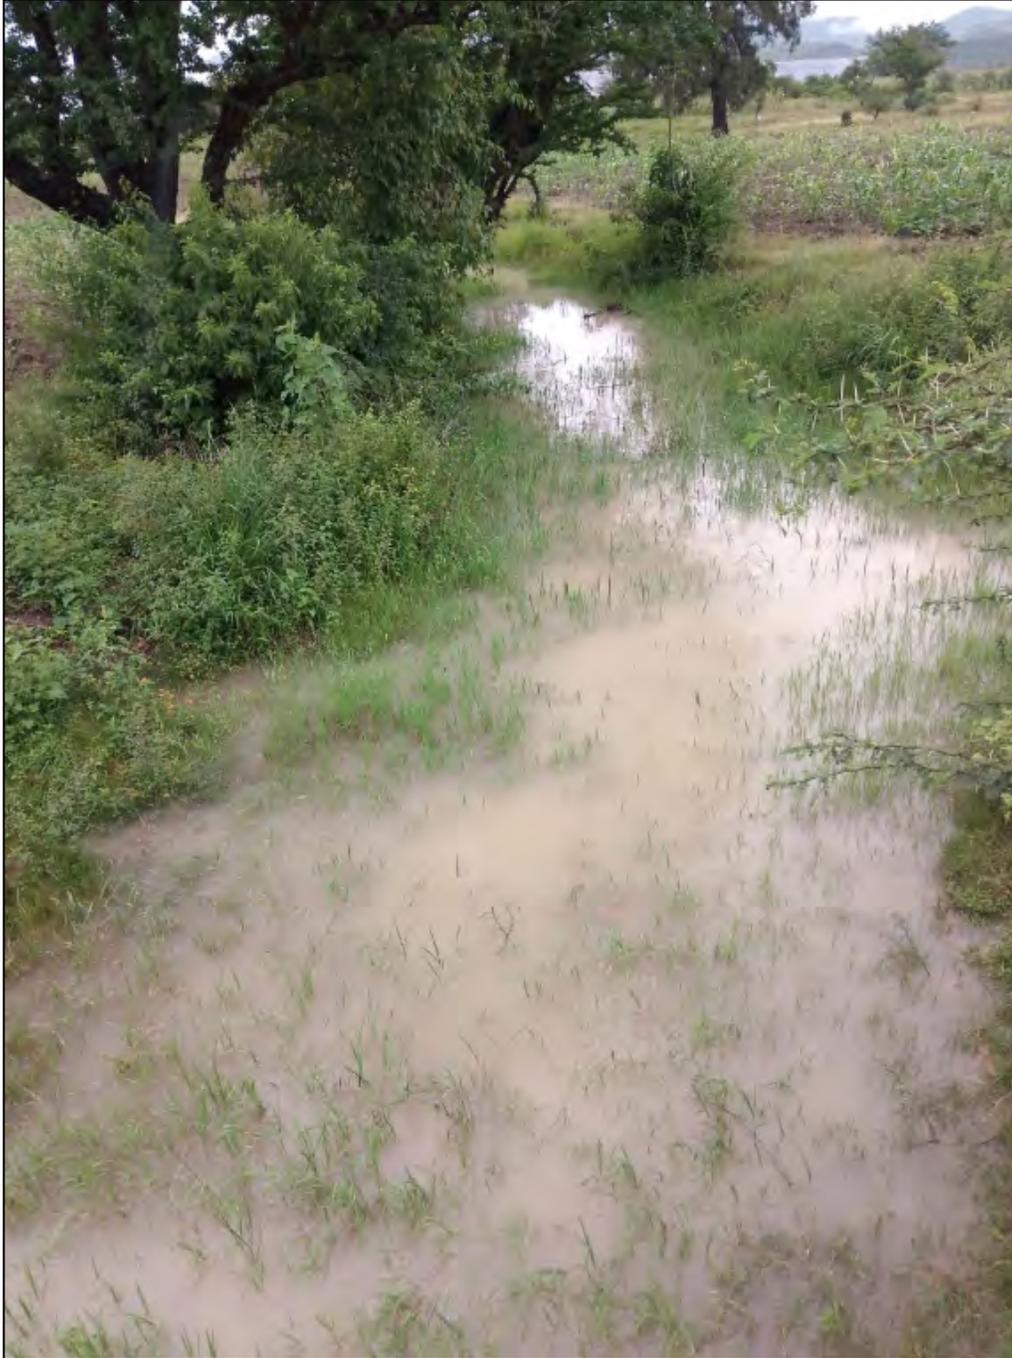
Figure 16. On September 24, 2024, a failure of the filtered tailings storage facility of the mining company Cuzcatlán SA de CV, a subsidiary of the Canadian company Fortuna Mining, in Oaxaca, Mexico, released contaminated water into the El Coyote river. The contamination extended to the drinking water well that supplies the communities of Magdalena Ocotlán and San Matías Chilazoa. A previous failure with release of contaminated water had occurred in 2018. Photo from Desinformémonos (2024).

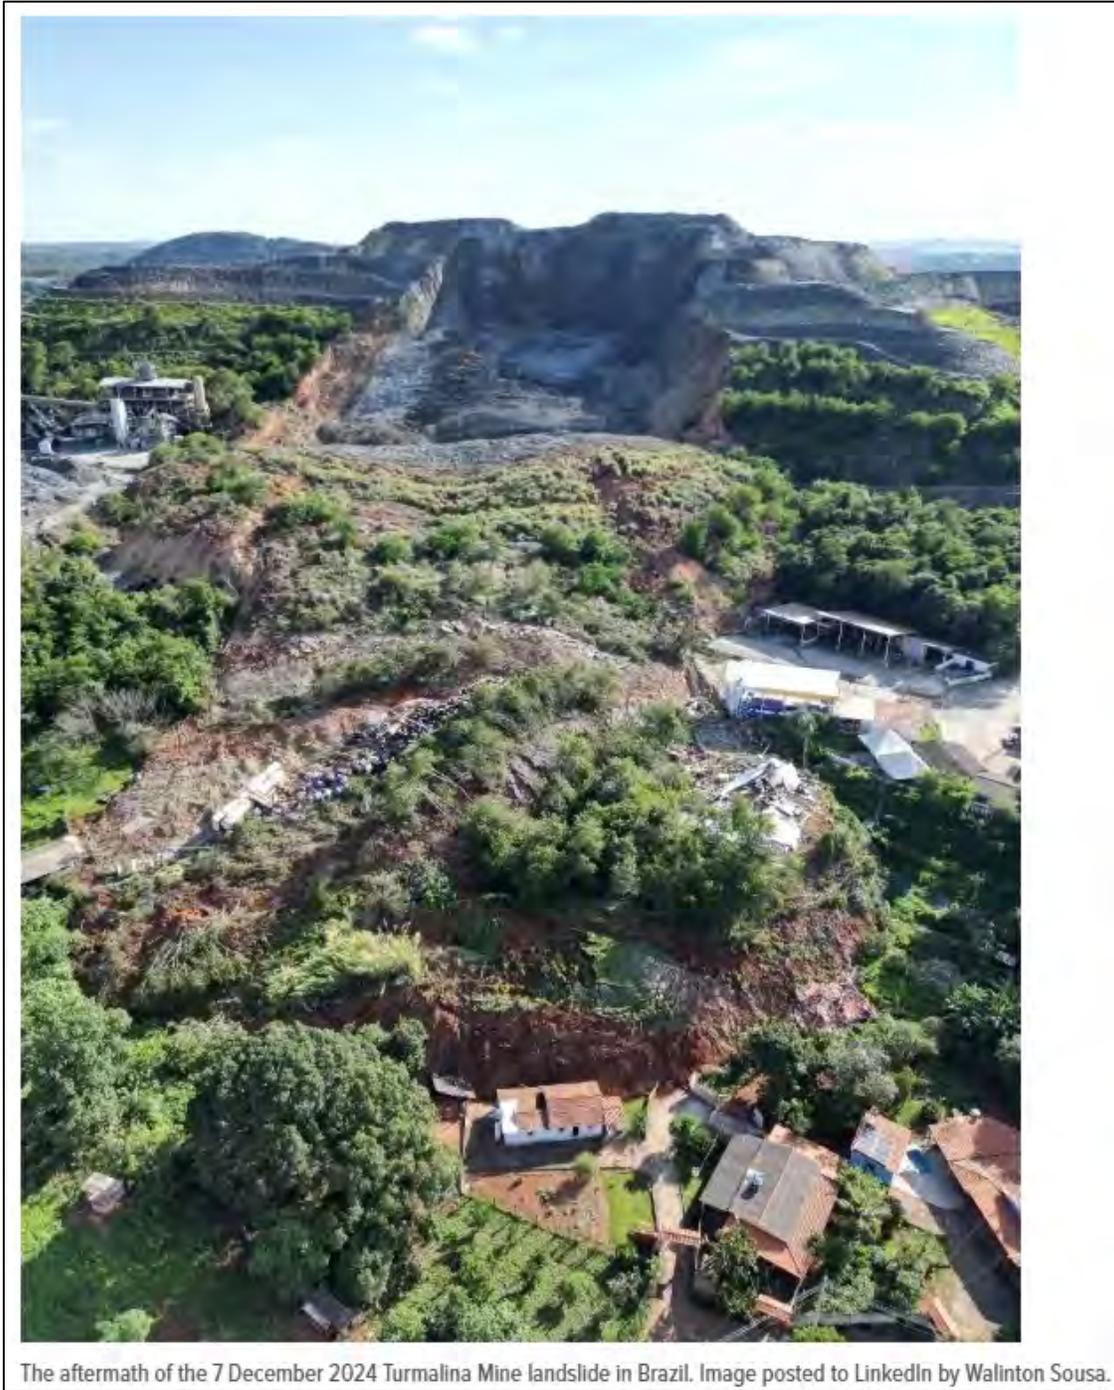
The aftermath of the 7 December 2024 Turmalina Mine landslide in Brazil. Image posted to LinkedIn by Walinton Sousa.

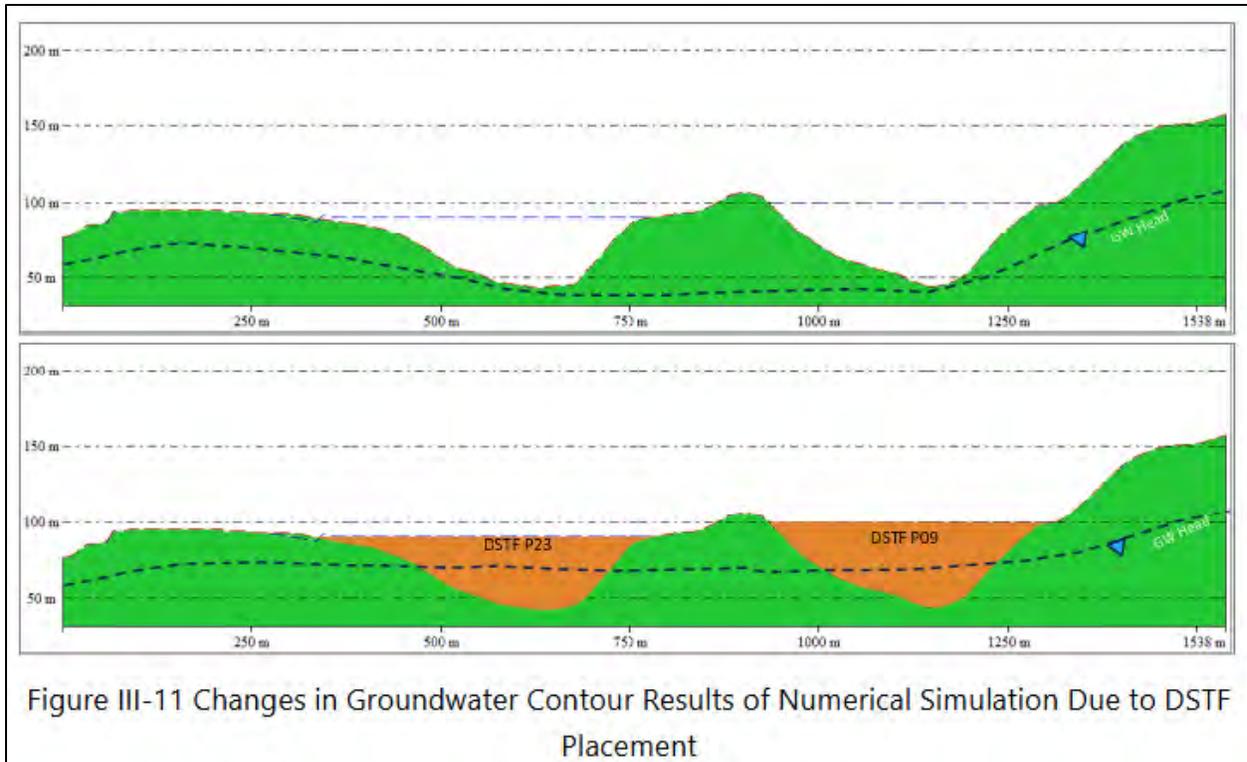
Figure 28. A consulting report by PT Lapi ITB predicted the rise in the water table within the Dry Stack Tailings Facility (DSTF) at the PT HPL mine due to the inability of leakage from the facility to flow away fast enough into the underlying aquifer (see Figs. 27a-b). Another consulting report by Hatch (2020) expressed concern that the rise in the water table could lead to instability and liquefaction of the filtered tailings stack. According to Hatch (2020), “In their hydrogeological modelling [by PT Lapi] it was shown that the groundwater table will rise locally in the tailings stack sites to approximately 30 m to 80 masl ... This indicates that a system of internal drainage within the tailings stack will also be required in order to lower the groundwater table and reduce the risk of slope instability and liquefaction of the tailings ... The conclusion of this stability analysis is that the phreatic surface or water level within the tailings stack should be kept below the 30 m depth mark from the final stack elevation to satisfy the pseudostatic [seismic] stability condition.” Figure from PT Lapi ITB (2020).

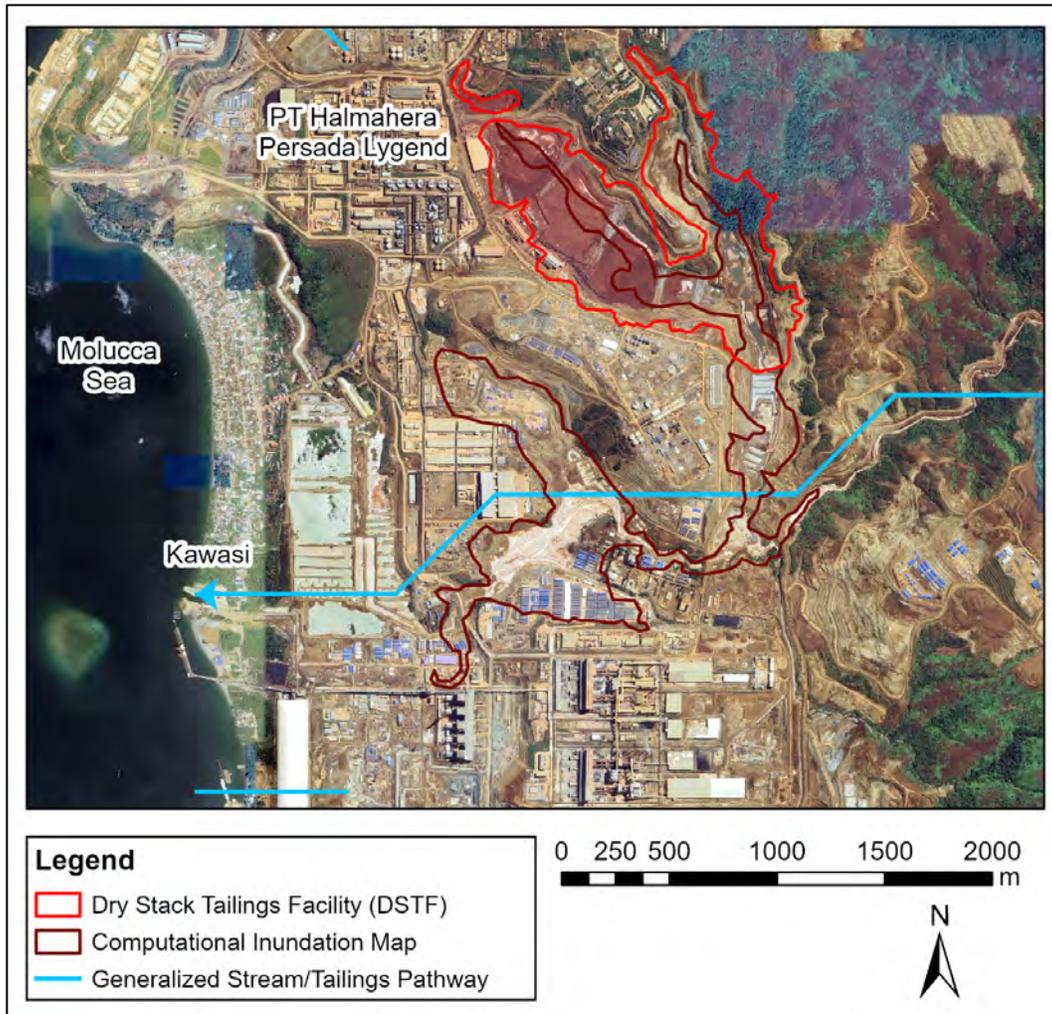
Figure 34. A computational model by consultants for Harita Nickel shows a runout distance of 2200 meters after collapse of the Dry Stack Tailings Facility (DSTF) assuming liquefaction of the tailings. By contrast, based on a statistical model of past tailings facility failures, the height (57 meters) and storage volume (25.8 million cubic meters) of the facility predict a runout distance of 47 kilometers (see Fig. 19b), which would easily transport the tailings to the ocean. The limited distance and irregular ponding predicted by the computational model probably results from an incorrect topographic model that creates fictitious barriers to flow. The most-likely scenario is that the tailings will enter an unnamed stream less than 600 meters downslope from the DSTF and then flow westward to the Molucca Sea with crossing of considerable mining infrastructure and overtopping of the stream channel onto the village of Kawasi. Note the small offset between the generalized stream from HydroSheds (2025) and the Google Earth imagery from August 6 and November 20, 2023. Even without initial liquefaction, a slump of the DSTF will carry the tailings to the unnamed stream, at which point the tailings will become a fully fluidized mass. Outline of Dry Stack Tailings Facility from PT Lapi ITB (2022) and outline of computational inundation map from PT Lapi ITB (2020).

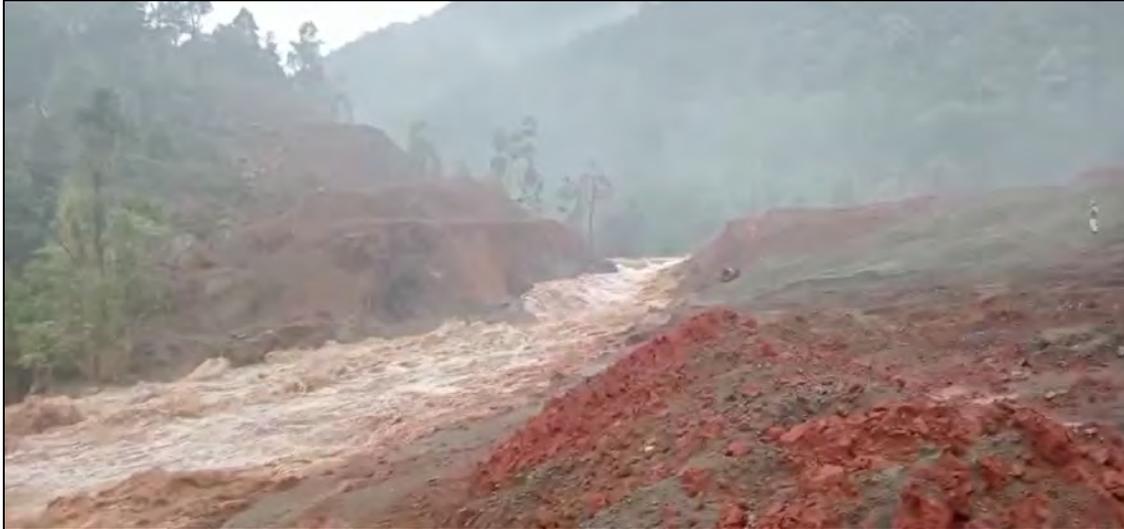
At the Indonesia Morowali Industrial Park, harmful and even deadly tailings failures are already happening. According to media and worker testimony, on March 16, 2025 the PT Huayue Nickel Cobalt (PT HYNC) tailings storage facility inside IMIP was breached, and liquified tailings flowed into the Bahadopi River and eventually the ocean.^{xix}

Figure 40a. Liquefied tailings flow through a breach of the filtered tailings storage facility of PT Huayue Nickel Cobalt (HYNC) in the Indonesia Morowali Industrial Park (see Figs. 3, 24, and 41a-b) on March 16, 2025. Still image at 0:00 of 9-second video by mineworker at PT HYNC. Photo also available in Business & Human Rights Resource Centre (2025a) and Moore (2025).

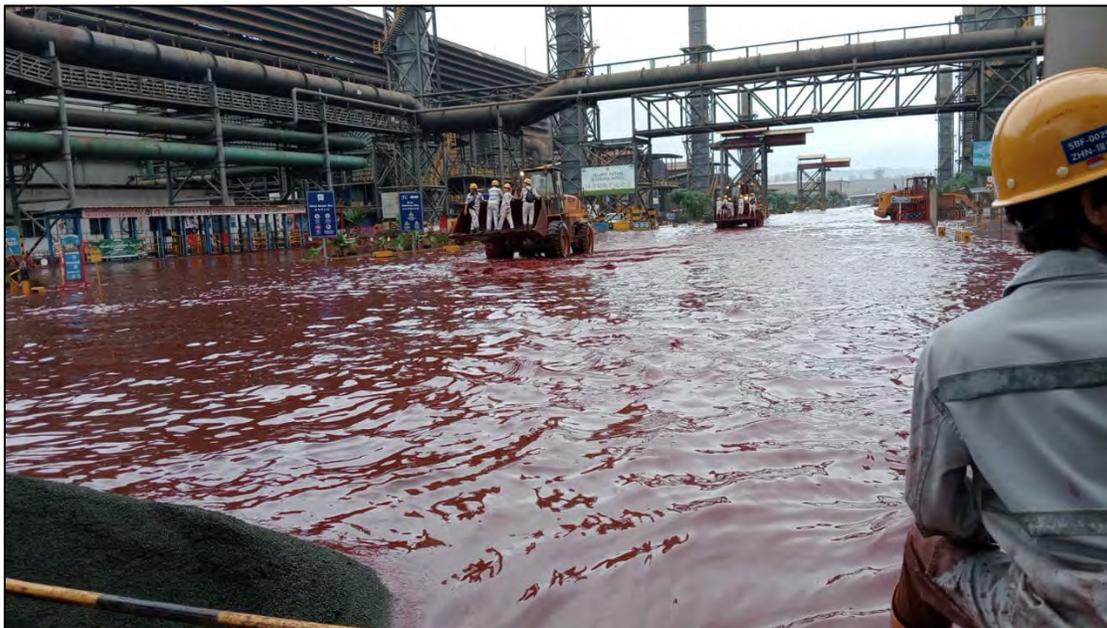
Figure 40b. Tailings released by a collapse on March 16, 2025, of the filtered tailings storage facility of PT Huayue Nickel Cobalt (HYNC) in the Indonesia Morowali Industrial Park (see Figs. 3, 23, 24, and 41a-b) flow down the Bahodopi River. Photo by mineworker at PT HYNC and available in Business & Human Rights Resource Centre (2025a) and Moore (2025). Similar photos are available in Bhawano (2025), Pristiandaru (2025), Teraskabar.id (2025), and Wikaksono (2025).

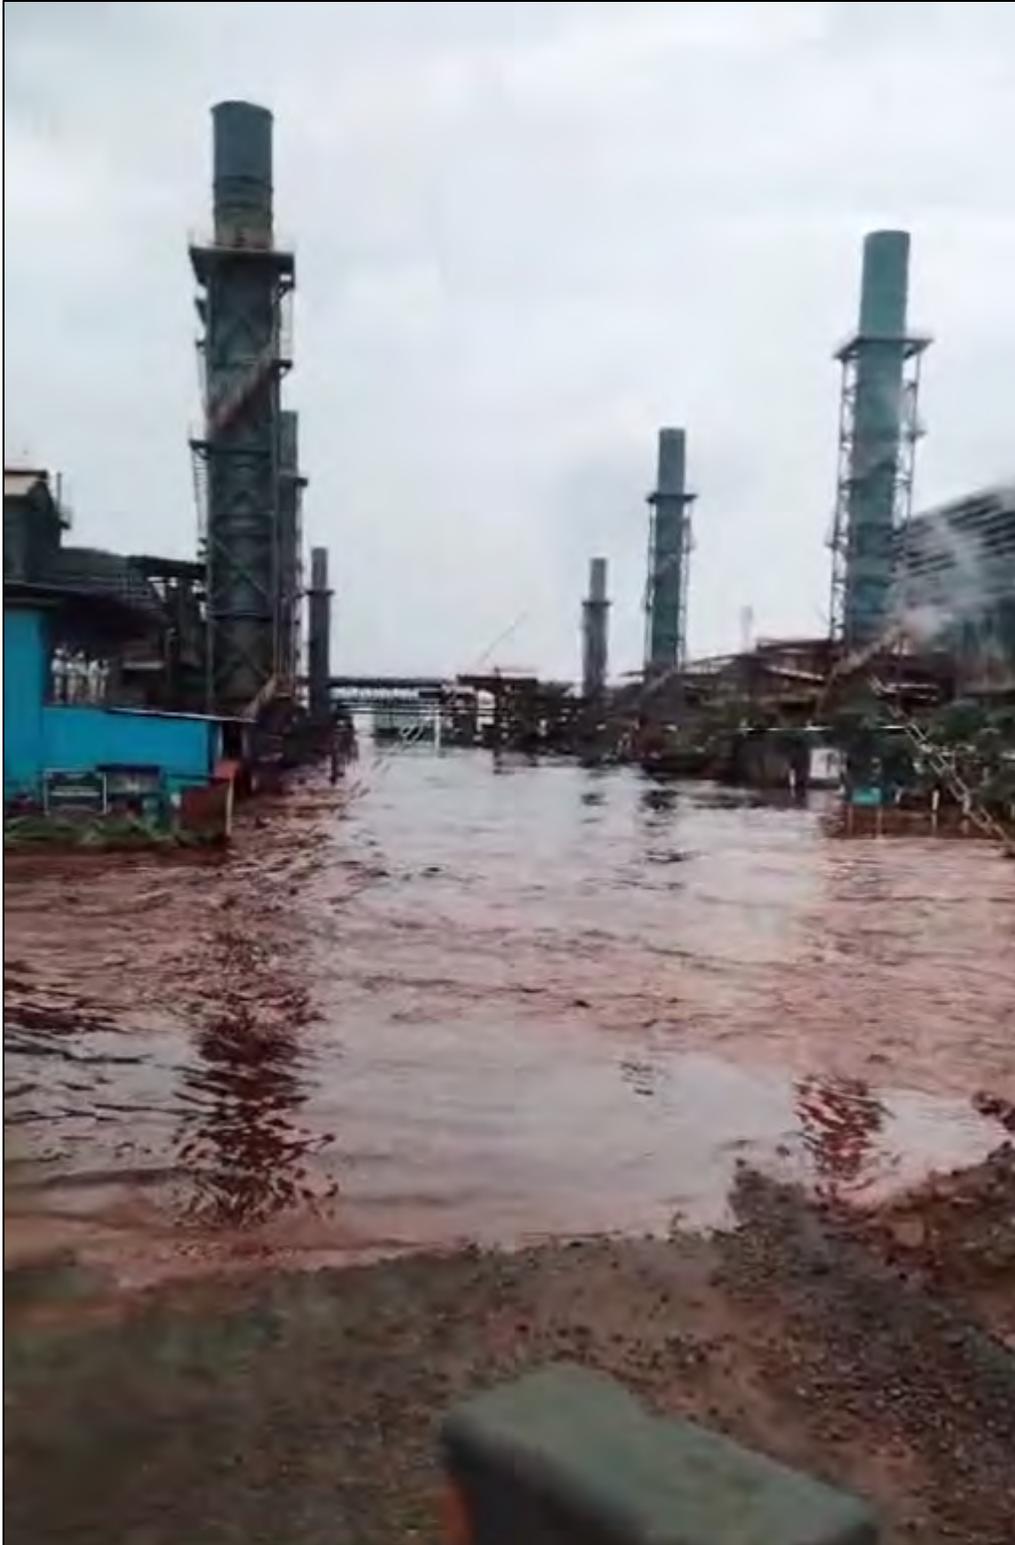
Figure 40c. Liquefied tailings from the failure of the filtered tailings storage facility of PT HYNC plus flood water from the Bahodopi River (see Figs. 40a-b) overflow onto the site of PT Fajar Metal Industry (FMI) on March 16, 2025 (see Figs. 23-24). Still image at 0:03 of 10-second video by mineworker.

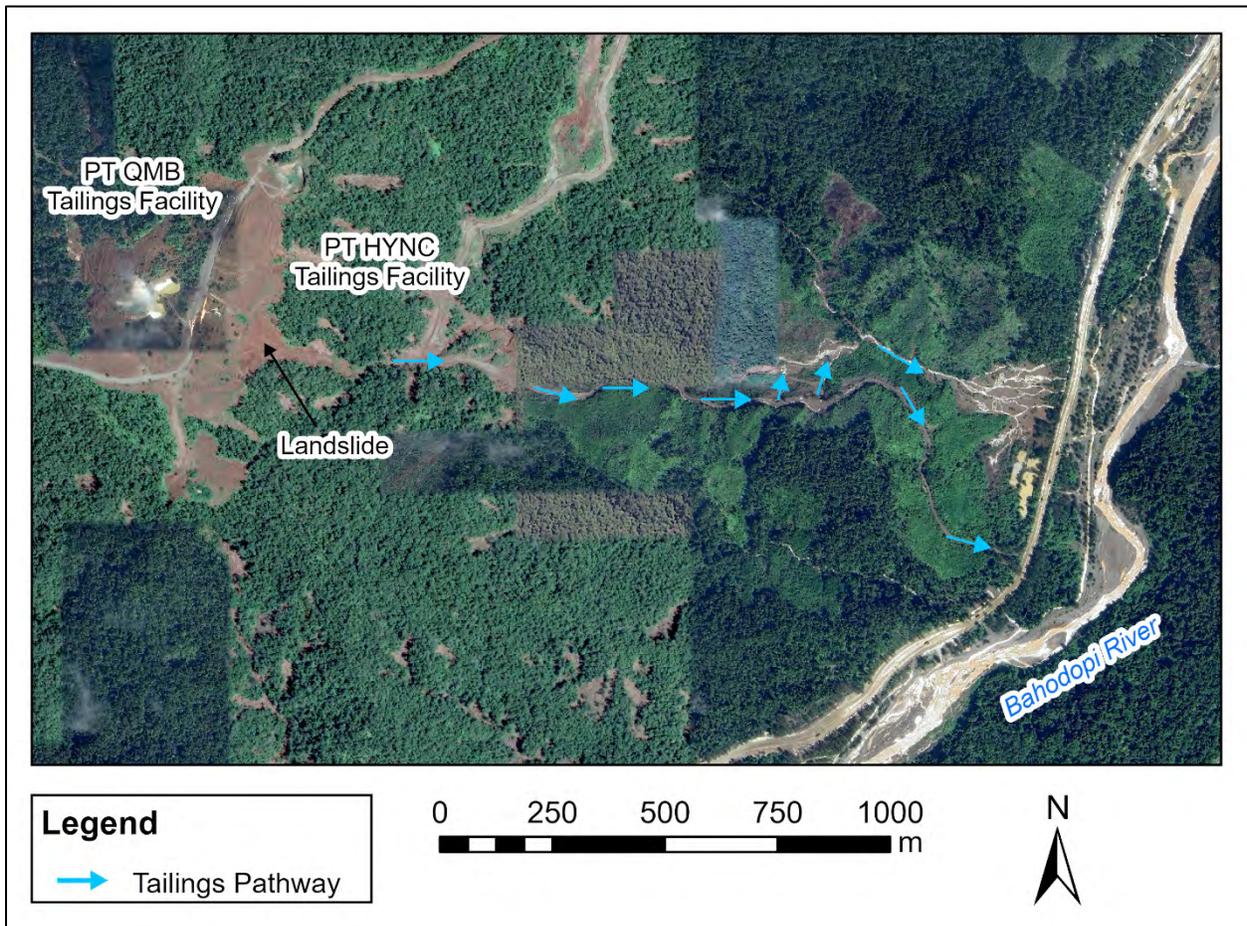
Satellite imagery shows that the March 2025 failures at IMIP were likely not the first. Images from January 3, 2025, show a clearly-defined landslide from the PT HYNC filtered tailings storage facility with channels for tailings to travel to the Bahodopi River. A video taken by a mineworker in September 2023 shows a bulldozer being engulfed by a landslide at an unidentified filtered tailings storage facility at IMIP.^{xxiv}

Figure 41a. Google Earth imagery from January 3, 2025, shows a clearly-defined landslide from the filtered tailings storage facility operated by PT Huayue Nickel Cobalt (HYNC) with clearly-defined channels for tailings to travel to the Bahodopi River (see smaller-scale view in Fig. 41b). Thus, it appears that at least one collapse of the PT HYNC tailings facility occurred even before the collapse on March 16, 2025 (see Fig. 40a-c). It is not entirely clear as to whether the filtered tailings storage facilities for PT HYNC and PT QMB are actually separate facilities (see Figs. 40a and 42a). The darker Google Earth imagery is from January 7, 2020. Indonesian versions of the above map are available in Bhawano (2025) and Yayasan Tanah Merdeka (YTM) (2025b).

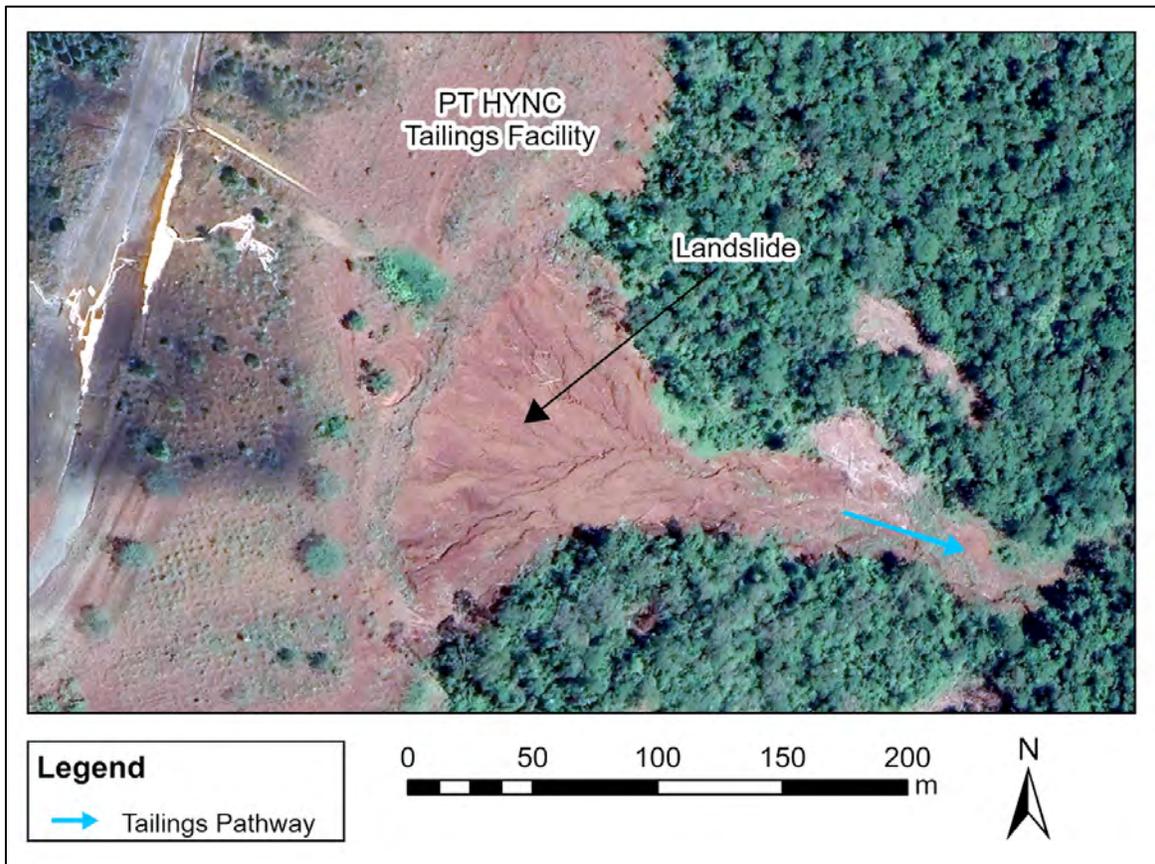
Figure 41b. Google Earth imagery from January 3, 2025, shows a clearly-defined landslide from the filtered tailings storage facility operated by PT Huayue Nickel Cobalt (HYNC) (see larger-scale view with continuation of tailings pathway in Fig. 41a). Thus, it appears that at least one collapse of the PT HYNC tailings facility occurred even before the collapse on March 16, 2025 (see Figs. 40a-c). Map also available in Business & Human Rights Resource Centre (2025a) and Moore (2025).

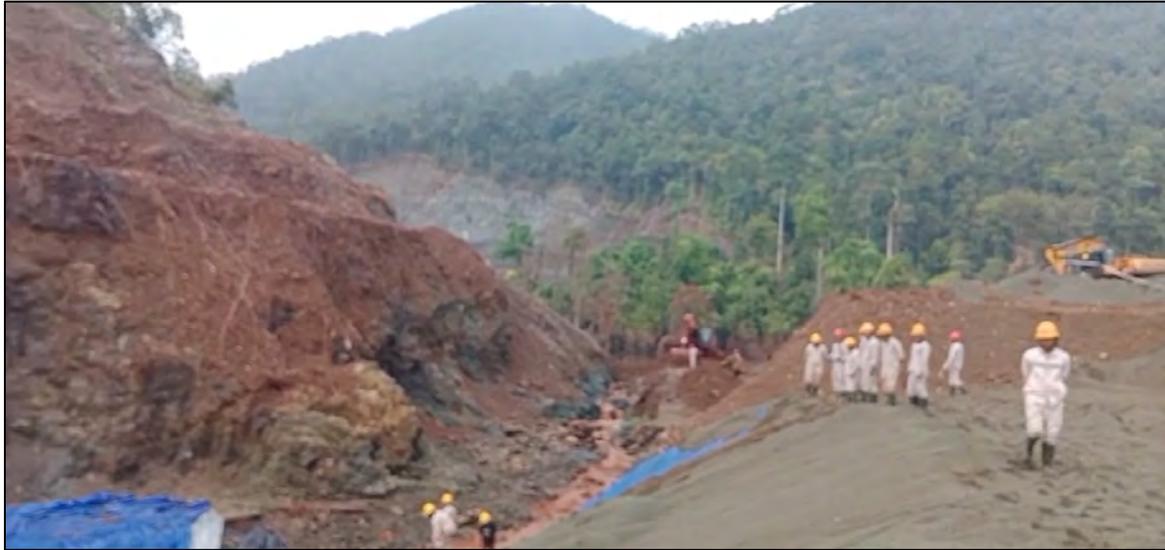
Five days later, on March 21, another tailings facility inside IMIP, owned by PT Qing Mei Bang (PT QMB) New Energy Materials, collapsed, killing three workers.^{xx} According to testimony from workers represented by SPIM-KPBI, the second largest union at IMIP, the tailings facility was constructed on top of an infilled pond. Photos taken at the site of rescue efforts show a pond where the body of one of the workers was found. The PT QMB tailings facility that collapsed is located right next to the PT Huayue Nickel Cobalt (PT HYNC) tailings facility, at a location locally known as KM8. It is unclear if these two facilities actually operate as one.

Figure 42a. The collapse of the filtered tailings storage facility of PT Qing Mei Bang (QMB) New Energy Materials in the Indonesia Morowali Industrial Park (see Figs. 3, 23, 24, and 41a) on March 21, 2025, resulted in the burial of four workers with three fatalities and one survivor. The four workers were employees of PT Morowali Investasi Konstruksi Indonesia (MIKI), which is a contractor of PT QMB New Energy Materials. Because of the similarity with Fig. 40a, it is not clear as to whether the filtered tailings storage facilities of PT HYNC and PT QMB are actually separate facilities. Still image at 0:12 from video shared by mineworker.

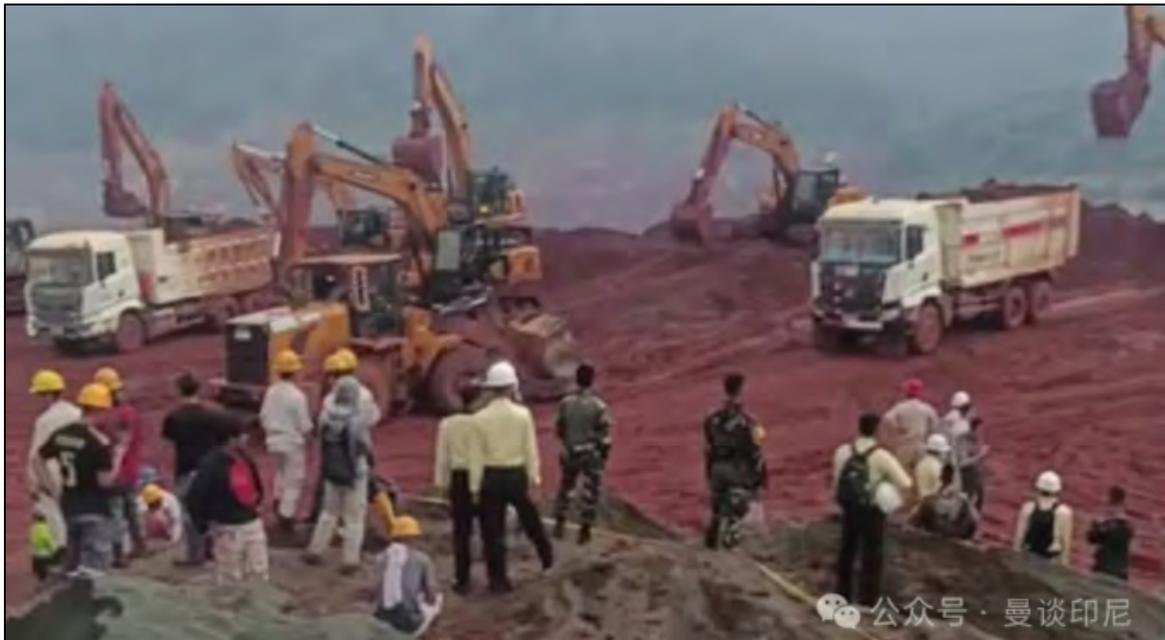
Figure 42b. On March 22, 2025, excavators search for four buried workers from the collapse on the previous day of the filtered tailings storage facility of PT Qing Mei Bang (QMB) New Energy Materials in the Indonesia Morowali Industrial Park (see Figs. 3, 23, 24, and 41a). The four workers were employees of PT Morowali Investasi Konstruksi Indonesia (MIKI), which is a contractor of PT QMB New Energy Materials. Photo from 曼谈印尼 [Man in Indonesia] (2025).

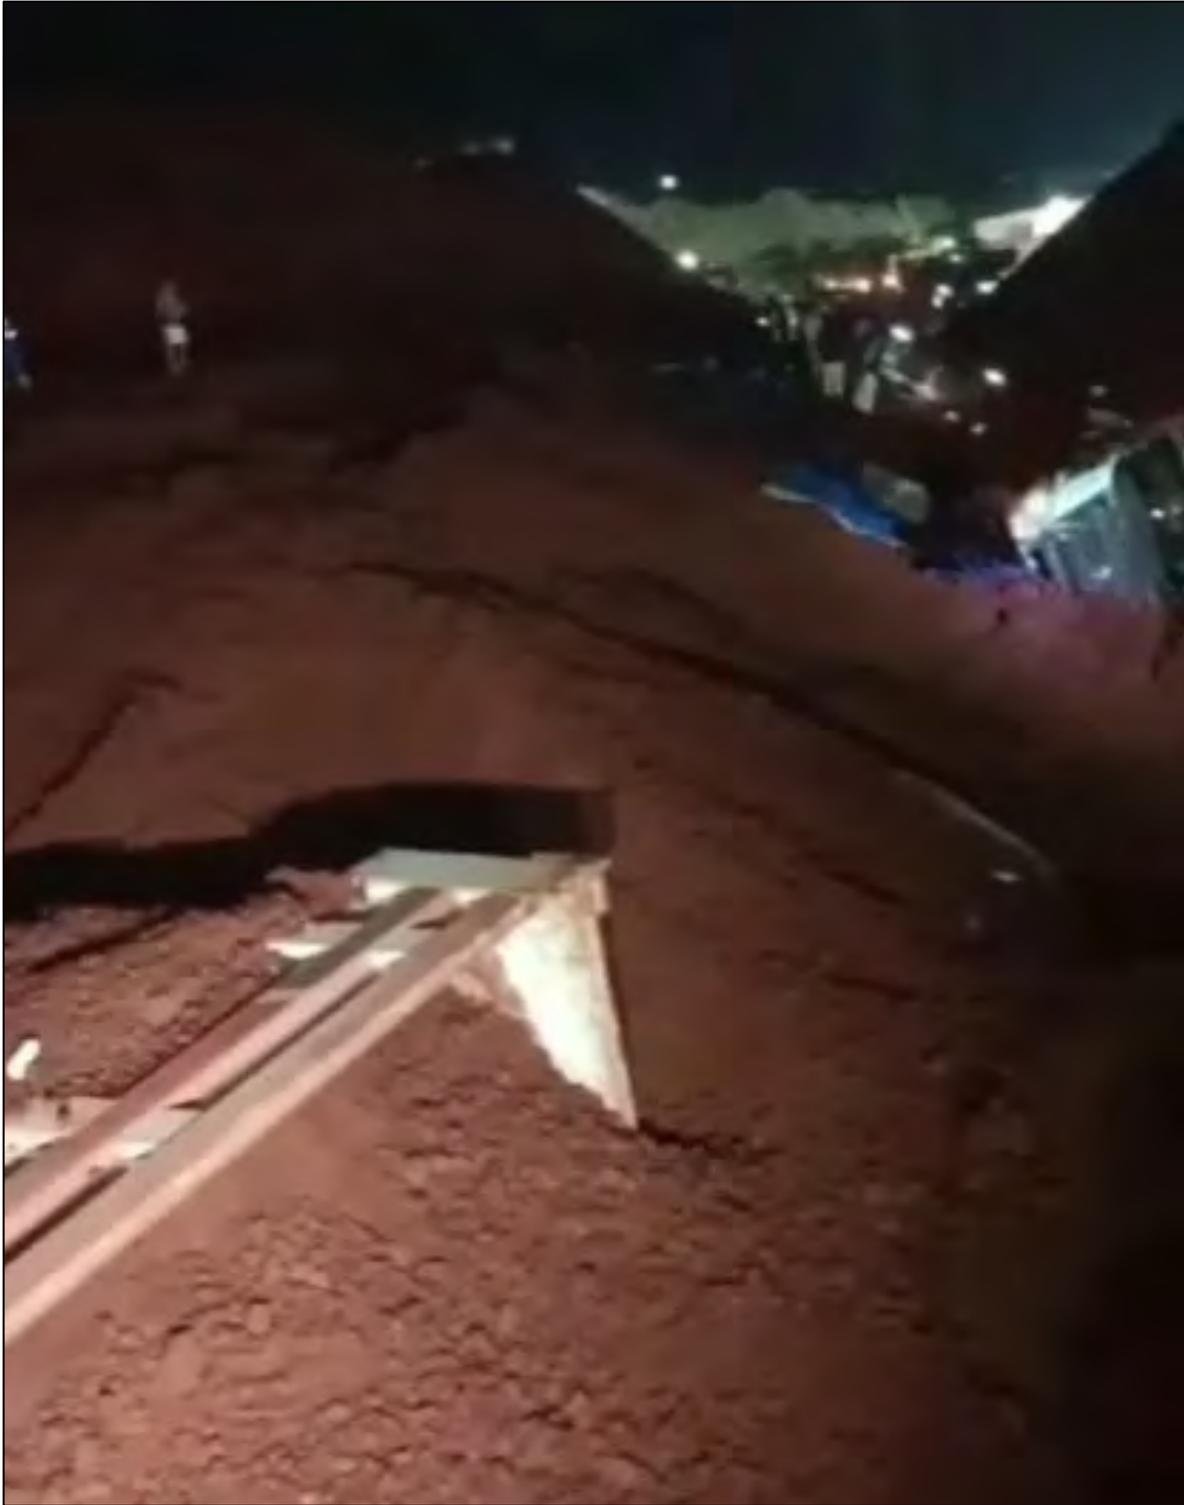
Figure 43. On March 27, 2025, an ore stockpile collapsed at the PT Qing Mei Bang (QMB) New Energy Materials project in the Indonesia Morowali Industrial Park (see Figs. 3 and 23), resulting in the burial of heavy equipment. The location of the ore stockpile is not known. Still image at 0:13 from video shared by mineworker.

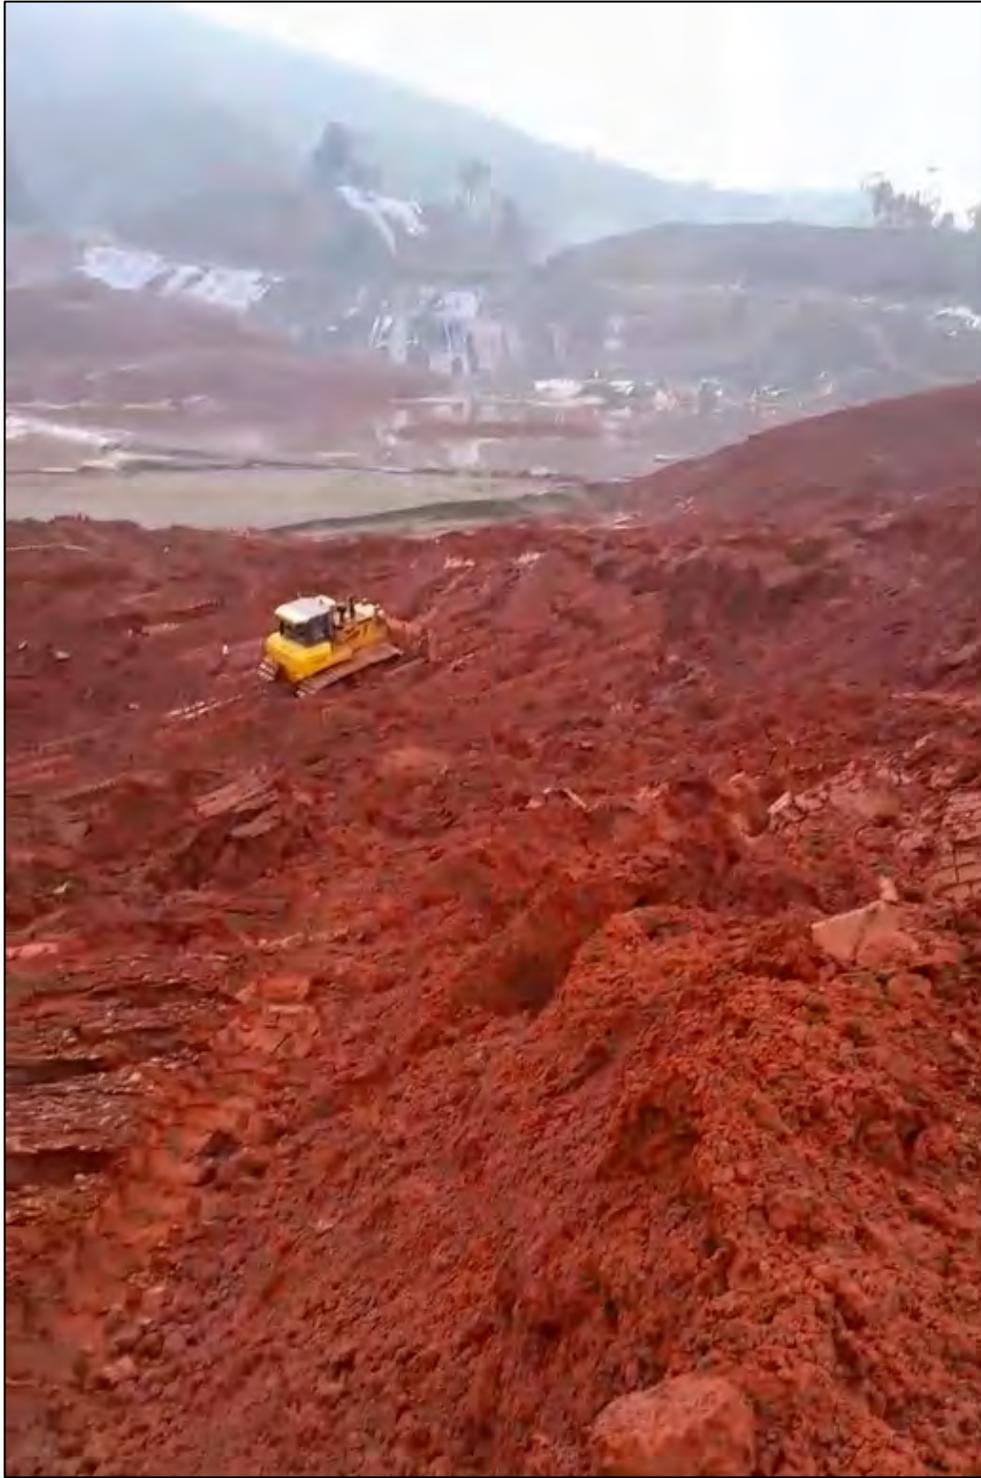
Figure 44. On April 30, 2025, a landslide occurred at the filtered tailings storage facility of PT Qing Mei Bang (QMB) New Energy Materials project in the Indonesia Morowali Industrial Park (see Figs. 3, 23, and 24), Still image at 0:12 of 30-second video by mineworker.
