COPPER SULFIDE MINING:

THE TRACK RECORD OF WATER QUALITY IMPACTS RESULTING FROM PIPELINE SPILLS, TAILINGS FAILURES AND WATER COLLECTION AND TREATMENT FAILURES.

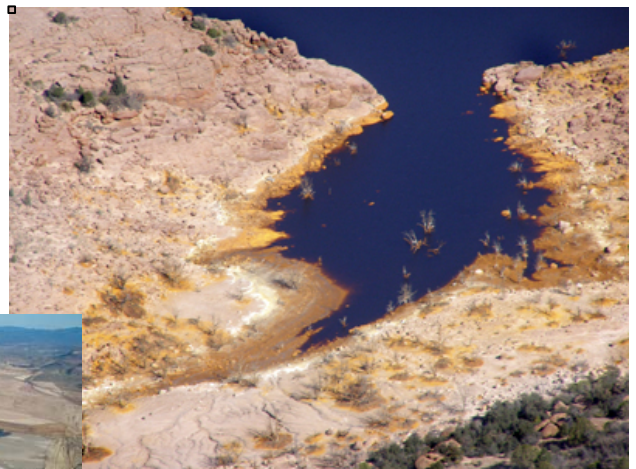
Mine pollution at Arizona copper mine.

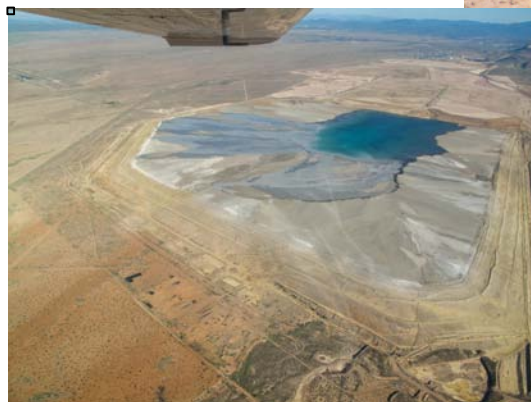
Tailings pond at copper sulfide mine.
