Cause of Failure of the Lagoa do Pirocáua Dam at the Aurizona Mine on March 25, 2021, Maranhão State, Northeast Brazil

Steven H. Emerman, Malach Consulting, 785 N 200 W, Spanish Fork, Utah 84660, USA,
E-mail: SHEmerman@gmail.com, Tel: 1-801-921-1228

Report prepared at the request of Conselho Nacional de Direitos Humanos (CNDH)
Submitted on July 16, 2021

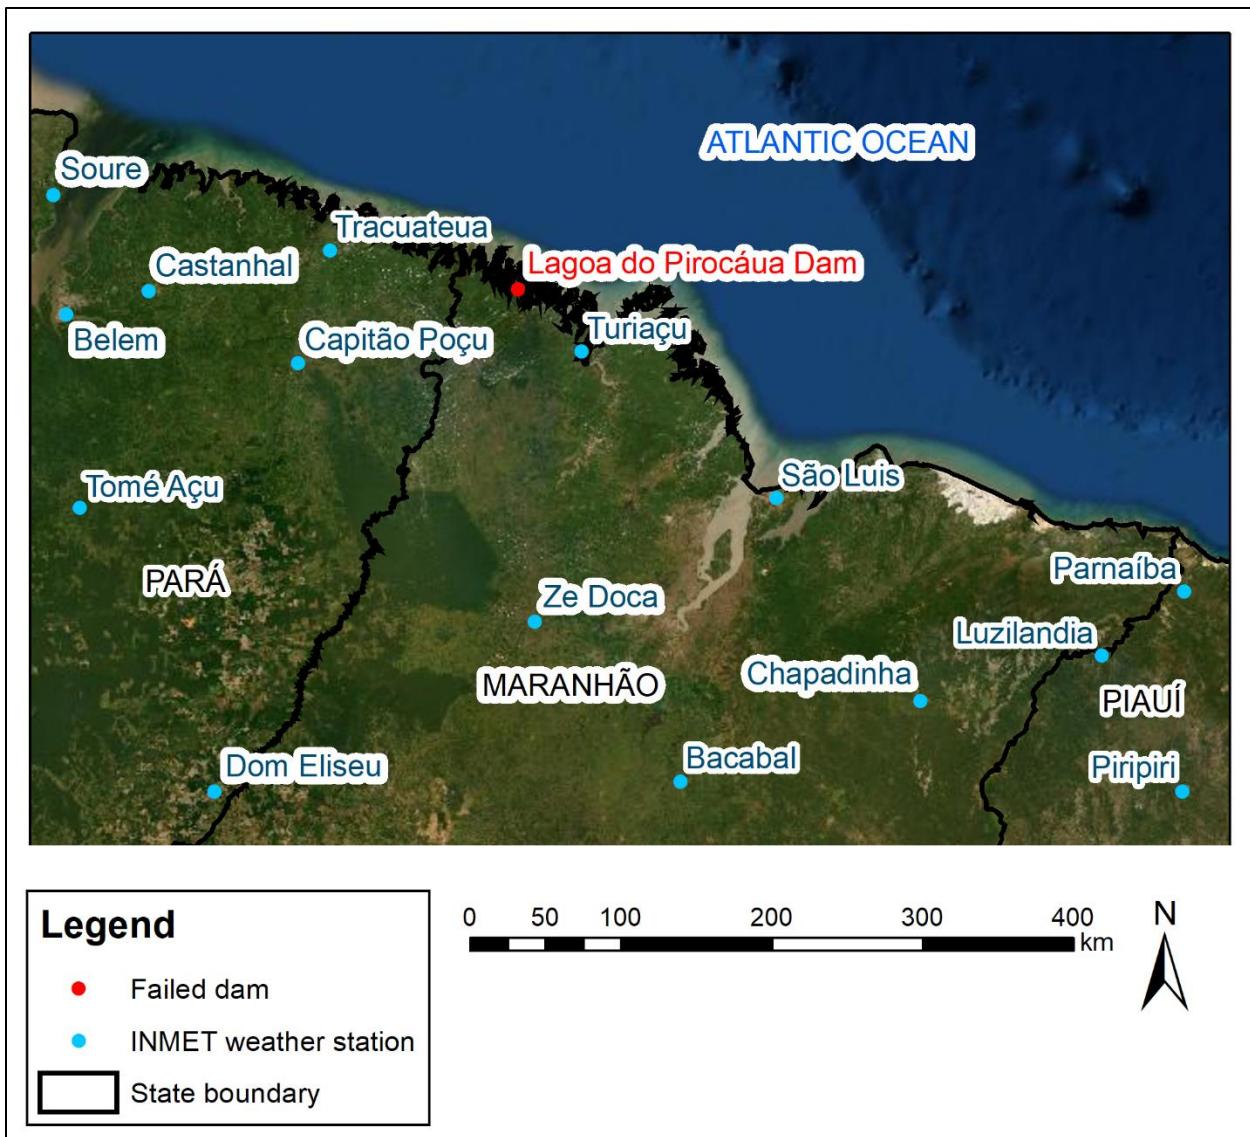
Figure 2. The closest National Institute of Meteorology (INMET) weather stations to the failed Lagoa do Pirocáua dam are at Turiaçu (59 kilometers to the southeast), Tracuateua (128 kilometers to the northwest), and Capitão Poço (154 kilometers to the southwest). The precipitation records at the Turiaçu weather station are most likely to be representative of conditions at the Lagoa do Pirocáua dam, due to their proximity and common location on the Atlantic coast. In addition, the elevation of the crest of the Lagoa do Pirocáua dam (30 meters above sea level) is within 5 meters of the Turiaçu weather station (34.38 meters above sea level; see Table 1). Locations of weather stations from INMET (2021b).

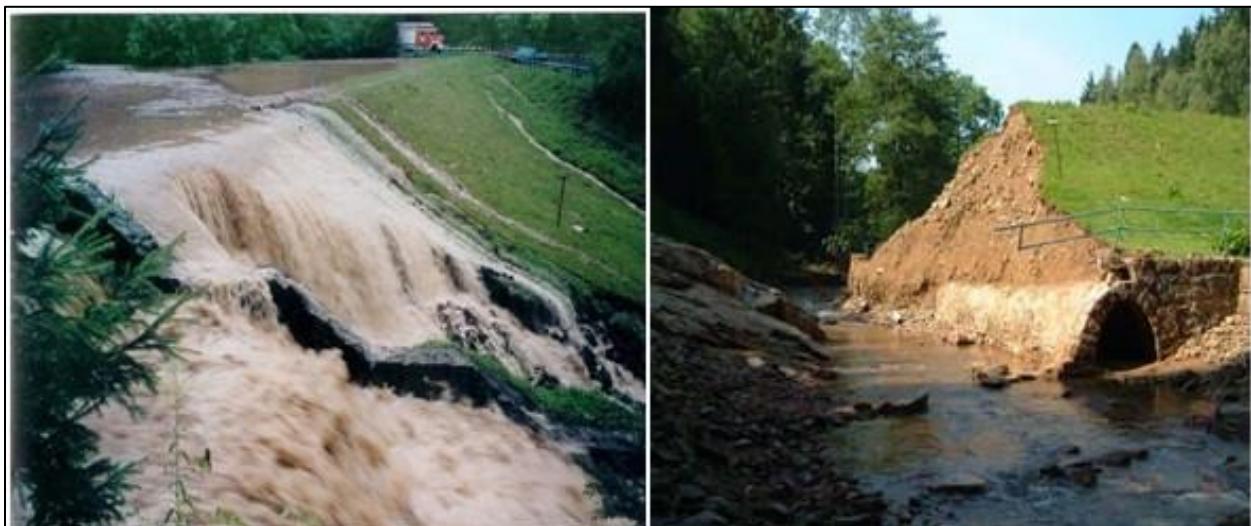
Figure 7. Overtopping of an embankment dam often results in the erosion and breach of the dam. The photos above show the overtopping and breach of the Glashütte embankment dam in Germany on August 23, 2002. Photos from Association of State Dam Safety Officials (2021a).

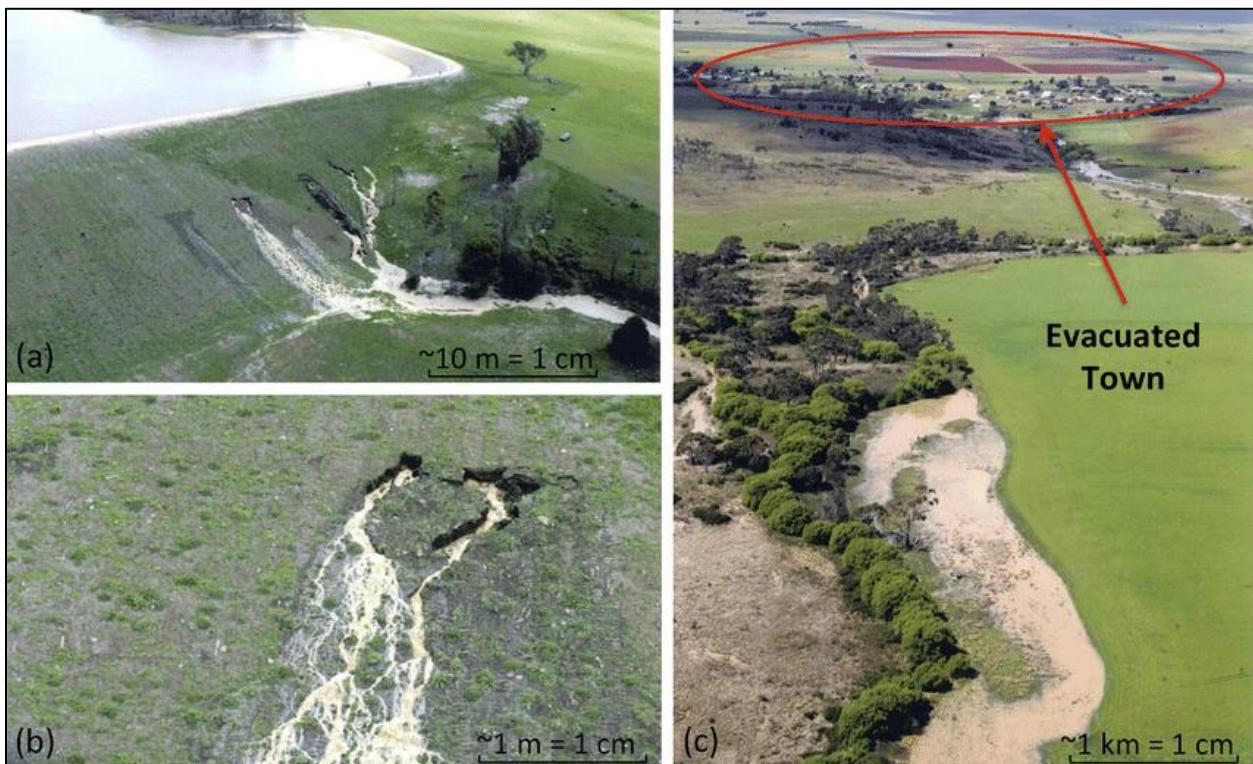
Figure 8. Internal erosion (also called piping) is the phenomenon in which seepage through an embankment dam washes solid particles out of the dam, resulting in the loss of structural integrity of the dam. Photos show an embankment dam in the process of failure by internal erosion near Tunbridge, Australia, in 2005. Photos from Fisher et al. (2017).

Internal erosion (also called piping) is the phenomenon in which seepage through an embankment dam washes solid particles out of the dam, resulting in the loss of structural integrity of the dam (see Fig. 8). Internal erosion can be prevented by increasing the width of the dam (distance from the reservoir to the downstream face) or decreasing the slope of the downstream embankment, so as to decrease the hydraulic gradient and, thus, the seepage

velocity. Other preventive measures including the installation of drains, which will force seepage to exit at the toe of the dam rather than along the face, or filters that will trap fine particles and prevent their transport out of the dam. Typically, the emergence of muddy water on the downstream face of an embankment dam is a sign of the initiation of internal erosion and a signal to begin emergency repairs, such as constructing a buttress along the toe of the dam to lengthen the seepage pathway.

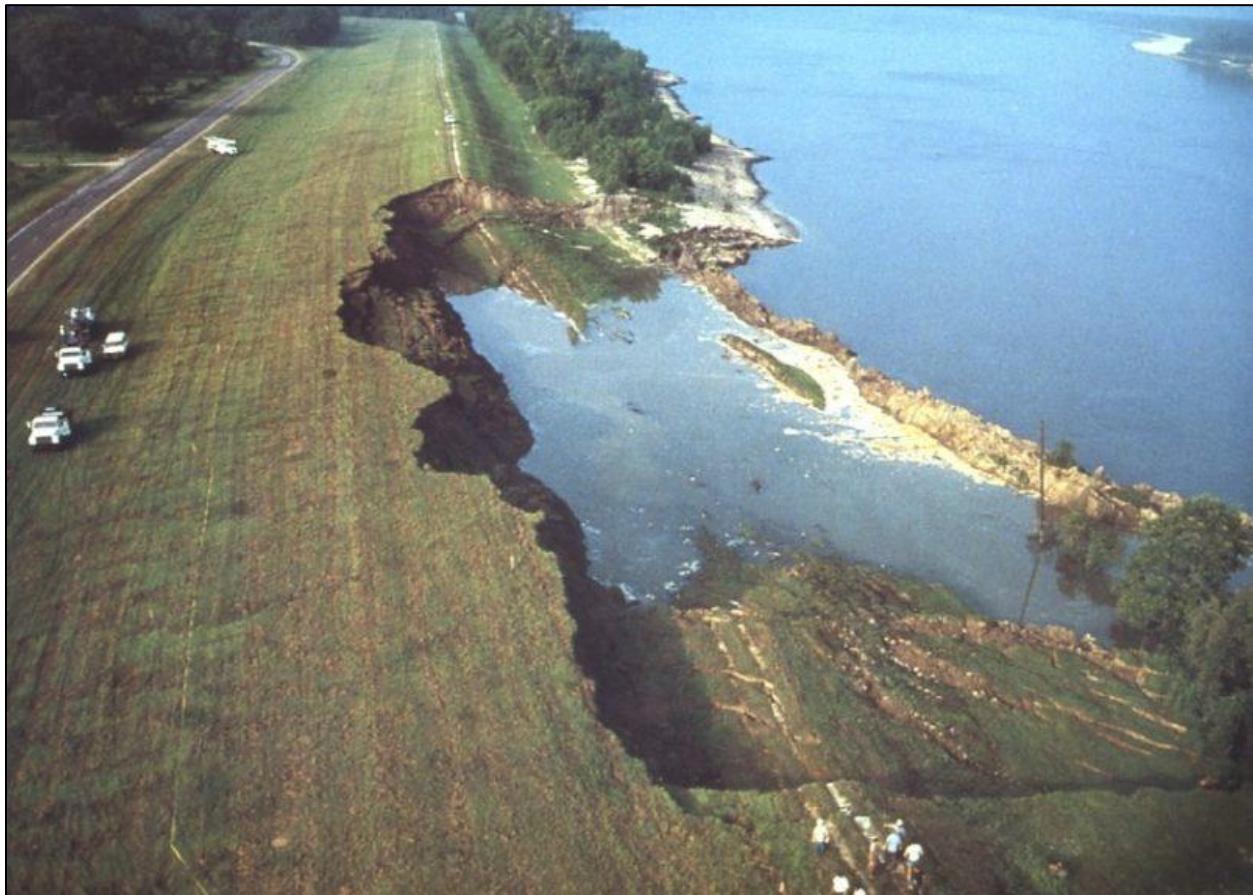
Slope instability occurs when the shear stress exceeds the shear strength along a surface within the dam (see Fig. 9). Slope instability can be promoted by an increase in pore pressure within the dam or by a rise in the water table. Under certain circumstances, the dam material can undergo liquefaction, in which the pore pressure rises high enough that the solid particles no longer touch other, so that the mass of solid particles and water behaves like a liquid with zero shear strength. Liquefaction and slope instability can also be promoted by the cyclic action that occurs during earthquakes.

Figure 9. Slope instability occurs when the shear stress exceeds the shear strength along a surface within the dam. Photo shows a failure of a levee along the Mississippi River near Darrow, Louisiana, in 1983. Photo from Association of State Dam Safety officials (2021b).

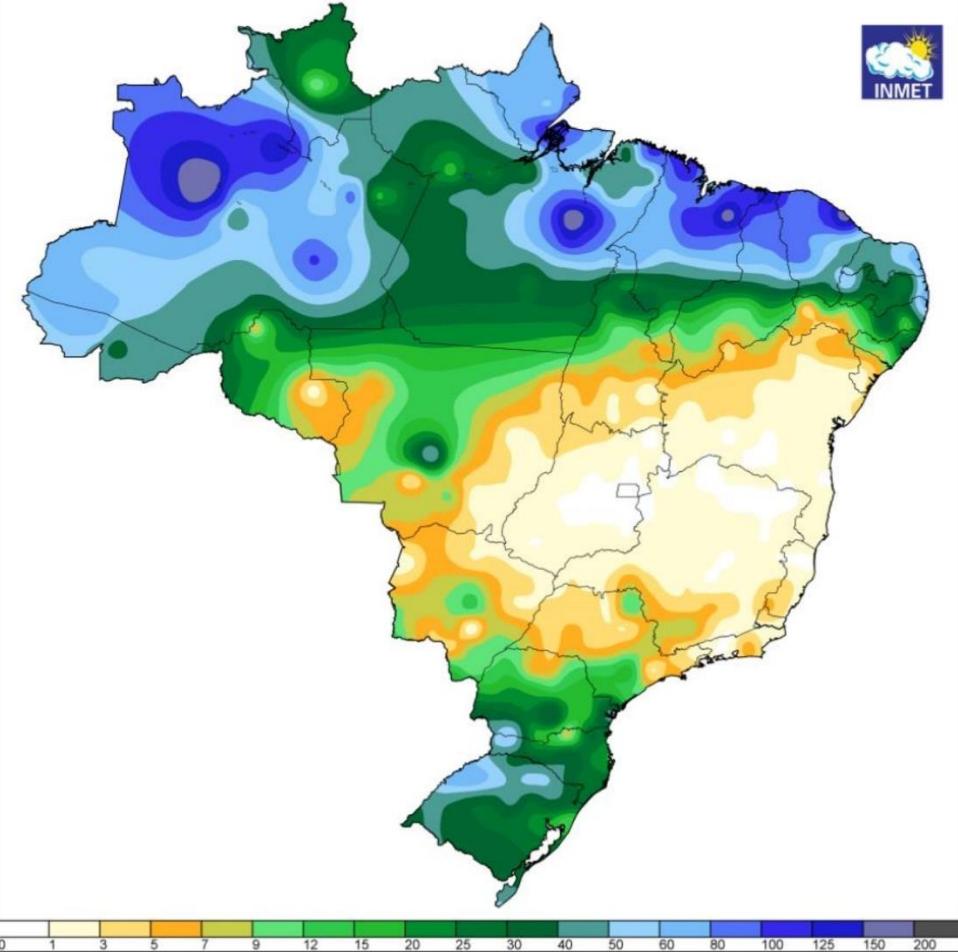
National Institute of Meteorology – INMET
Accumulated Precipitation over last 5 days
Map of March 28, 2021

Figure 10. According to INMET (2021c), no part of the Atlantic coast of the state of Maranhão (including the Aurora mine) received more than 150 mm of rain during the five days between March 24 and 28, 2021 (compare with Fig. 2). This observation could be reconciled with the claim of Equinox Gold (2021a-c) that 426 mm of rain fell on the mine site during March 23-24, 2021, only if at least 276 mm of rain fell on March 23 and no more than 150 mm of rain fell on March 24 with no rain during March 25-28. On the other hand, Equinox Gold (2021c) claims that rainfall amounts were 112.7 mm, 315 mm and 27 mm on March 23, 24, and 25, respectively (see Table 2). (Note that 112.7 mm and 315 mm add to 427.7 mm, not 426 mm.) Map from INMET (2021c) with overlay of English labels.

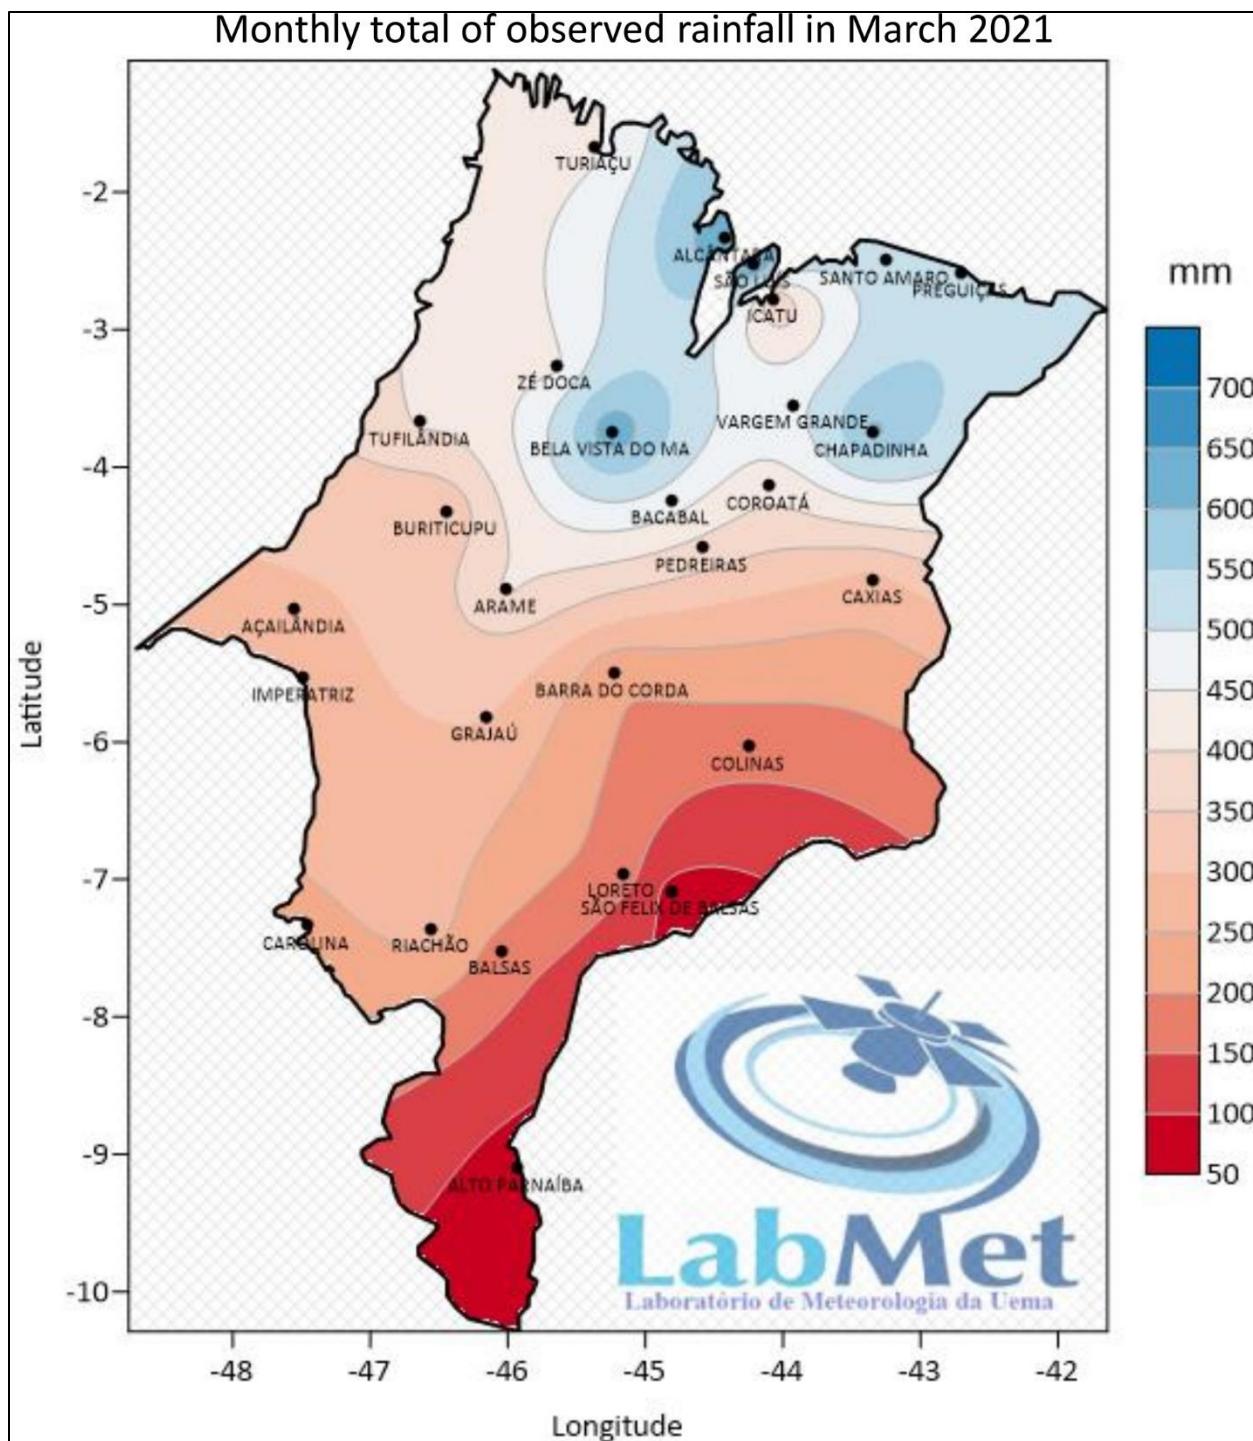
As a second step, the precipitation records of Equinox Gold can be compared with monthly precipitation maps for the state of Maranhão by the Laboratory of Meteorology – UEMA (Núcleo Geoambiental, 2021a). Fig. 11a shows total precipitation of 400-450 mm for the entire month of March 2021 at the site of the Aurizona mine, near the northernmost point of Maranhão (compare Fig. 11a with Fig. 2). This observation cannot be reconciled with the precipitation records by Equinox Gold (see Table 2) even if no rain at all fell during the entire month of March outside of March 23-25. Fig. 11b shows the deviation in total precipitation for the month of March 2021 in comparison with climatological normals. The monthly rainfall at the site of the Aurizona mine (compare Fig. 11b with Fig. 2) was well within the normal range (in the range between 25% below and 35% above the average monthly rainfall). This last observation is certainly inconsistent with the occurrence of a 48-hour, 10,000-year storm during the same month.

Figure 11a. Precipitation maps for the state of Maranhão from the Laboratory of Meteorology at UEMA combine rainfall records from the INMET network (see Fig. 2) and the network of the National Center for Natural Disaster Monitoring and Alerts (CEMADEN). The above map shows total precipitation of 400-450 mm for the entire month of March 2021 at the site of the Aurizona mine, near the northernmost point of Maranhão (compare with Fig. 2). By contrast, Equinox Gold and ANM claim that 426 mm of rain fell at the mine site during March 23-24, 2021, corresponding to a 10,000-year event, with another 27 mm of rain on March 25, 2021. Map from Núcleo Geoambiental (2021a) with overlay of English labels.

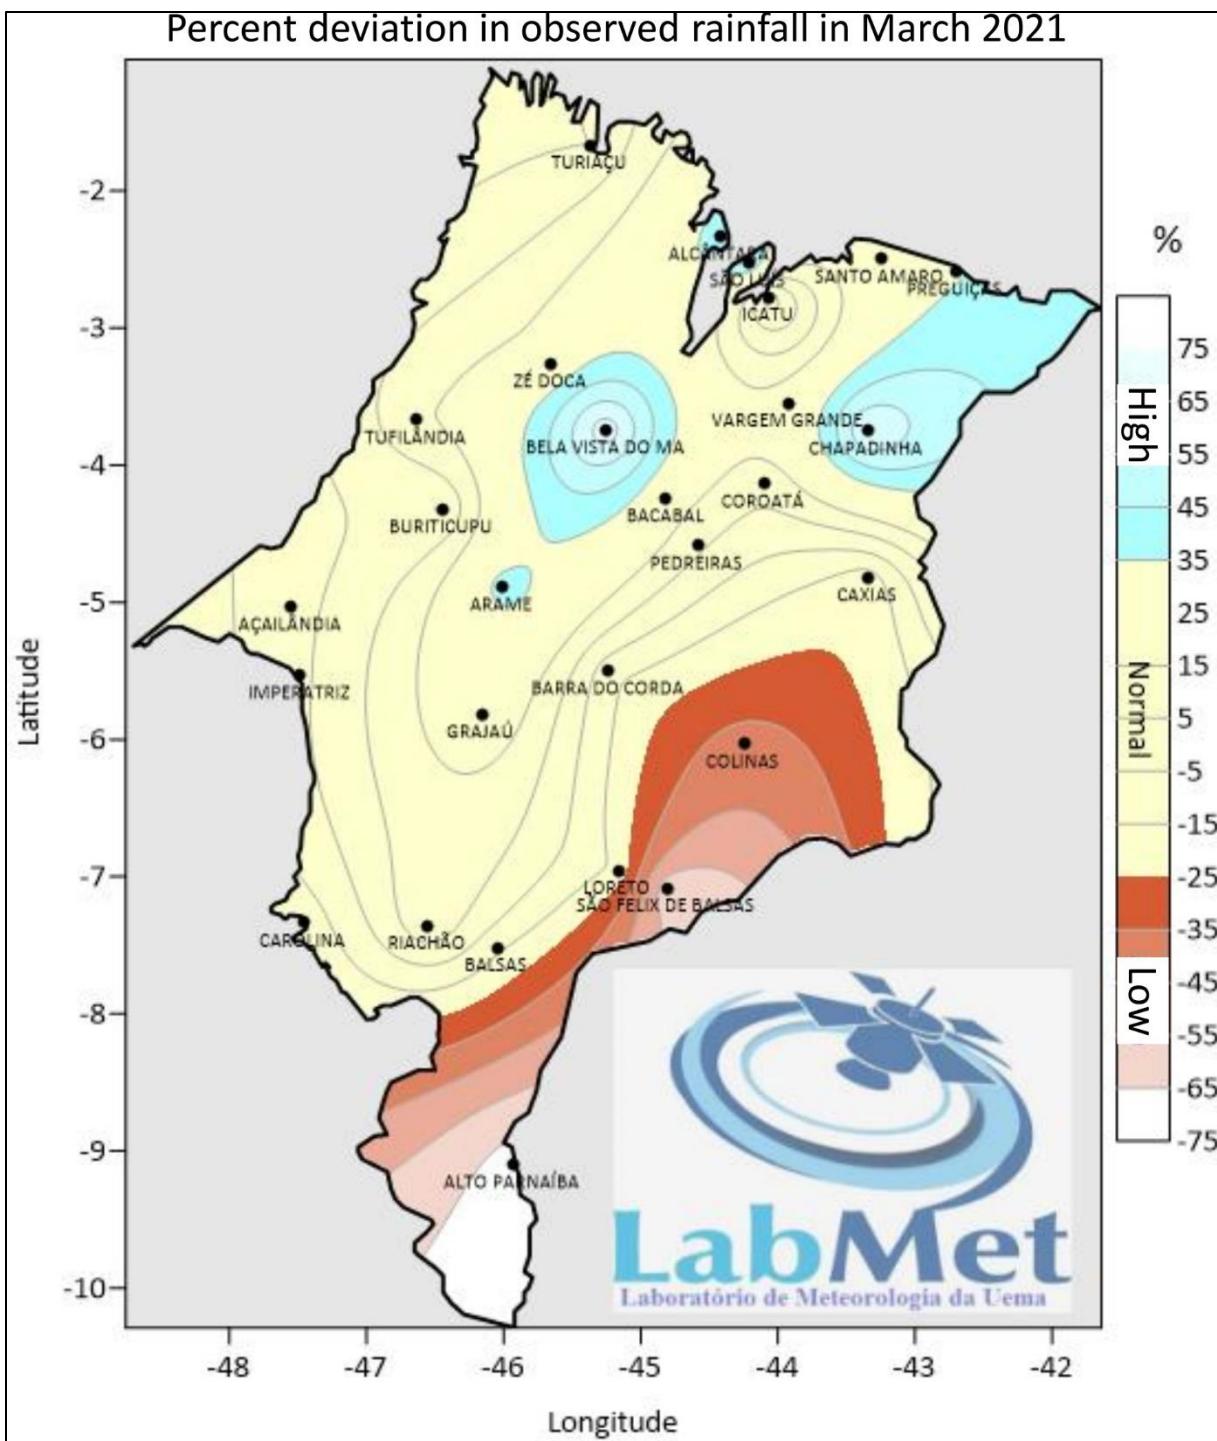
Figure 11b. Precipitation maps for the state of Maranhão from the Laboratory of Meteorology at UEMA combine rainfall records from the INMET network (see Fig. 2) and the network of the National Center for Natural Disaster Monitoring and Alerts (CEMADEN). The above map shows the deviation in total precipitation for the month of March 2021 in comparison with climatological normals. The monthly rainfall at the site of the Aurora mine, near the northernmost point of Maranhão (compare with Fig. 2), was well within the normal range. By contrast, Equinox Gold and ANM claim that 426 mm of rain fell at the mine site during March 23-24, 2021, corresponding to a 10,000-year event. Map from Núcleo Geoambiental (2021a) with overlay of English labels.

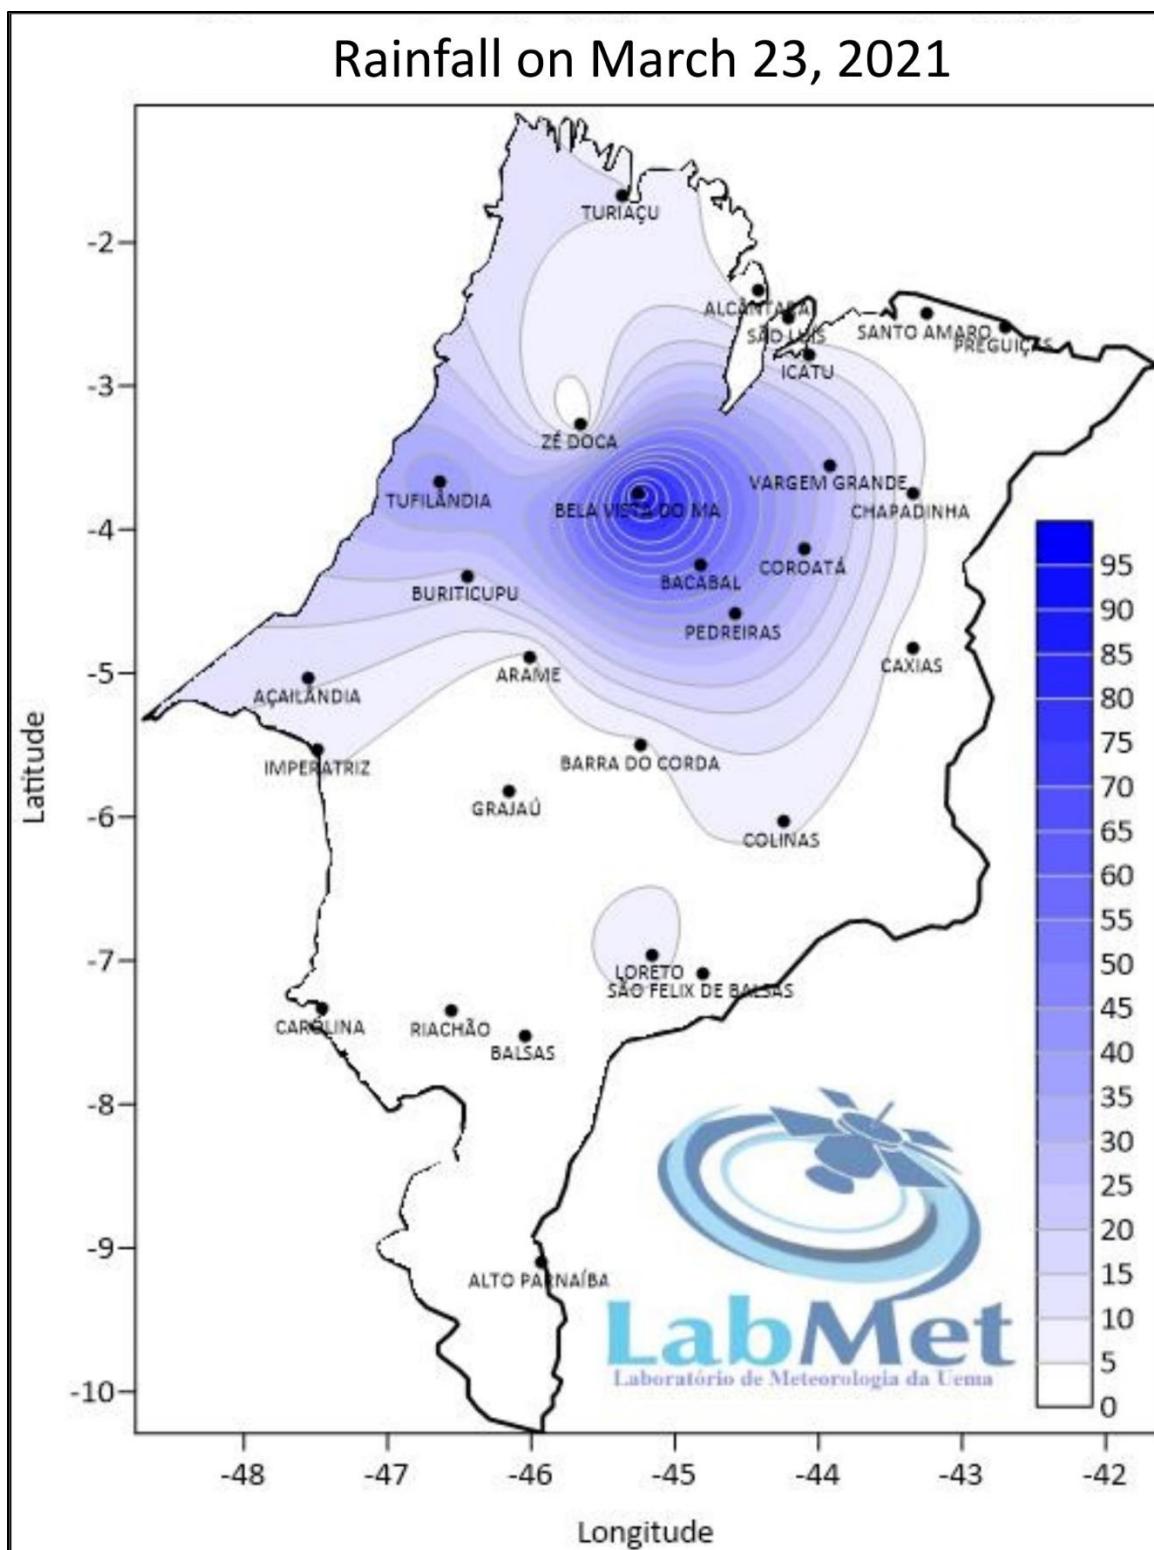
As a third step, the precipitation records of Equinox Gold can be compared with daily precipitation maps for the state of Maranhão by the Laboratory of Meteorology – UEMA (Núcleo Geoambiental, 2021b-d). The March 23 map shows 10-15 mm of rain at the site of the Aurizona mine (compare Fig. 2 with Fig. 12a). The March 24 map shows 25-30 mm of rain at the site of the Aurizona mine (compare Fig. 2 with Fig. 12b). The March 25 map shows 90-95 mm of rain at the site of the Aurizona mine (compare Fig. 2 with Fig. 12c). The daily precipitation maps cannot be reconciled with the precipitation records of Equinox Gold (see Table 2). In fact, the precipitation record of Equinox Gold does not even reproduce the temporal pattern of the daily precipitation maps for the state of Maranhão, which consists of steadily increasing rainfall amounts from March 23-25 with the maximum rainfall on March 25, or after the dam failure.

Figure 12a. Precipitation maps for the state of Maranhão from the Laboratory of Meteorology at UEMA combine rainfall records from the INMET and CEMADEN networks (see Fig. 2). The above map shows 10-15 mm of rainfall for March 23, 2021, at the site of the Aurizona mine, near the northernmost point of Maranhão (compare with Fig. 2). By contrast, Equinox Gold claims that the mine site received 112.7 mm of rainfall on March 23, 2021. Map from Núcleo Geoambiental (2021b) with overlay of English labels.

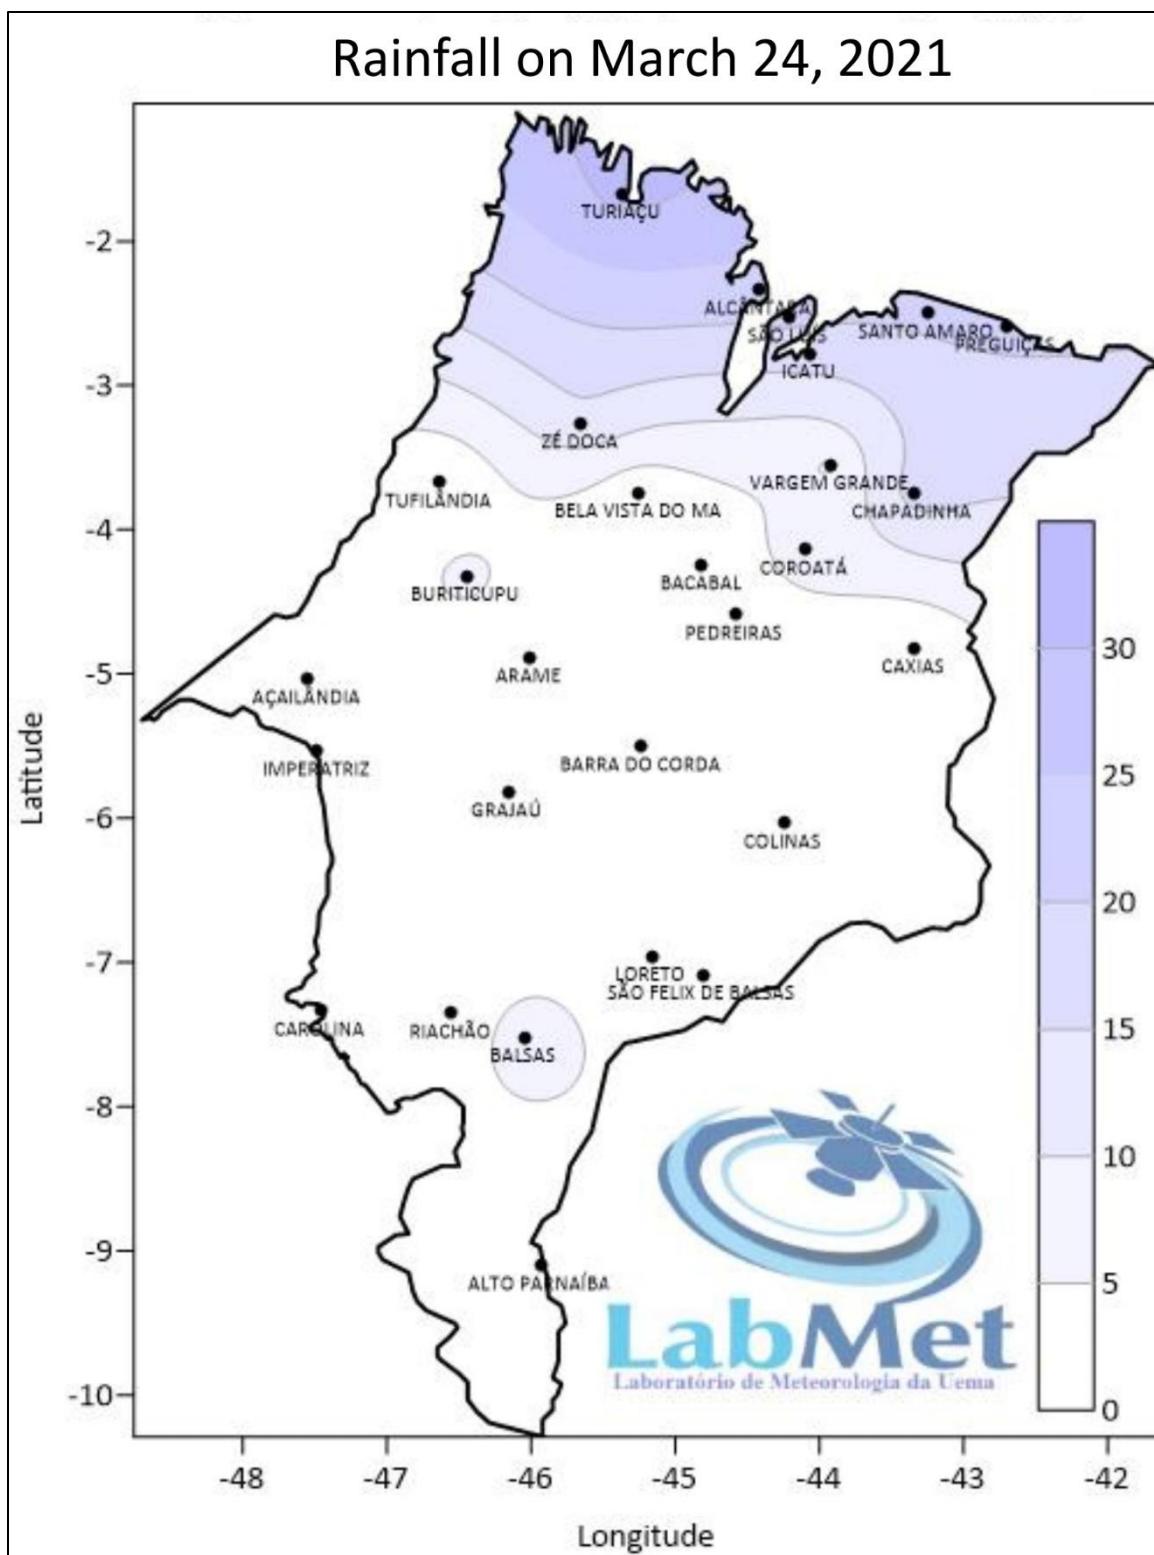
Figure 12b. Precipitation maps for the state of Maranhão from the Laboratory of Meteorology at UEMA combine rainfall records from the INMET and CEMADEN networks (see Fig. 2). The above map shows 25-30 mm of rainfall for March 24, 2021, at the site of the Aurizona mine, near the northernmost point of Maranhão (compare with Fig. 2). By contrast, Equinox Gold claims that the mine site received 315 mm of rainfall on March 24, 2021. Map from Núcleo Geoambiental (2021c) with overlay of English labels.

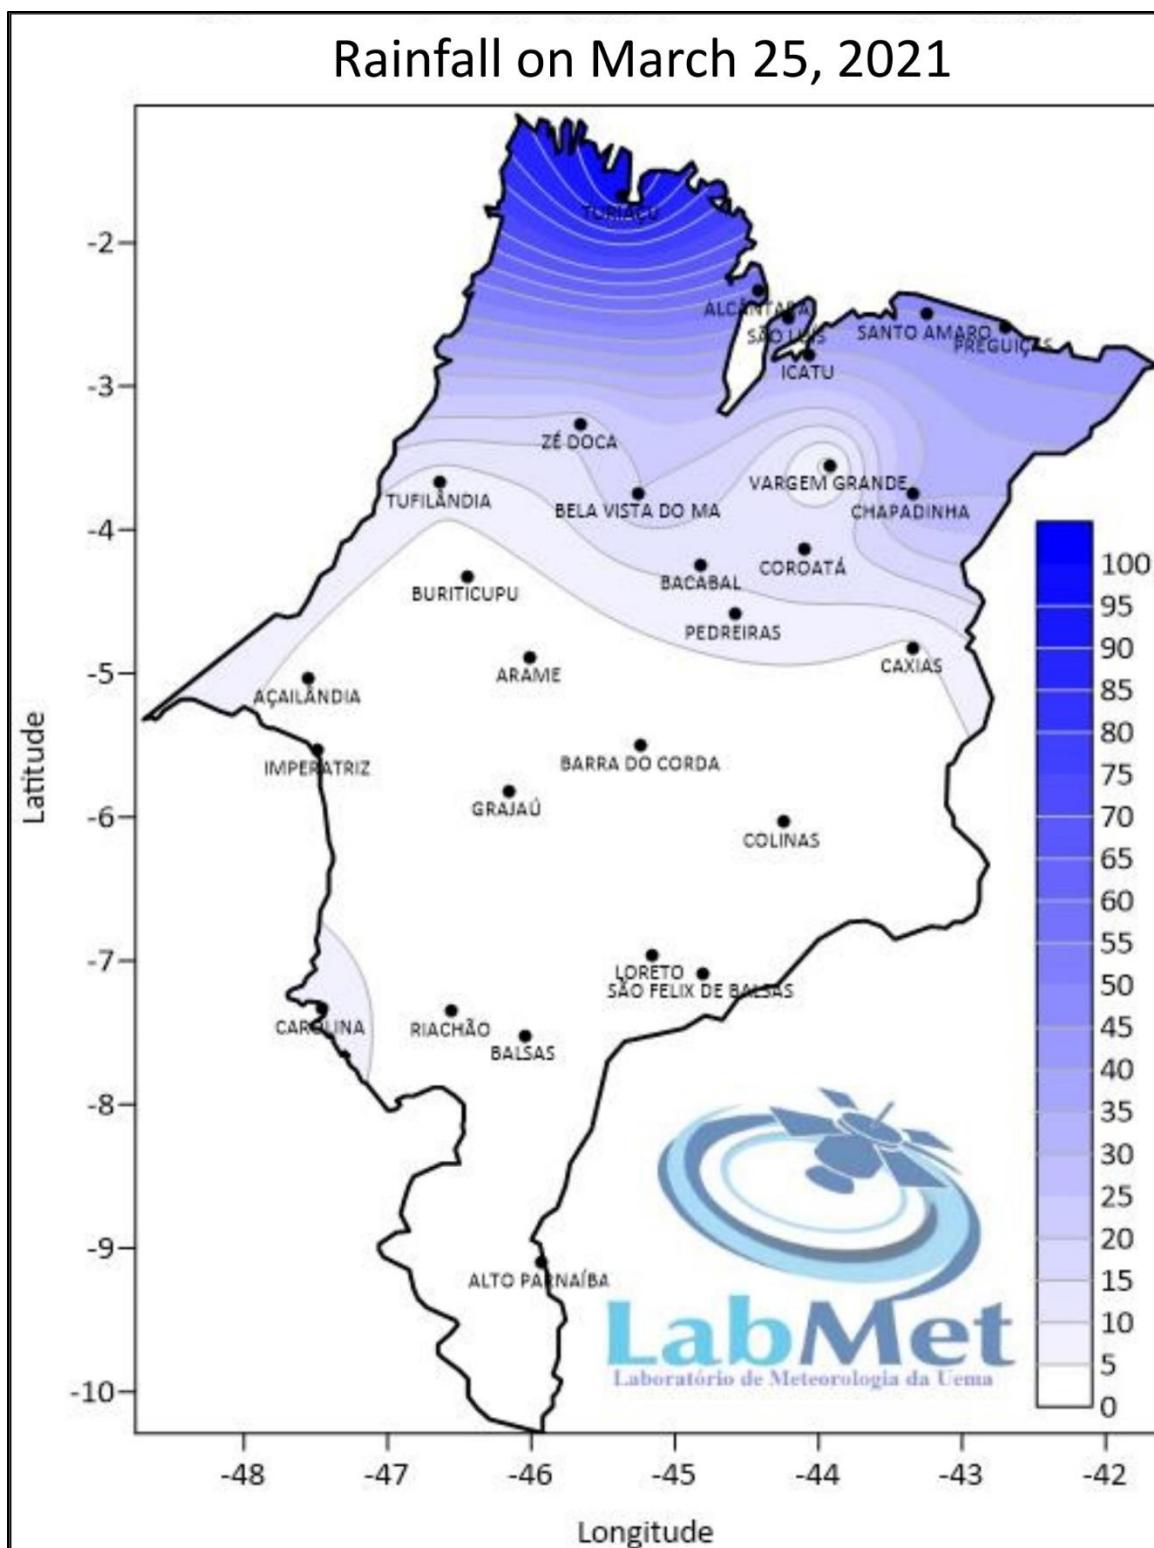
Figure 12c. Precipitation maps for the state of Maranhão from the Laboratory of Meteorology at UEMA combine rainfall records from the INMET and CEMADEN networks (see Fig. 2). The above map shows 90-95 mm of rainfall for March 25, 2021, at the site of the Aurizona mine, near the northernmost point of Maranhão (compare with Fig. 2). By contrast, Equinox Gold claims that the mine site received 27 mm of rainfall on March 25, 2021. Map from Núcleo Geoambiental (2021d) with overlay of English labels.

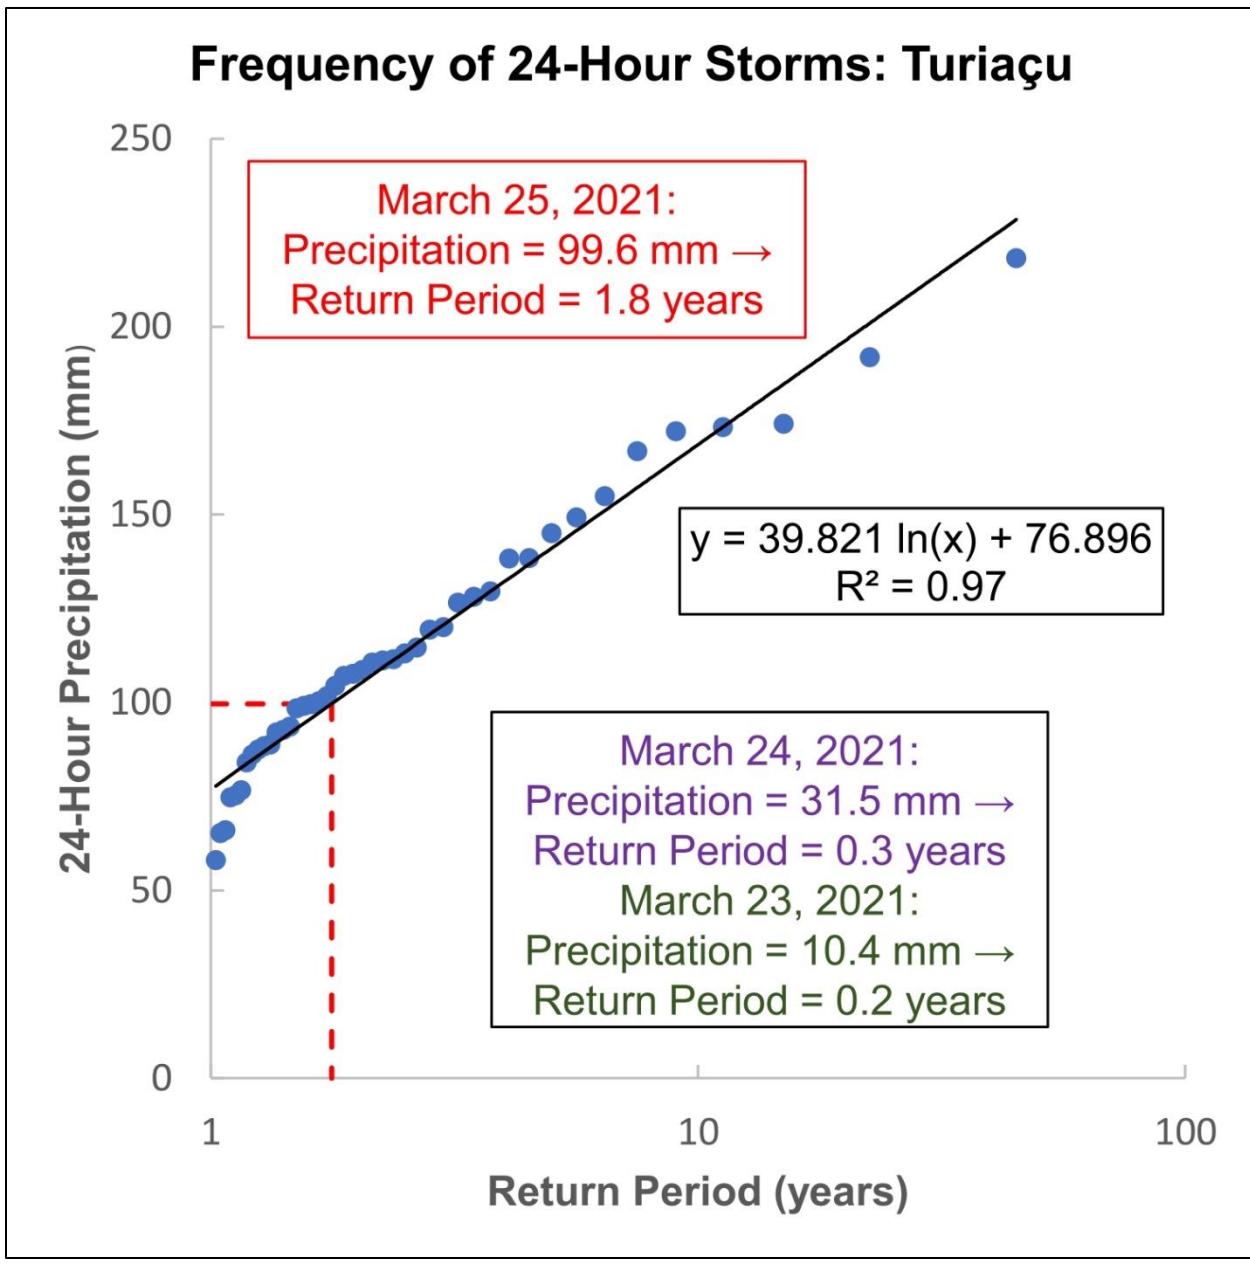
At the INMET Turiaçu weather station, 24-hour rainfall amounts were 10.4 mm, 31.5 mm, and 99.6 mm for March 23, 24 and 25, 2021, corresponding to return periods of 0.2 years, 0.3 years, and 1.8 years, respectively, with the 24-hour precipitation on March 25 corresponding to an annual exceedance probability of 56% (see Table 2 and Fig. 13a). The 48-hour rainfall amounts were 41.9 mm and 131.1 mm for March 23-24 and 24-25, 2021, corresponding to return periods of 0.3 years and 2.3 years (annual exceedance probability of 44%), respectively (see Table 2 and Fig. 13b). The 72-hour rainfall amount was 141.5 mm for March 23-25, 2021, corresponding to a return period of 1.8 years (annual exceedance probability of 55%) (see Table 2 and Fig. 13c).

Figure 13a. At the INMET Turiaçu weather station (see Fig. 2 and Table 1), 24-hour rainfall amounts were 10.4 mm, 31.5 mm, and 99.6 mm for March 23, 24 and 25, 2021, corresponding to return periods of 0.2 years, 0.3 years, and 1.8 years, respectively. Note that return periods shorter than one year are not meaningful, since a one-year return period already corresponds to events with a 100% probability of exceedance in any given year. By contrast, Equinox Gold (2021a-c) and ANM (2021a) claim that 426 mm of rain fell on the Aurizona mine site during March 23-24, 2021, corresponding to a 10,000-year event. Return periods for Turiaçu were calculated from data in INMET (2021b).

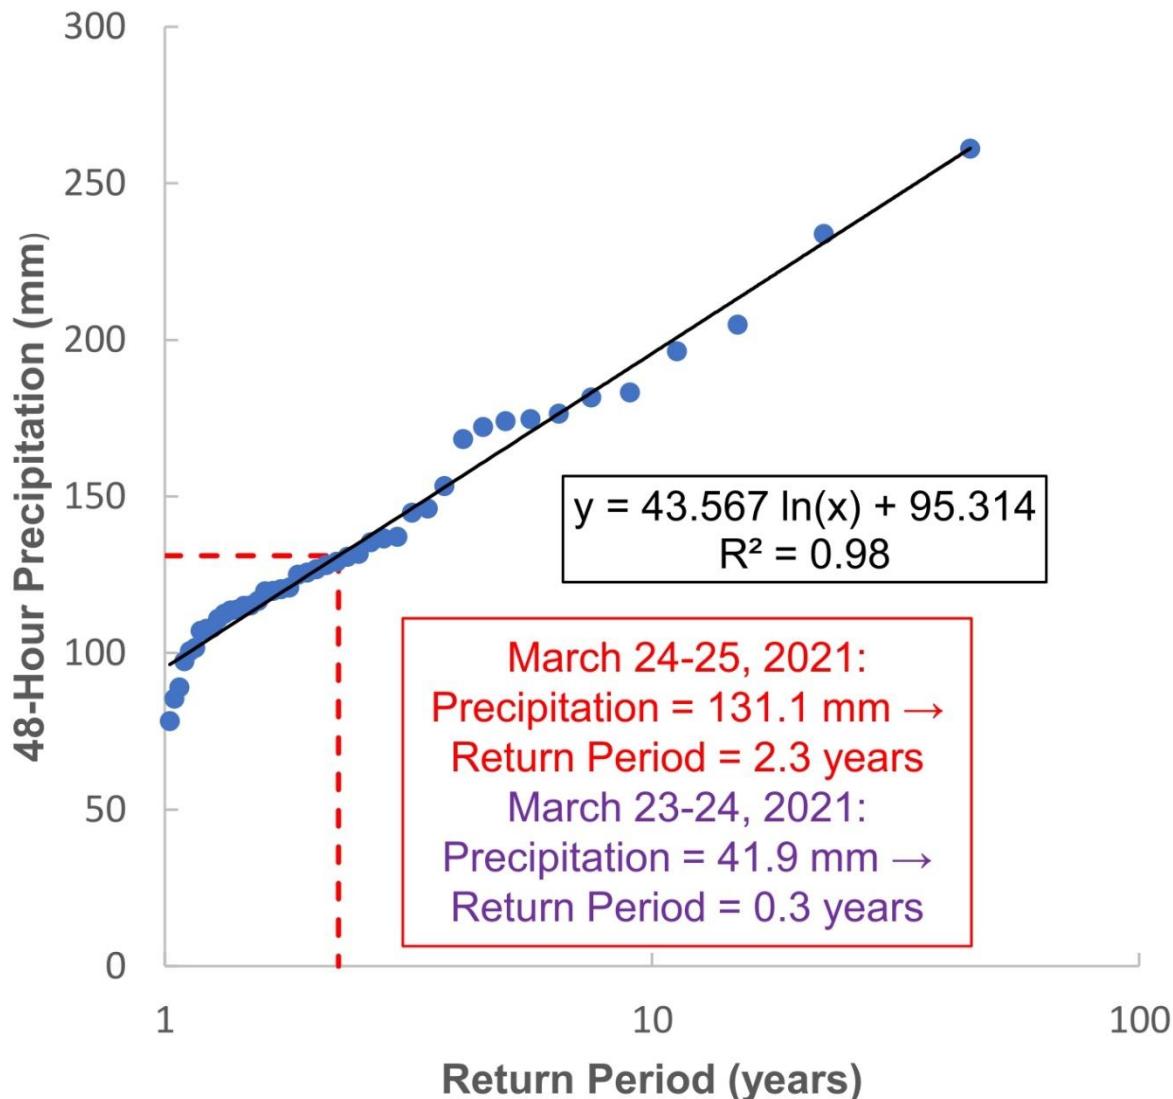
Frequency of 48-Hour Storms: Turiaçu

Figure 13b. At the INMET Turiaçu weather station (see Fig. 2 and Table 1), 48-hour rainfall amounts were 41.9 mm and 131.1 mm for March 23-24 and 24-25, 2021, corresponding to return periods of 0.3 years and 2.3 years, respectively. Note that return periods shorter than one year are not meaningful, since a one-year return period already corresponds to events with a 100% probability of exceedance in any given year. By contrast, Equinox Gold (2021a-c) and ANM (2021a) claim that 426 mm of rain fell on the Aurizona mine site during March 23-24, 2021, corresponding to a 10,000-year event. Return periods for Turiaçu were calculated from data in INMET (2021b).

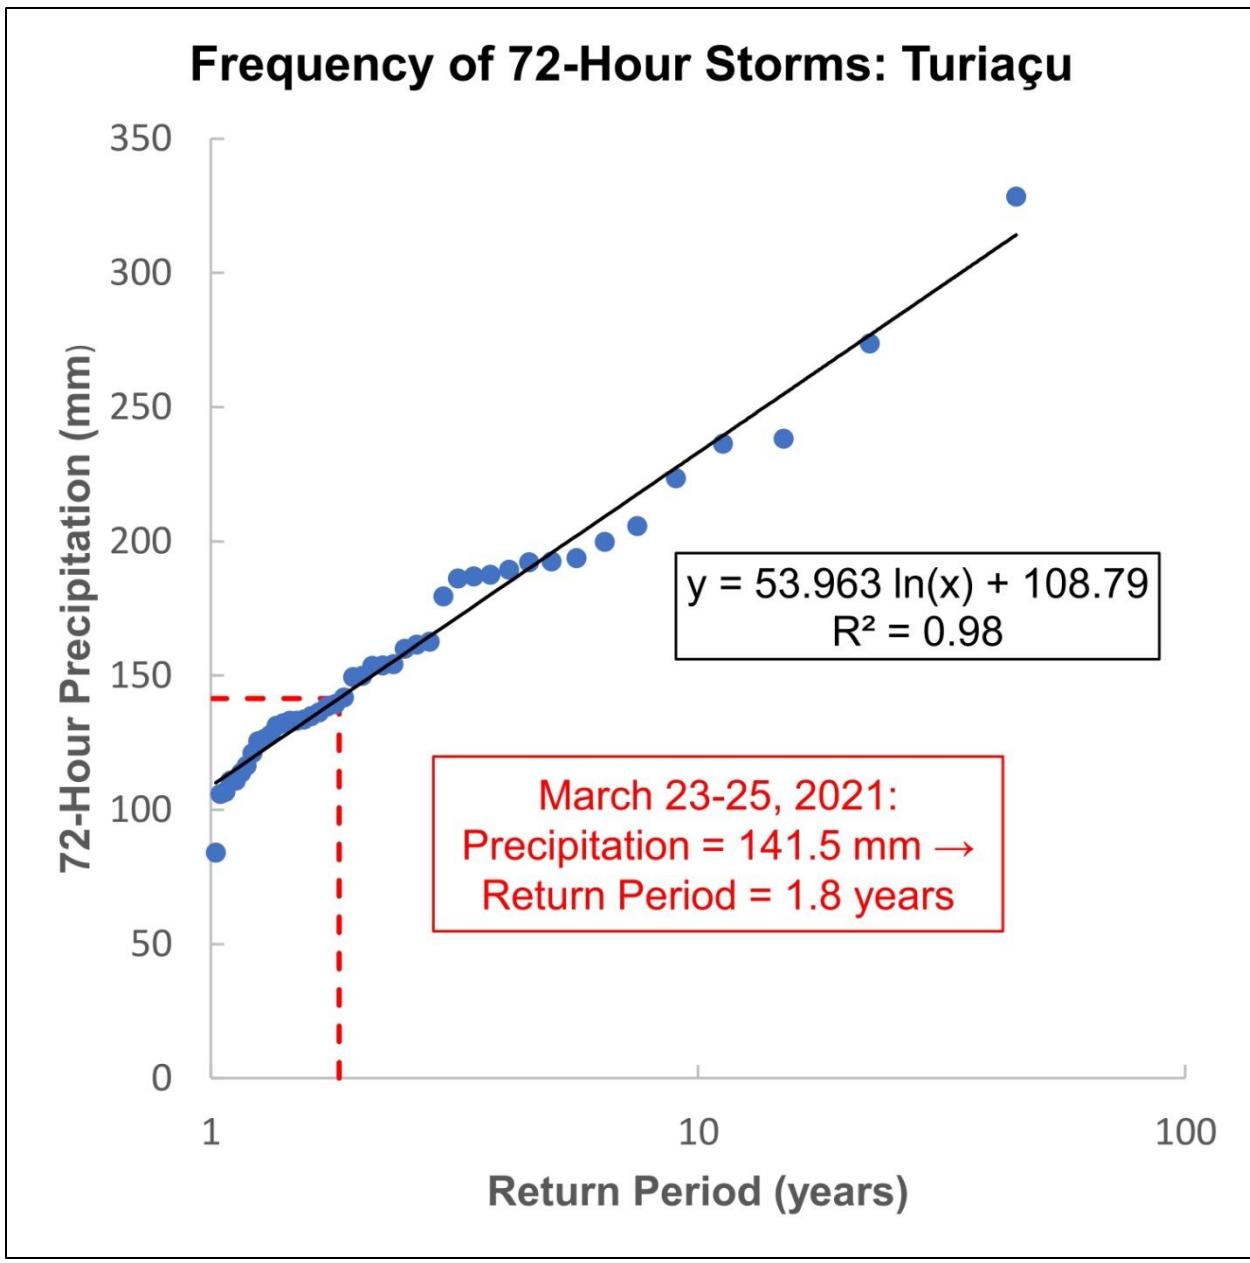
Figure 13c. At the INMET Turiaçu weather station (see Fig. 2 and Table 1), the 72-hour rainfall amount was 141.5 mm for March 23-25, 2021, corresponding to a return period of 1.8 years. By contrast, Equinox Gold (2021a-c) and ANM (2021a) claim that 426 mm of rain fell on the Aurizona mine site during March 23-24, 2021, corresponding to a 10,000-year event. Return periods for Turiaçu were calculated from data in INMET (2021b).
