Cause of Failure of the Lagoa do Pirocáua Dam at the Aurizona Mine on March 25, 2021, Maranhão State, Northeast Brazil

Steven H. Emerman, Malach Consulting, 785 N 200 W, Spanish Fork, Utah 84660, USA,
E-mail: SHEmerman@gmail.com, Tel: 1-801-921-1228

Report prepared at the request of Conselho Nacional de Direitos Humanos (CNDH)
Submitted on July 16, 2021

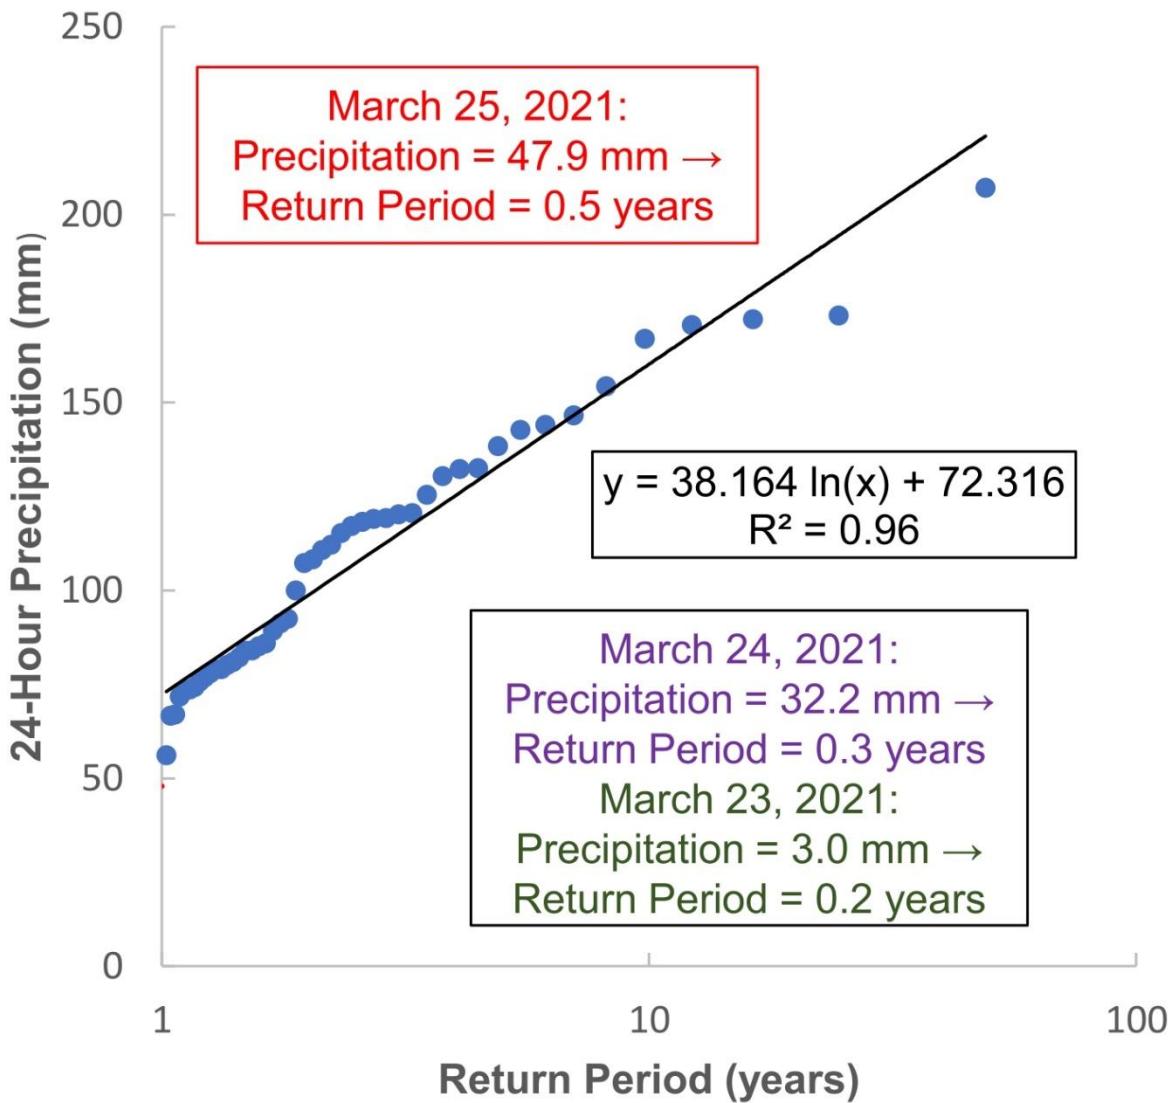
Frequency of 24-Hour Storms: Tracuateua

Figure 14a. At the INMET Tracuateua weather station (see Fig. 2 and Table 1), 24-hour rainfall amounts were 3.0 mm, 32.2 mm, and 47.9 mm for March 23, 24 and 25, 2021, corresponding to return periods of 0.2 years, 0.3 years, and 0.5 years, respectively. Note that return periods shorter than one year are not meaningful, since a one-year return period already corresponds to events with a 100% probability of exceedance in any given year. By contrast, Equinox Gold (2021a-c) and ANM (2021a) claim that 426 mm of rain fell on the Aurizona mine site during March 23-24, 2021, corresponding to a 10,000-year event. Return periods for Tracuateua were calculated from data in INMET (2021b).

At the INMET Tracuateua weather station, 24-hour rainfall amounts were 3.0 mm, 32.2 mm, and 47.9 mm for March 23, 24 and 25, 2021, corresponding to return periods of 0.2 years, 0.3 years, and 0.5 years, respectively (see Table 2 and Fig. 14a). The 48-hour rainfall amounts were 35.2 mm and 80.1 mm for March 23-24 and 24-25, 2021, corresponding to return periods of 0.2 years and 0.6 years, respectively (see Table 2 and Fig. 14b). The 72-hour rainfall amount

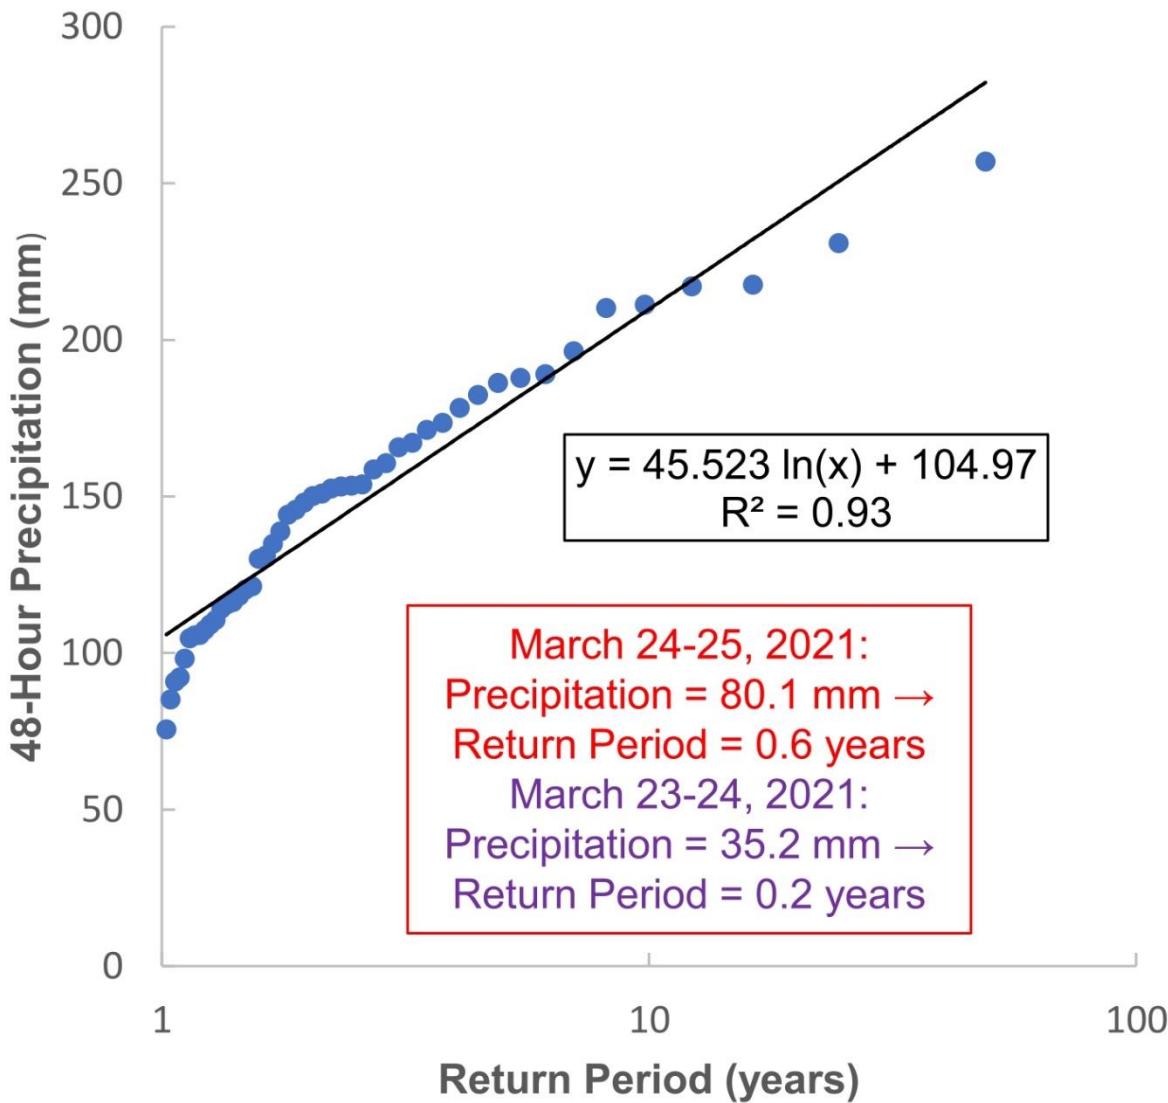
Frequency of 48-Hour Storms: Tracuateua

Figure 14b. At the INMET Tracuateua weather station (see Fig. 2 and Table 1), 48-hour rainfall amounts were 35.2 mm and 80.1 mm for March 23-24 and 24-25, 2021, corresponding to return periods of 0.2 years and 0.6 years, respectively. Note that return periods shorter than one year are not meaningful, since a one-year return period already corresponds to events with a 100% probability of exceedance in any given year. By contrast, Equinox Gold (2021a-c) and ANM (2021a) claim that 426 mm of rain fell on the Aurizona mine site during March 23-24, 2021, corresponding to a 10,000-year event. Return periods for Tracuateua were calculated from data in INMET (2021b).

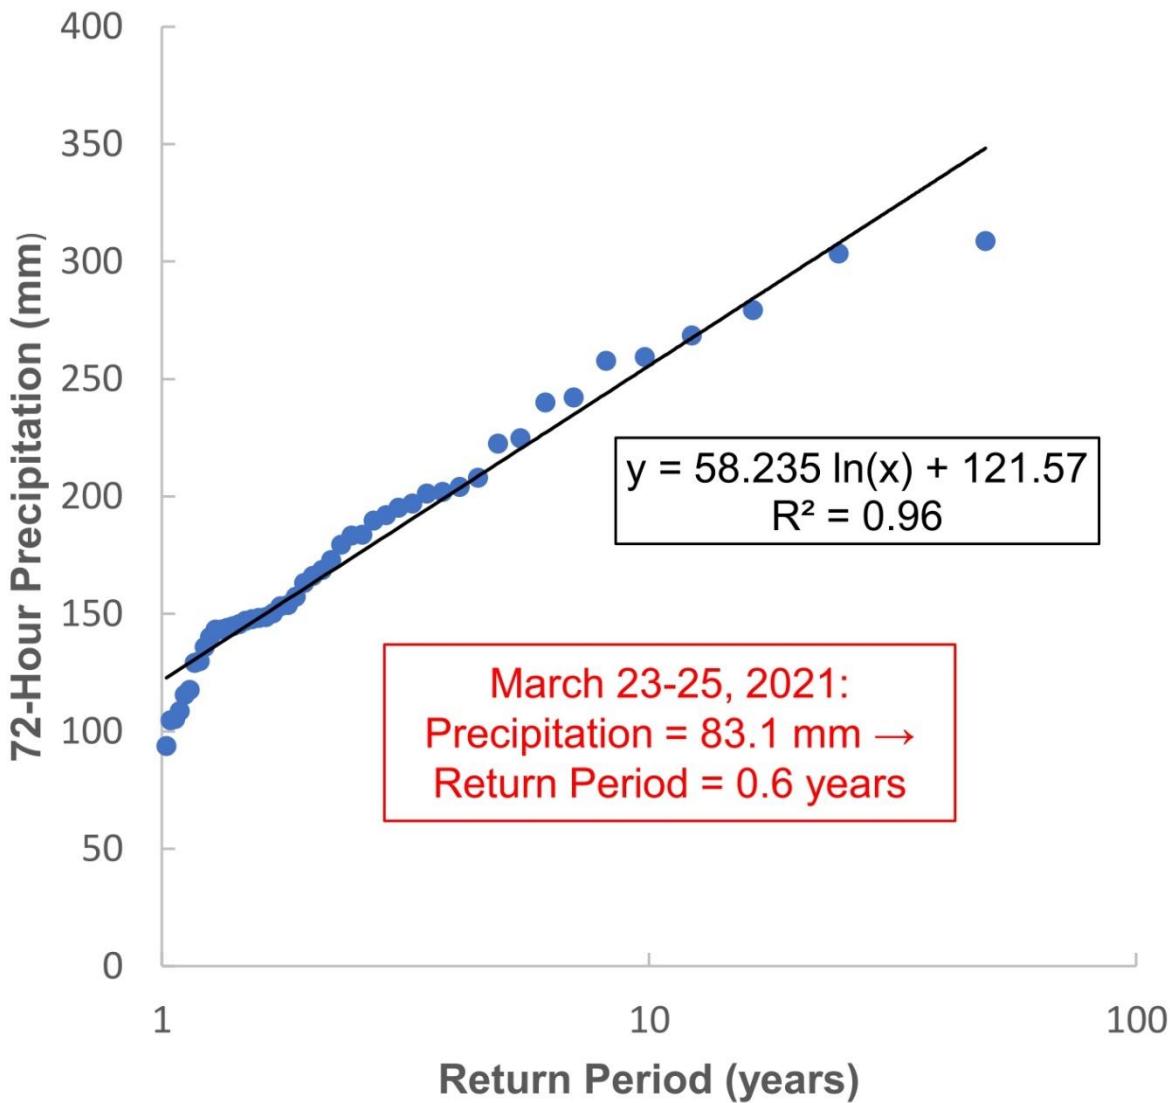
Frequency of 72-Hour Storms: Tracuateua

Figure 14c. At the INMET Tracuateua weather station (see Fig. 2 and Table 1), the 72-hour rainfall amount was 83.1 mm for March 23-25, 2021, corresponding to a return period of 0.6 years. Note that return periods shorter than one year are not meaningful, since a one-year return period already corresponds to events with a 100% probability of exceedance in any given year. By contrast, Equinox Gold (2021a-c) and ANM (2021a) claim that 426 mm of rain fell on the Aurizona mine site during March 23-24, 2021, corresponding to a 10,000-year event. Return periods for Tracuateua were calculated from data in INMET (2021b).

was 83.1 mm for March 23-25, 2021, corresponding to a return period of 0.6 years (see Table 2 and Fig. 14c).

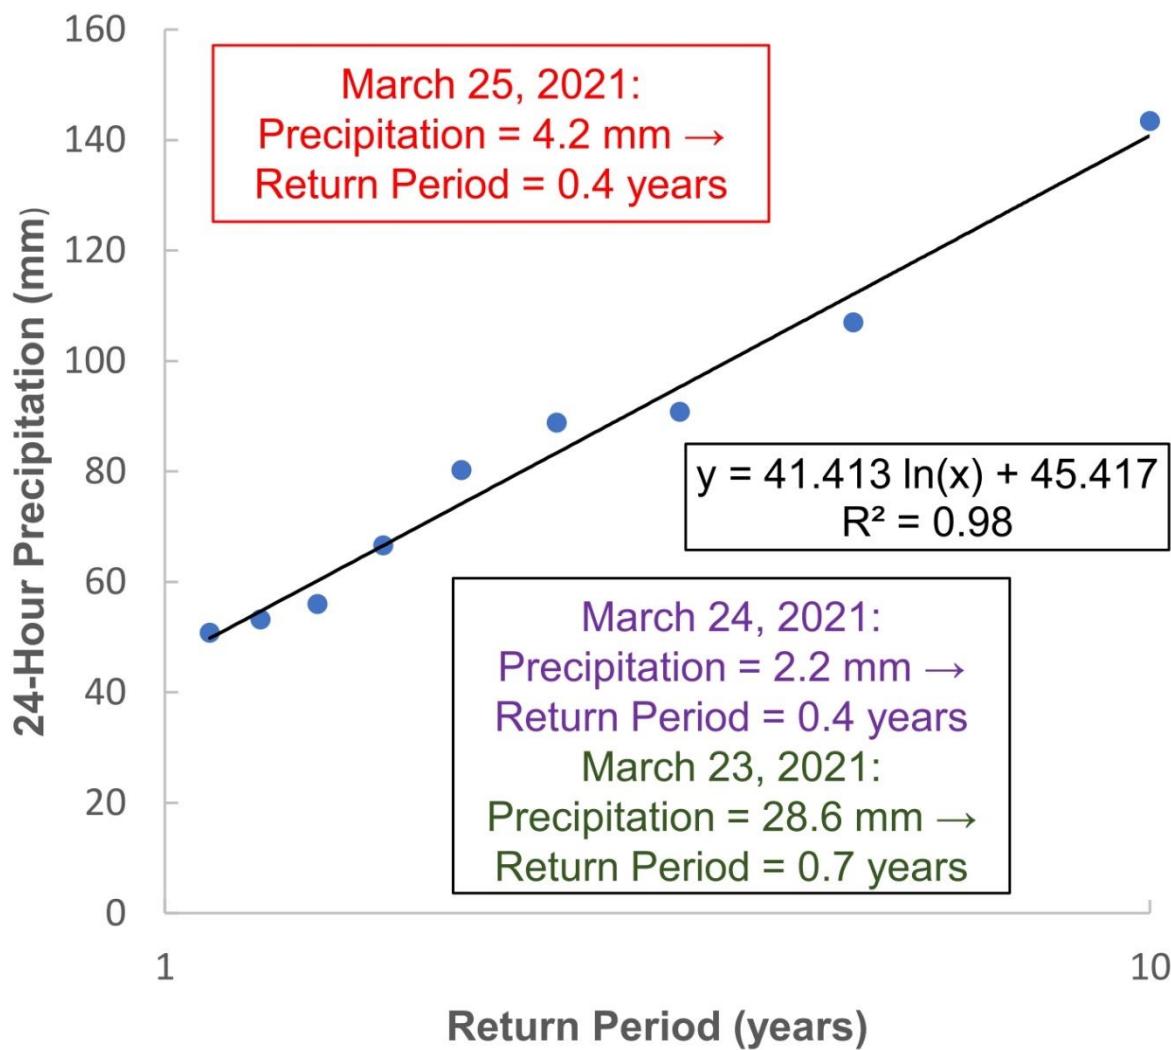
Frequency of 24-Hour Storms: Capitão Poço

Figure 15a. At the INMET Capitão Poço weather station (see Fig. 2 and Table 1), 24-hour rainfall amounts were 28.6 mm, 2.2 mm, and 4.2 mm for March 23, 24 and 25, 2021, corresponding to return periods of 0.7 years, 0.4 years, and 0.4 years, respectively. Note that return periods shorter than one year are not meaningful, since a one-year return period already corresponds to events with a 100% probability of exceedance in any given year. By contrast, Equinox Gold (2021a-c) and ANM (2021a) claim that 426 mm of rain fell on the Aurizona mine site during March 23-24, 2021, corresponding to a 10,000-year event. Return periods for Capitão Poço were calculated from data in INMET (2021b).

At the INMET Capitão Poço weather station, 24-hour rainfall amounts were 28.6 mm, 2.2 mm, and 4.2 mm for March 23, 24 and 25, 2021, corresponding to return periods of 0.7 years, 0.4 years, and 0.4 years, respectively (see Table 2 and Fig. 15a). The 48-hour rainfall amounts were 30.8 mm and 6.4 mm for March 23-24 and 24-25, 2021, corresponding to return periods of 0.5 years and 0.3 years, respectively (see Table 2 and Fig. 15b). The 72-hour rainfall amount was 97.8 mm for March 23-25, 2021, corresponding to a return period of 0.6 years (see Table 2 and Fig. 15c).

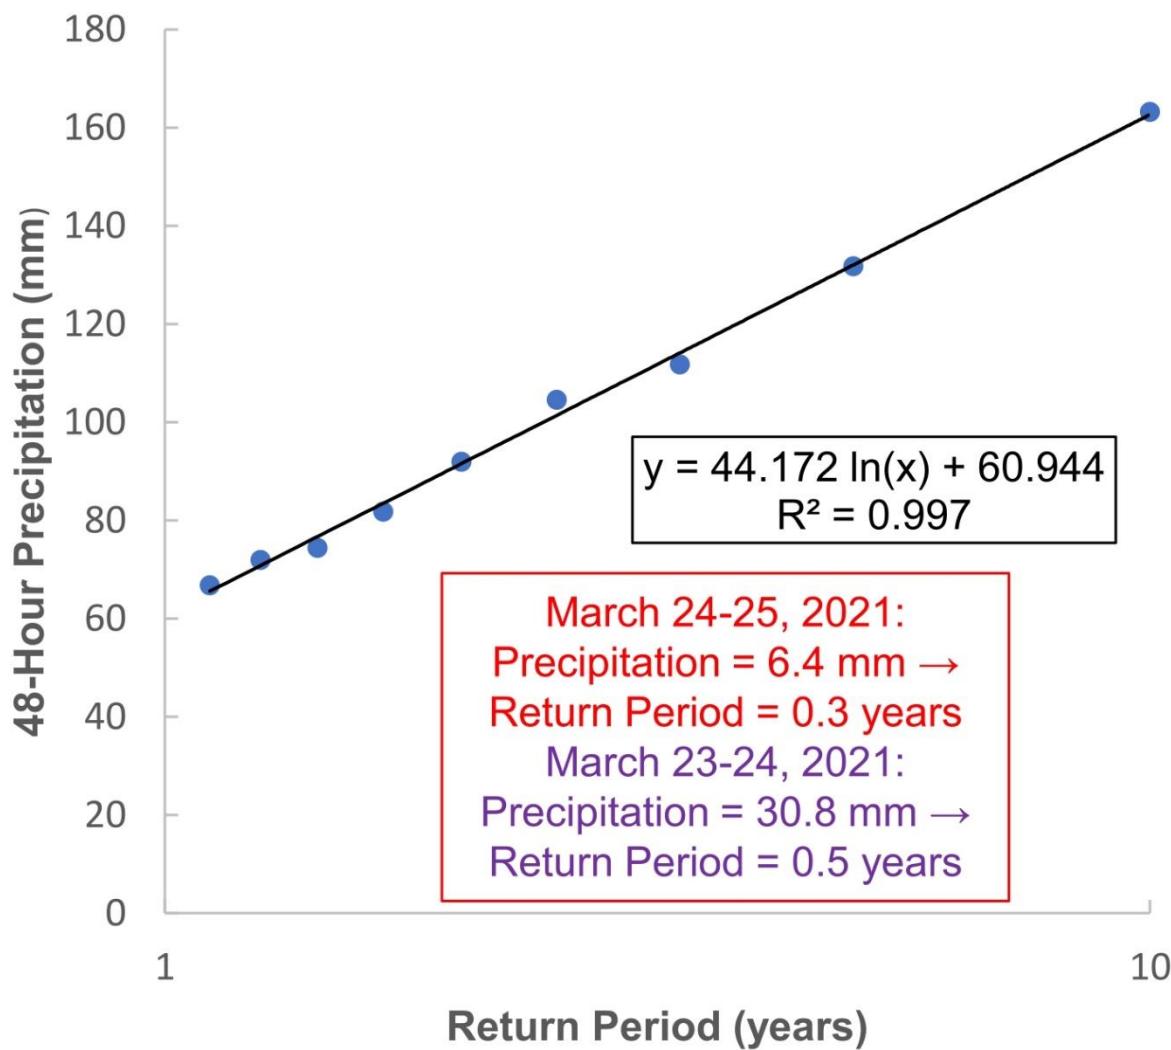
Frequency of 48-Hour Storms: Capitão Poço

Figure 15b. At the INMET Capitão Poço weather station (see Fig. 2 and Table 1), 48-hour rainfall amounts were 30.8 mm and 6.4 mm for March 23-24 and 24-25, 2021, corresponding to return periods of 0.5 years and 0.3 years, respectively. Note that return periods shorter than one year are not meaningful, since a one-year return period already corresponds to events with a 100% probability of exceedance in any given year. By contrast, Equinox Gold (2021a-c) and ANM (2021a) claim that 426 mm of rain fell on the Aurizona mine site during March 23-24, 2021, corresponding to a 10,000-year event. Return periods for Capitão Poço were calculated from data in INMET (2021b).

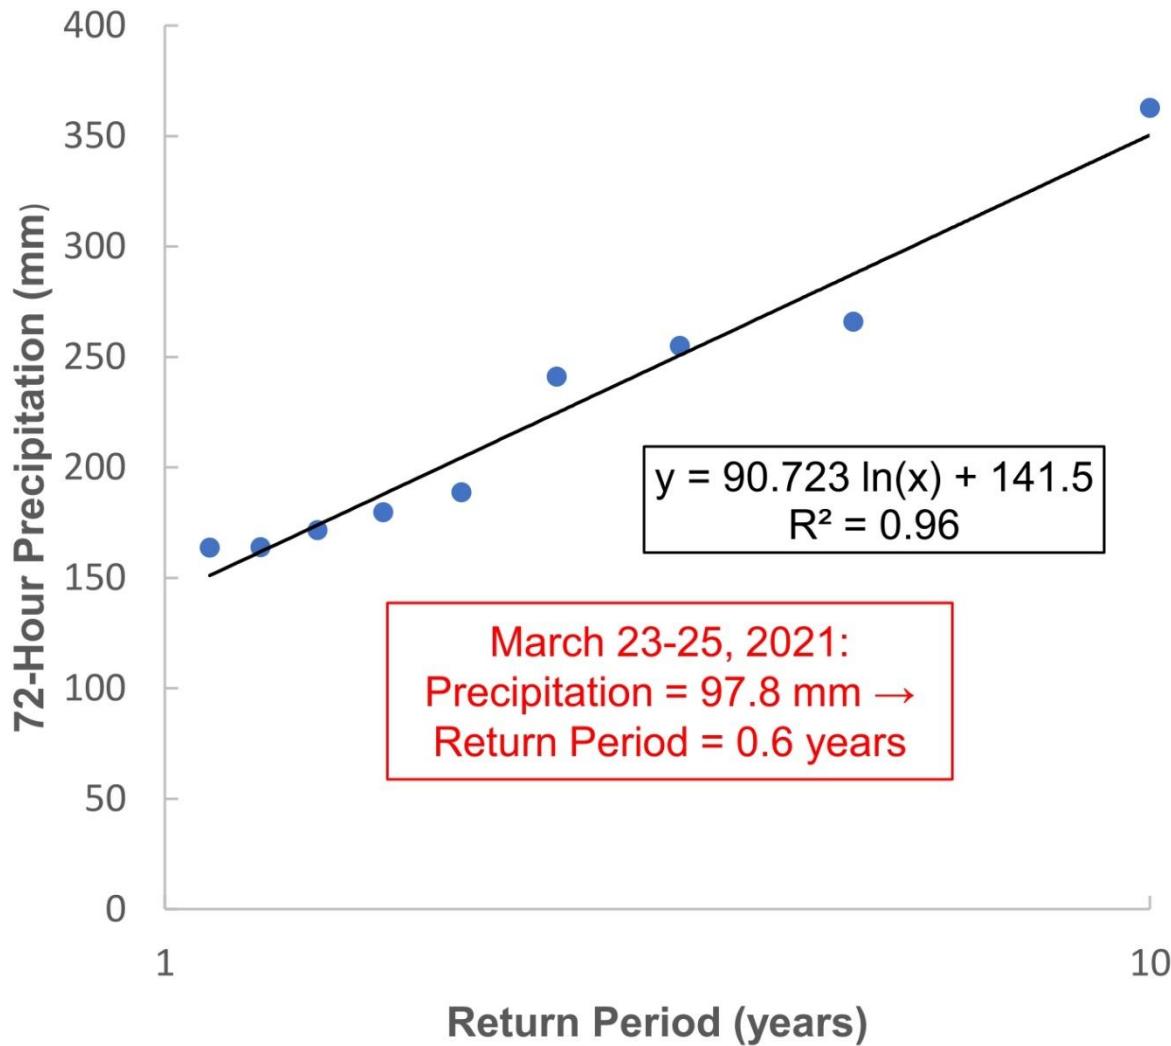
Frequency of 72-Hour Storms: Capitão Poço

Figure 15c. At the INMET Capitão Poço weather station (see Fig. 2 and Table 1), the 72-hour rainfall amount was 97.8 mm for March 23-25, 2021, corresponding to a return period of 0.6 years. Note that return periods shorter than one year are not meaningful, since a one-year return period already corresponds to events with a 100% probability of exceedance in any given year. By contrast, Equinox Gold (2021a-c) and ANM (2021a) claim that 426 mm of rain fell on the Aurizona mine site during March 23-24, 2021, corresponding to a 10,000-year event. Return periods for Capitão Poço were calculated from data in INMET (2021b).
