Causes and Consequences of the Failure of the Tailings Dam at the Agroindustrial El Corazón Gold Mine on November 4, 2023, Imbabura Province, Northern Ecuador

Steven H. Emerman, Malach Consulting, 785 N 200 W, Spanish Fork, Utah 84660, USA,
E-mail: SHEmerman@gmail.com, Tel: 1-801-921-1228

Report prepared at the request of Asociación de Propietarios de Tierras Rurales del Norte
[Association of Northern Rural Landowners] and Frente Antiminero [Antimining Front]
Submitted June 10, 2024

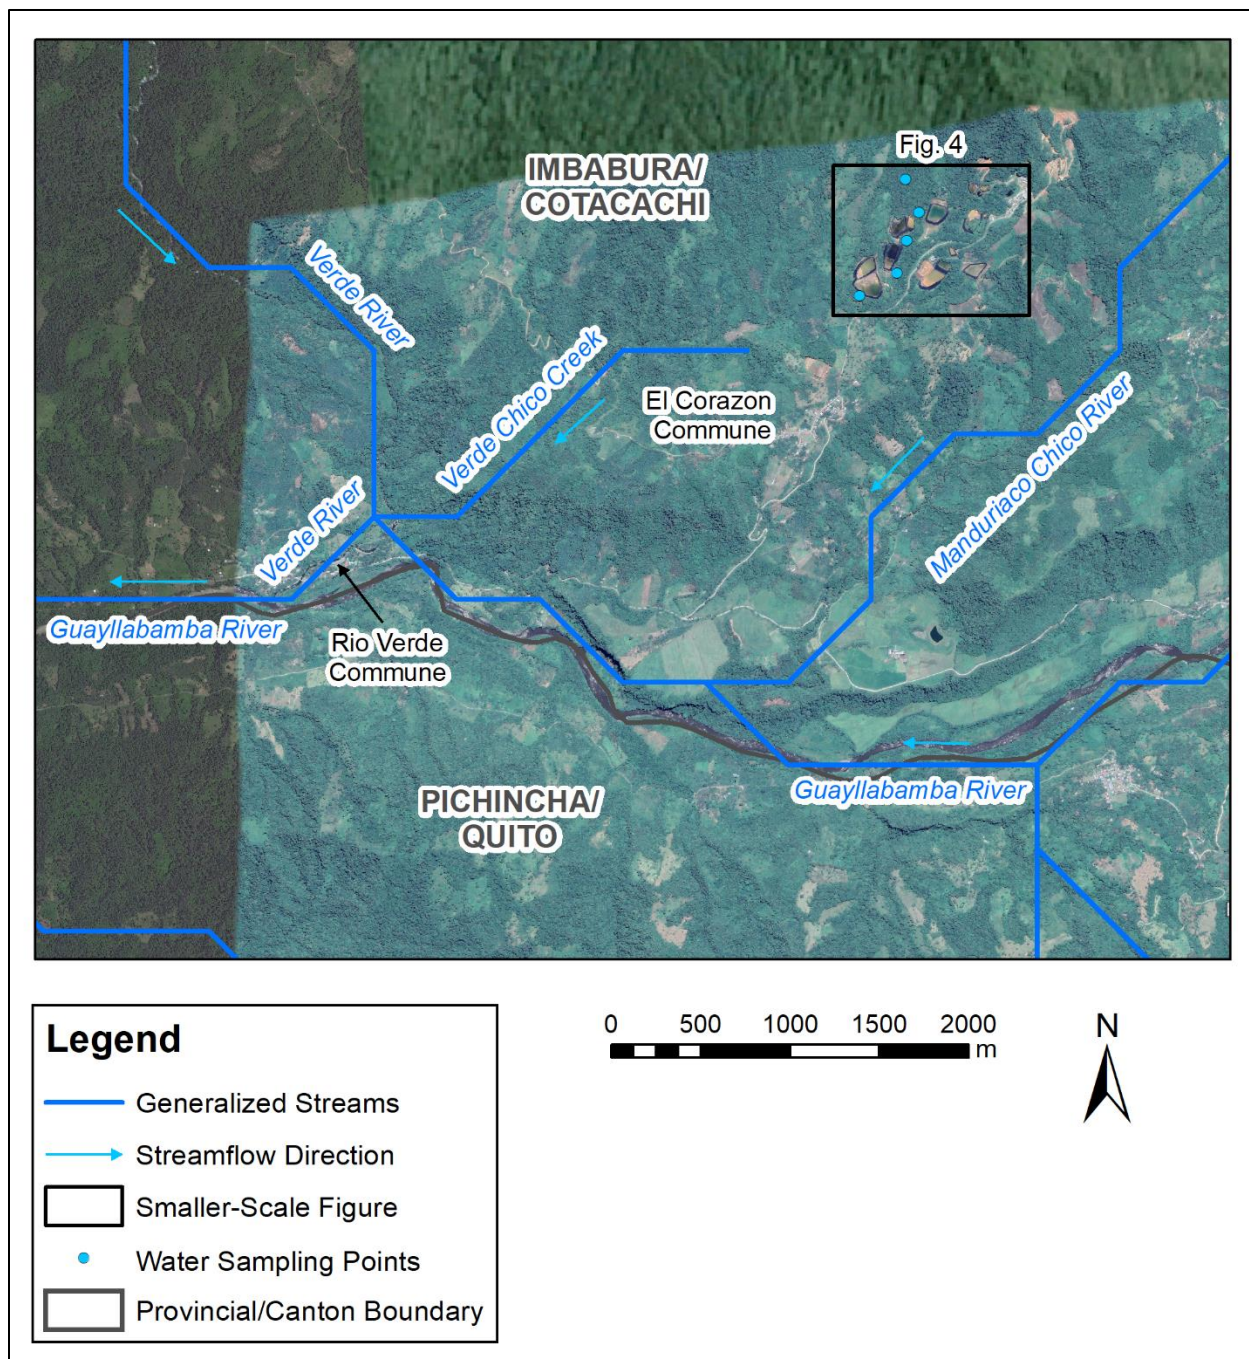
The close proximity of Pond No. 15 to a downstream waterway has been a violation of the regulations of the canton of Cotacachi, in which the El Corazón mine is located (see Fig. 3). According to a Technical Report by the Municipio de Cotacachi (2023a), *“La piscina 15 ha sido construida a menos de 15 metros de la quebrada los monos, afluente de la Quebrada Verde Chico que desemboca en el Río Verde ... Se evidenció que la piscina de relave minero número 15 está construida a pocos metros de la Quebrada Los Monos* [Pond 15 has been built less than 15 meters from Los Monos Creek, a tributary of Verde Chico, which flows into the Verde River ... It was evident that mine tailings pond number 15 is built a few meters from the Los Monos Creek] (see Figs. 3-4). The Municipio de Cotacachi (2023a) continues, *“Conforme lo estipula la ‘ORDENANZA SUSTITUTIVA QUE DELIMITA, REGULA, AUTORIZA Y CONTROLA EL USO DE RIBERAS Y LECHOS DE RÍOS, LAGOS Y LAGUNAS, QUEBRADAS, CURSOS DE AGUA, ACEQUÍAS Y SUS MÁRGENES DE PROTECCIÓN EN EL CANTÓN SANTA ANA DE COTACACHI’, en su Art. 12, Inciso 5, donde se establece que: ‘...los márgenes de todos los ríos y quebradas del cantón, tendrán una zona de protección según establece el PDOT cantonal: para la Zona de Intag 30 metros para ríos’ ... la empresa minera está incumpliendo con lo que establece la presente normativa ... por lo que deberá tomar acciones inmediatas, a fin de dar cumplimiento a la Ordenanza vigente”* [As stipulated in the “SUBSTITUTE ORDINANCE THAT DELIMITS, REGULATES, AUTHORIZES AND CONTROLS THE USE OF BANKS AND BEDS OF RIVERS, LAKES AND LAGOONS, STREAMS, WATERWAYS, CHANNELS AND THEIR PROTECTIVE MARGINS IN THE CANTON SANTA ANA DE COTACACHI,” in its Art. 12, Section 5, which establishes that: “...the margins of all the rivers and streams of the canton will have a protection zone as established by the cantonal PDOT: for the Intag Zone 30 meters for rivers” ... the mining company is failing to comply with what is established by this regulation ... so it must take immediate action in order to comply with the current Ordinance] (capitalization in the original). The Intag Zone that is mentioned in the ordinance is a mountainous area of the province of Imbabura. The entire parish of Garcia Moreno, in which the El Corazón mine is located, is included within the Intag Zone. An engineer with the Municipio de Cotacachi confirmed to the Defensoría del Pueblo del Ecuador [Ombudsman of Ecuador] (2024) that *“es común que en las concesiones mineras no consideren las ordenanzas que constituyen normativa local, en cuanto la distancia que deben conservar de quebradas, ríos o*

Figure 3. Contaminants released by the failure of Pond 15 at the El Corazón mine would flow into Verde Chico Creek, then into the Verde River, followed by flow into the Guayllabamba River (see Fig. 2). Contaminants from Pond 15 or other tailings ponds could potentially reach the Manduriaco Chico River and then flow into the Guayllabamba River, although the pathway from the mine site to the Manduriaco Chico River is not clear from the available stream maps, aerial photos, and satellite imagery. See larger-scale maps in Figs. 2-3 and smaller-scale map in Fig. 4. Background is Google Earth imagery from April 9, 2013, April 24, 2016, and June 27, 2019. Streams from HydroSHEDS (2024) are more generalized than can be seen in the Google Earth imagery. Water sampling points were determined by comparing the sketch map from Agroindustrial El Corazón (2023a) (see Fig. 19) with Google Earth imagery from June 27, 2019 (see Table 6).

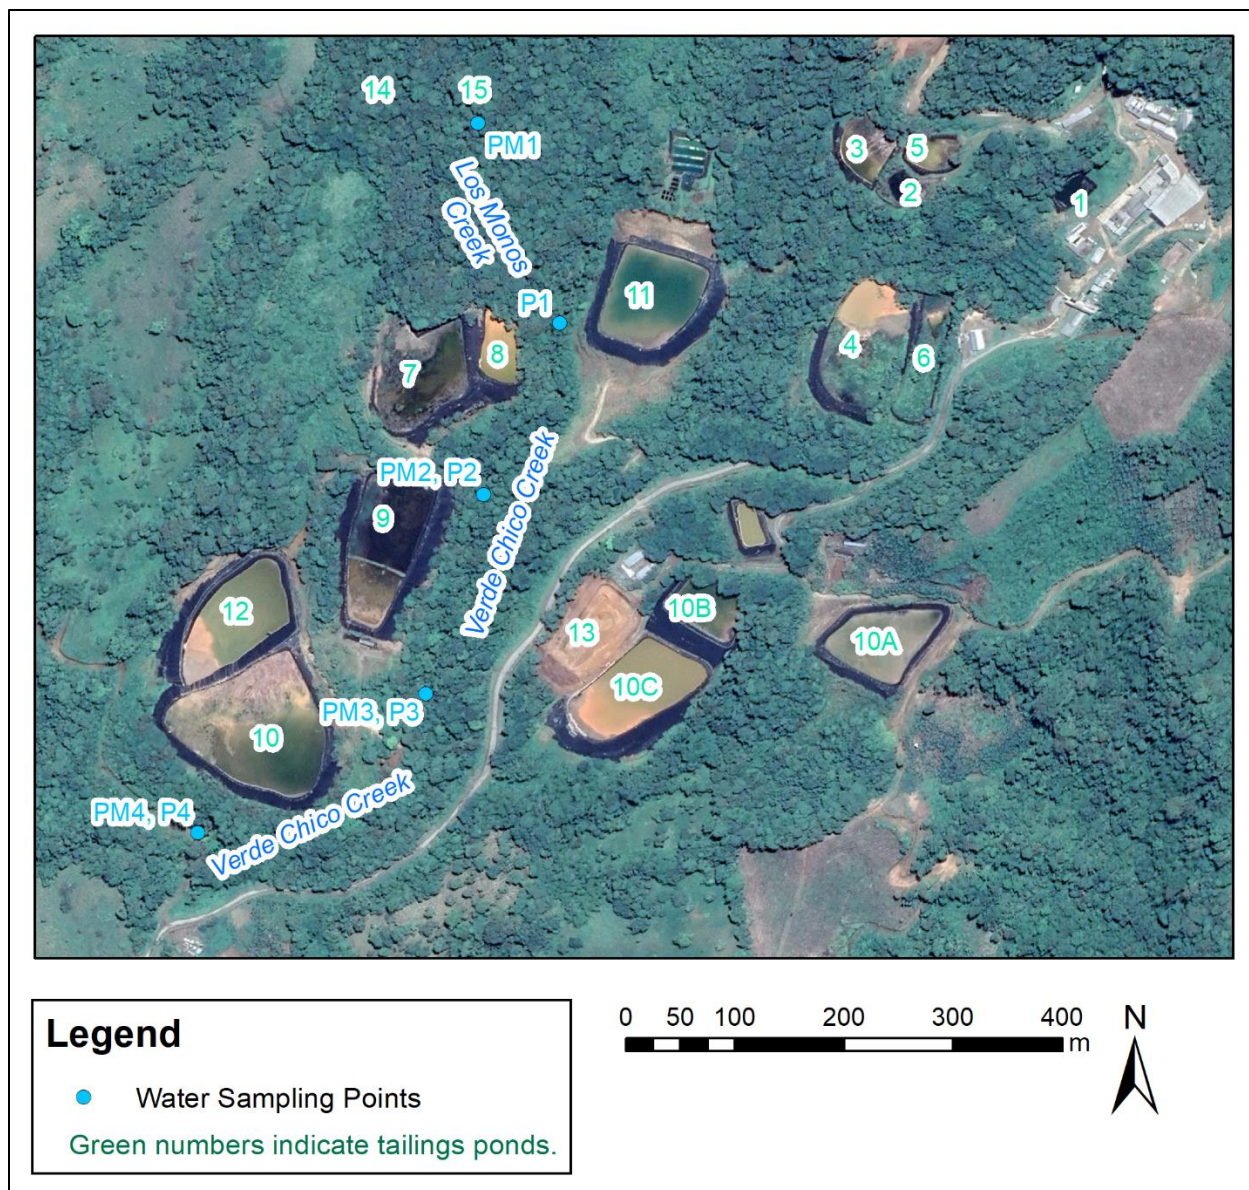
Figure 4. Water samples were collected by the mining company at points PM1, PM2, PM3 and PM4 and by the consulting company GRUNTEC at points P1, P2, P3, and P4. Point PM1 is also the point of discharge from Pond 15. Water sampling points were determined by comparing the sketch map from Agroindustrial El Corazón (2023a) (see Fig. 19) with Google Earth imagery from June 27, 2019 (see Table 6). The coordinates of the sampling points stated in Agroindustrial El Corazón (2023a) (see Fig. 20) do not correspond to the measured coordinates (compare Table 6 with Fig. 20). The tailings ponds were labeled by comparison with the sketch map (see Fig. 19). Background is Google Earth imagery from June 27, 2019. Note that Ponds 14 and 15 were constructed between 2020 and 2021, so that they are absent from the background imagery.

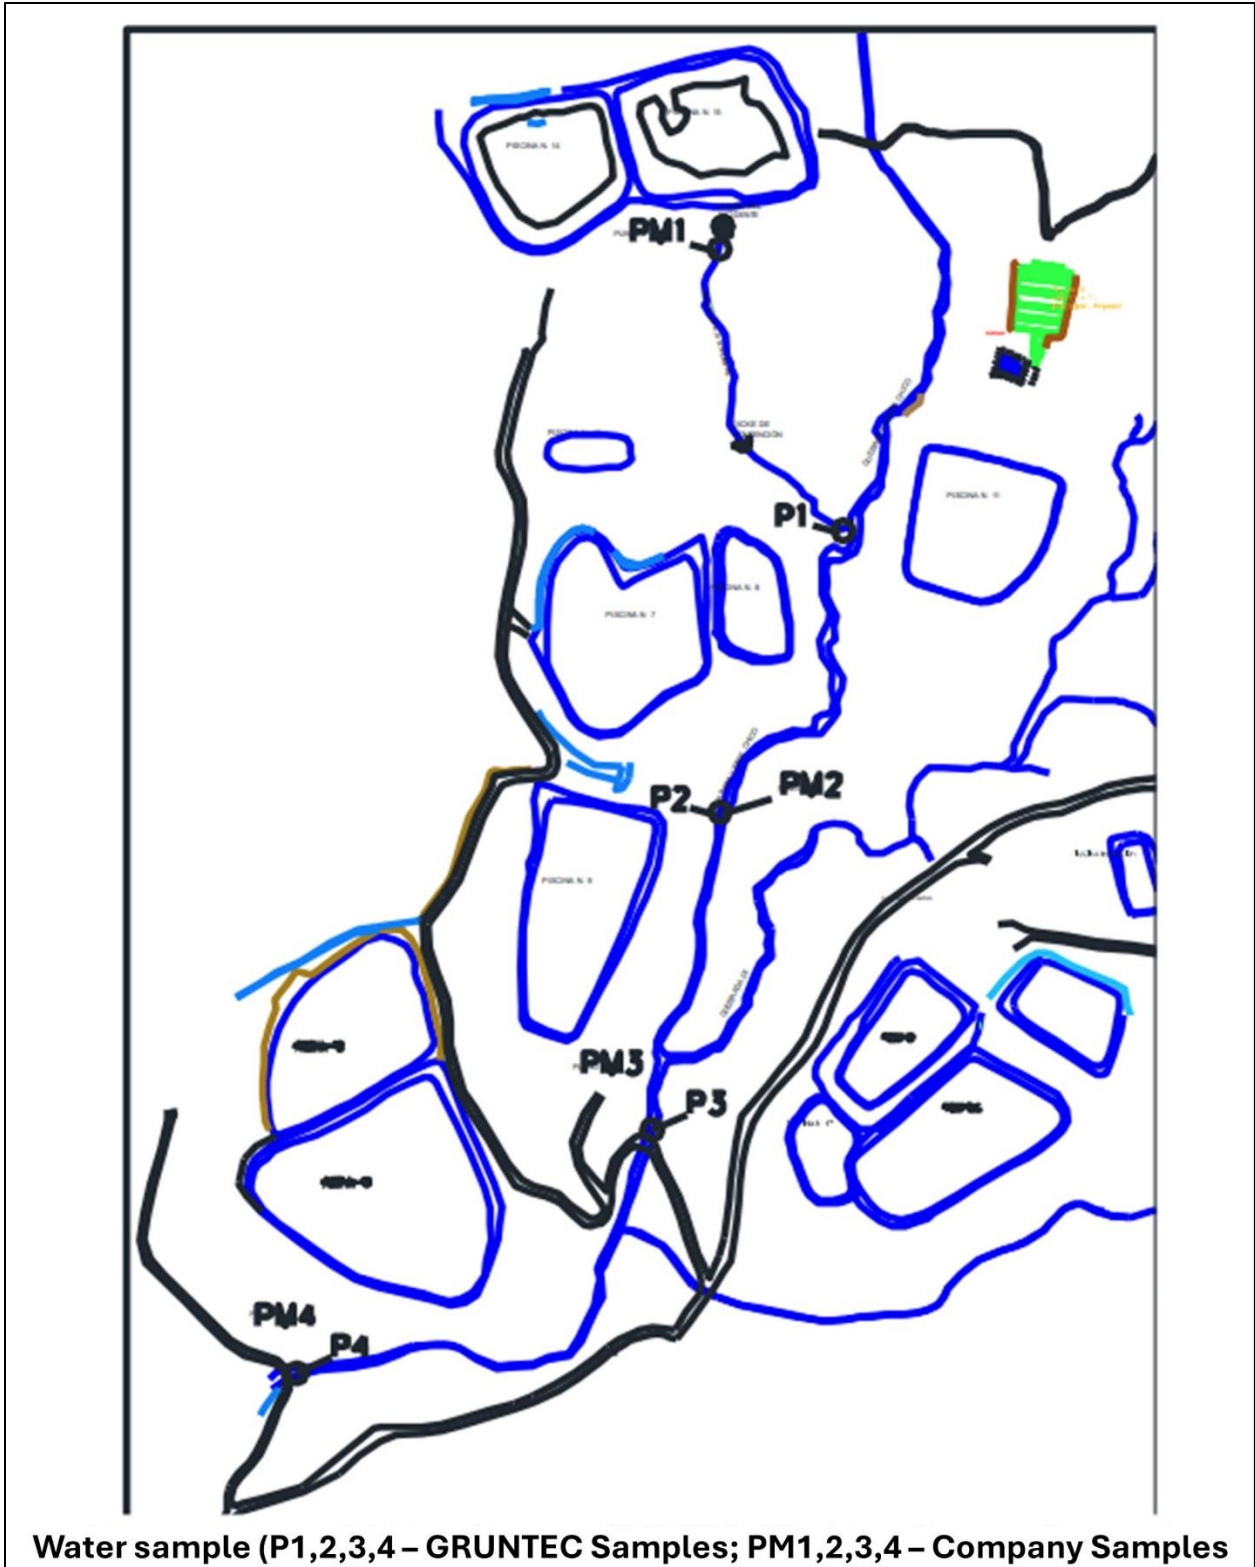
Figure 19. The above sketch map was compared with Google Earth imagery from June 27, 2019, to determine coordinates for the points of water sampling by the company and its consultants (see Table 6 and Fig. 4). The measured coordinates do not correspond to the coordinates stated in Agroindustrial El Corazón S.A. (2023a). The misfit for points P1, P2, P3 and P4 are 18 meters, 392 meters, 206 meters, and 535 meters, respectively (compare Table 6 with Fig. 20). Figure from Agroindustrial El Corazón S.A. (2023a) with overlay of English label.

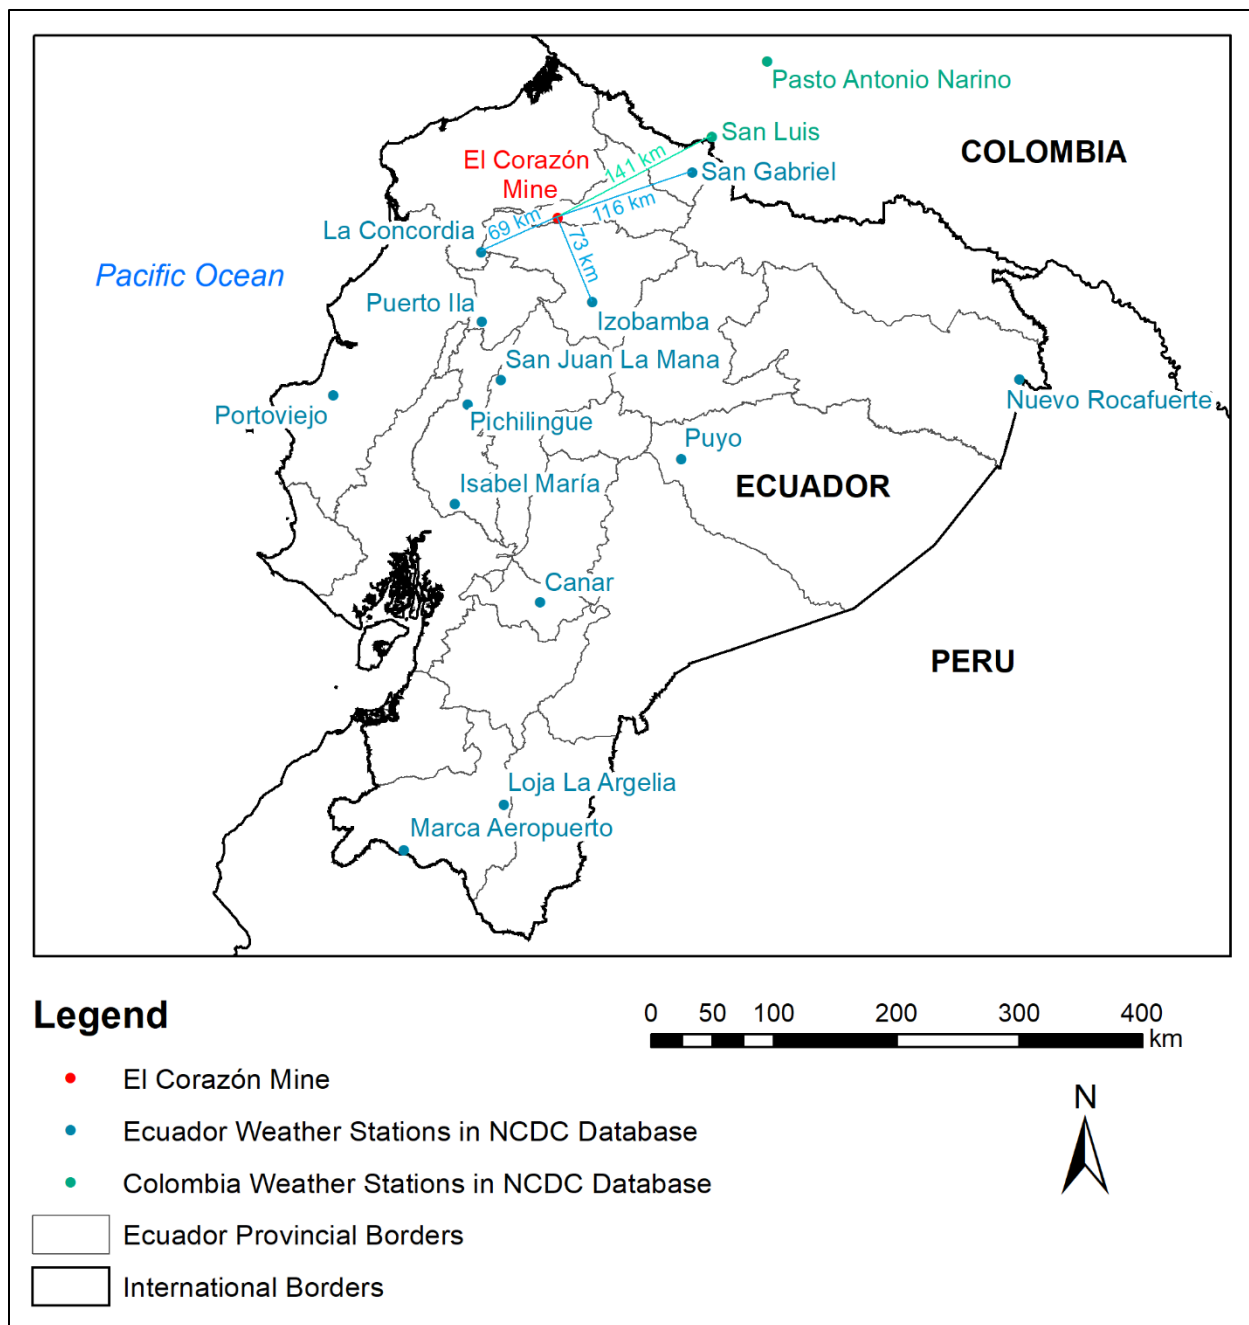
Figure 21. The closest weather stations to the El Corazón mine in the National Climate Data Center (NCDC) database are La Concordia to the southwest (distance of 69 kilometers), Izobamba to the south-southeast (distance of 73 kilometers), San Gabriel to the northeast (distance of 116 kilometers), and San Luis in Colombia to the northeast (distance of 141 kilometers) (see Tables 3a-b and 4a-b). The El Corazón mine is mapped as the center of the mining concession as stated in Agroindustrial El Corazón S.A. (2023b). Weather station locations from NOAA (2024).

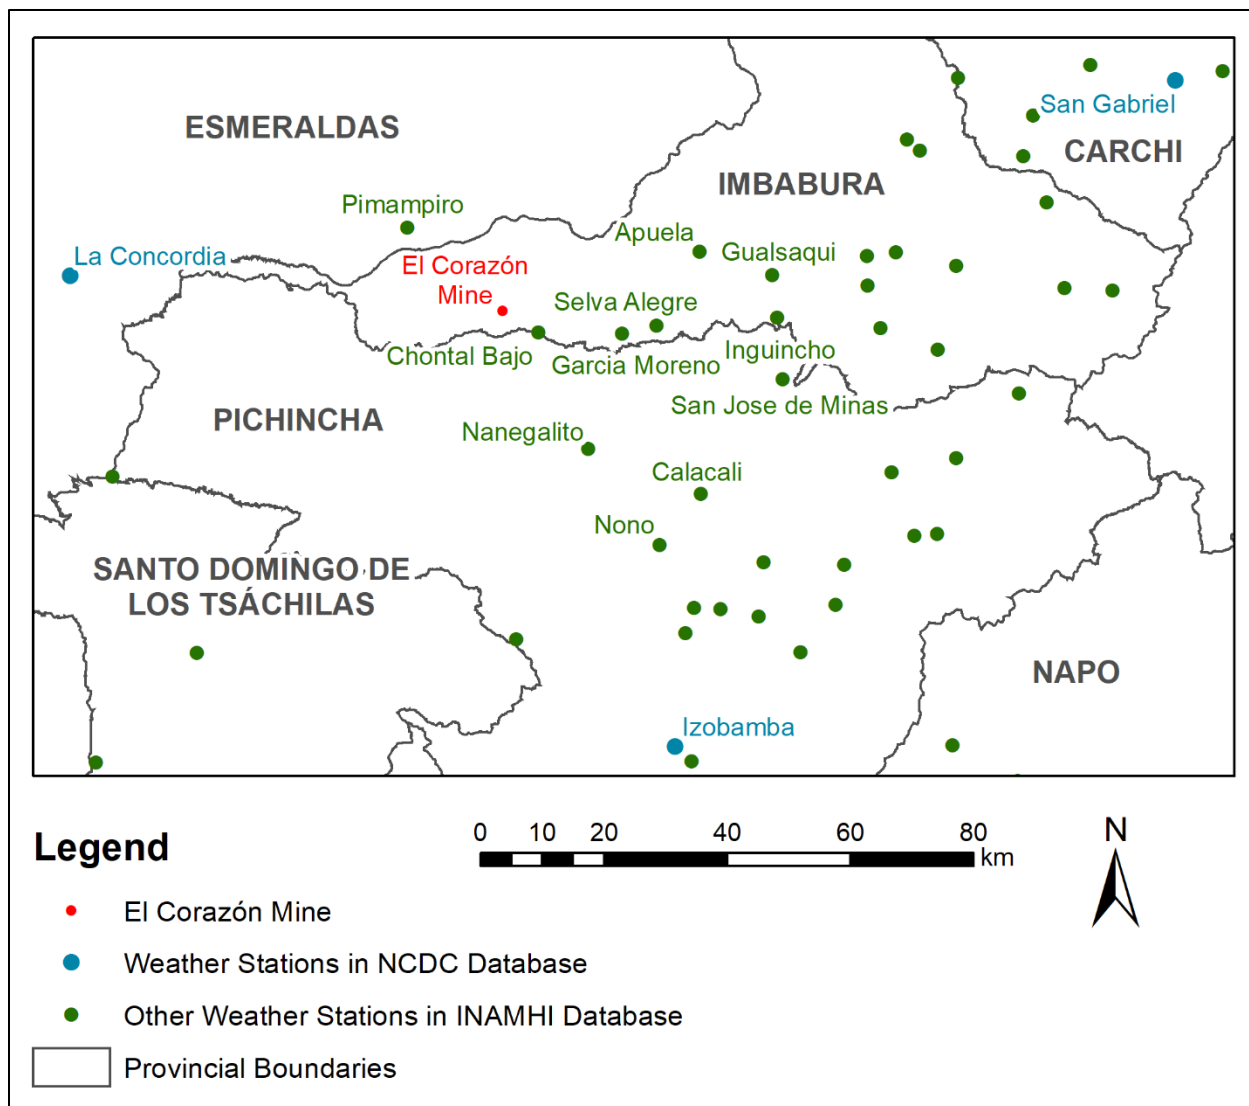
Figure 22. There are 11 weather stations in the INAMHI database within 50 kilometers of the El Corazón mine. The closest weather station is Chontal Bajo, 6.9 kilometers to the southeast (see Table 5). The El Corazón mine is mapped as the center of the mining concession as stated in Agroindustrial El Corazón S.A. (2023b). Weather station locations from INAMHI (2015).
