Filtered Tailings in Indonesia

The Catastrophic Failure of a Disruptive Technology

Technical Report: Steven H. Emerman, PhD, Malach Consulting

March, 2026

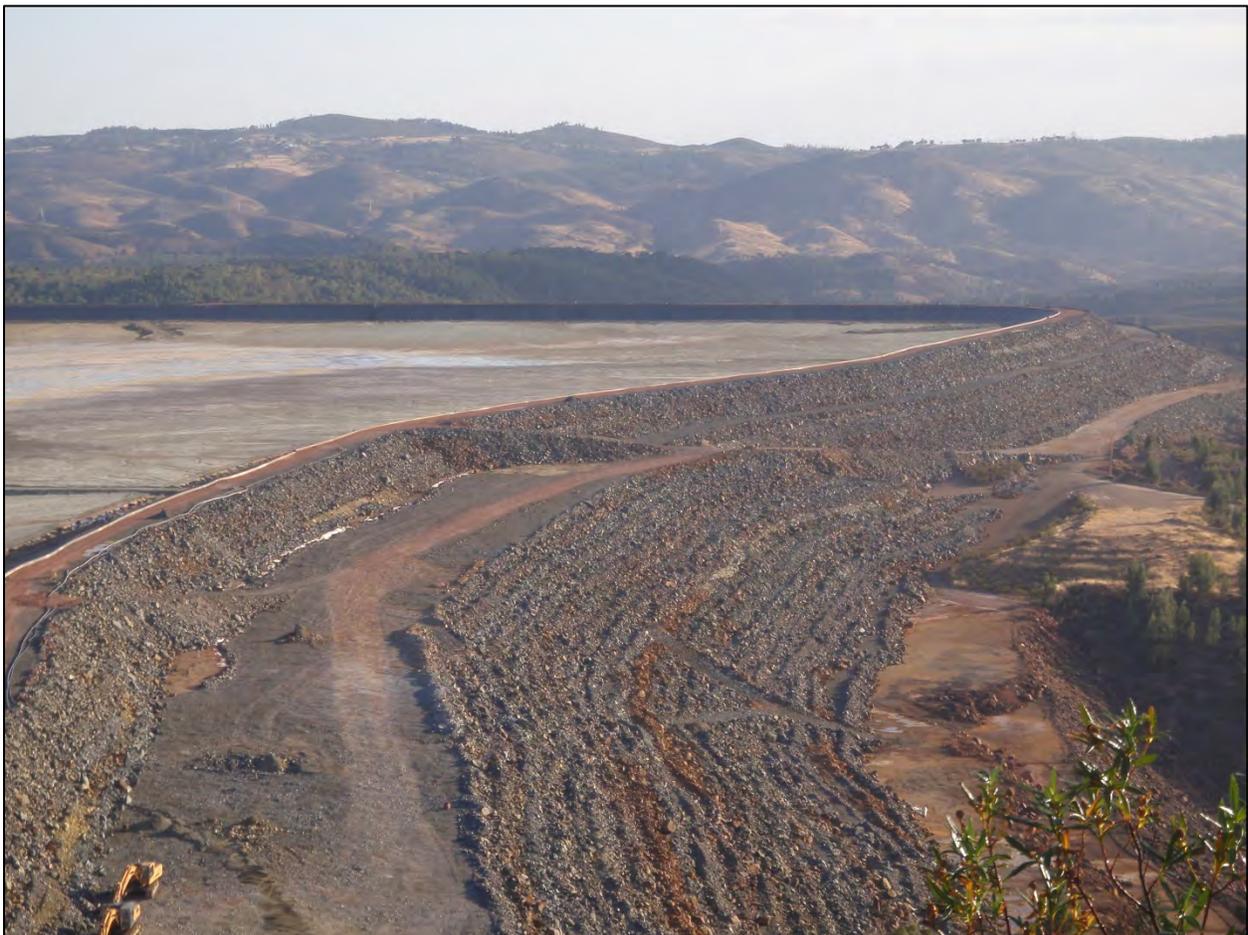
Figure 7. In conventional tailings management, wet tailings are permanently stored behind a dam constructed from waste rock, the coarser fraction of the tailings, or rockfill or earthfill that is available on the mine site. Photo of the Aguzadera dam at the Atalaya Mining Riotinto mine in Andalusia, Spain, taken by the author on June 19, 2019.

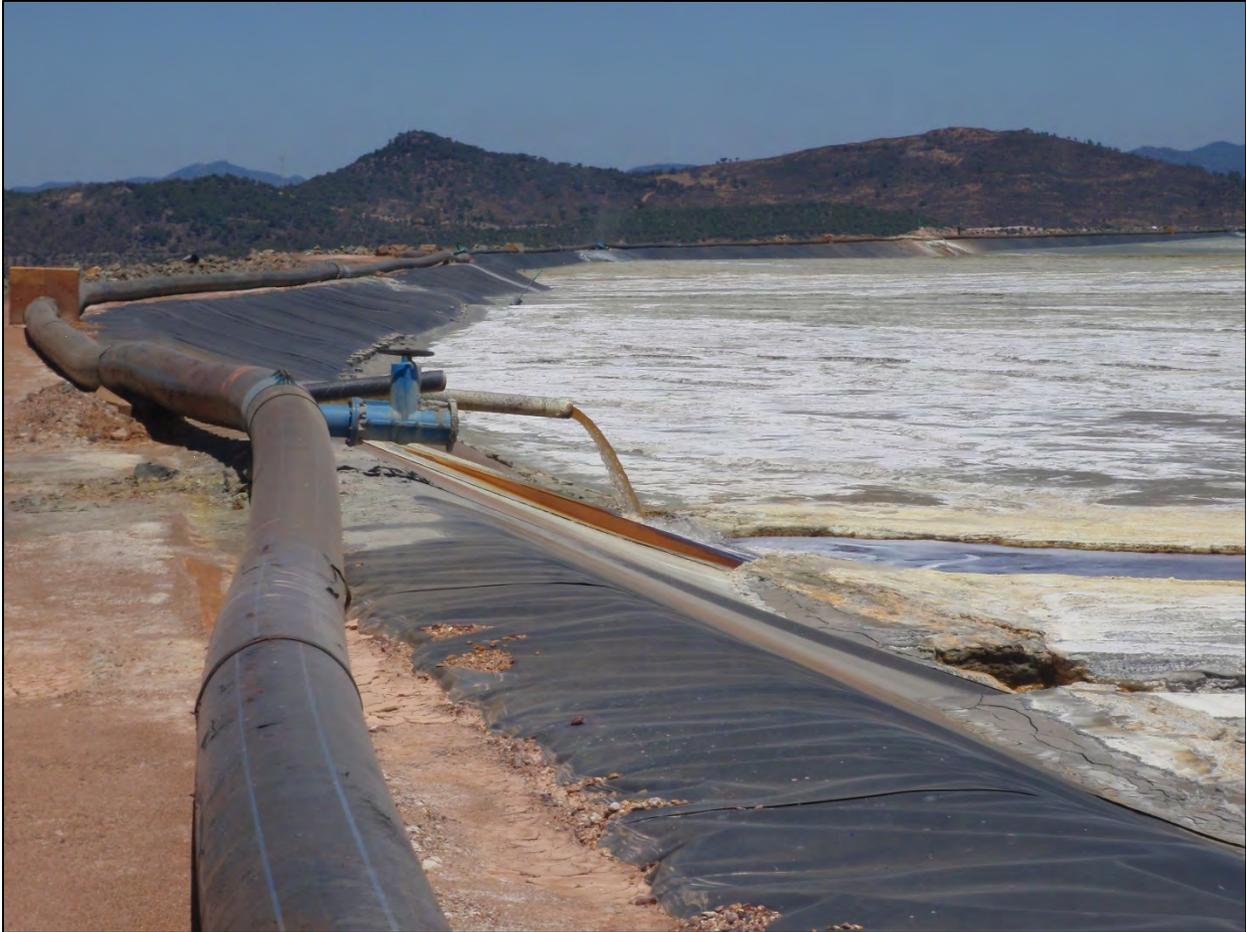
Figure 8a. A mixture of water and tailings with a solids content of 35% by mass is hydraulically discharged into the tailings pond from the crest of the Cobre dam at the Atalaya Mining Riotinto mine in Andalusia, Spain (see Fig. 7). Because of the lack of compaction, the loosely-packed tailings are susceptible to liquefaction (see Fig. 10). Photo taken by the author on June 21, 2019.

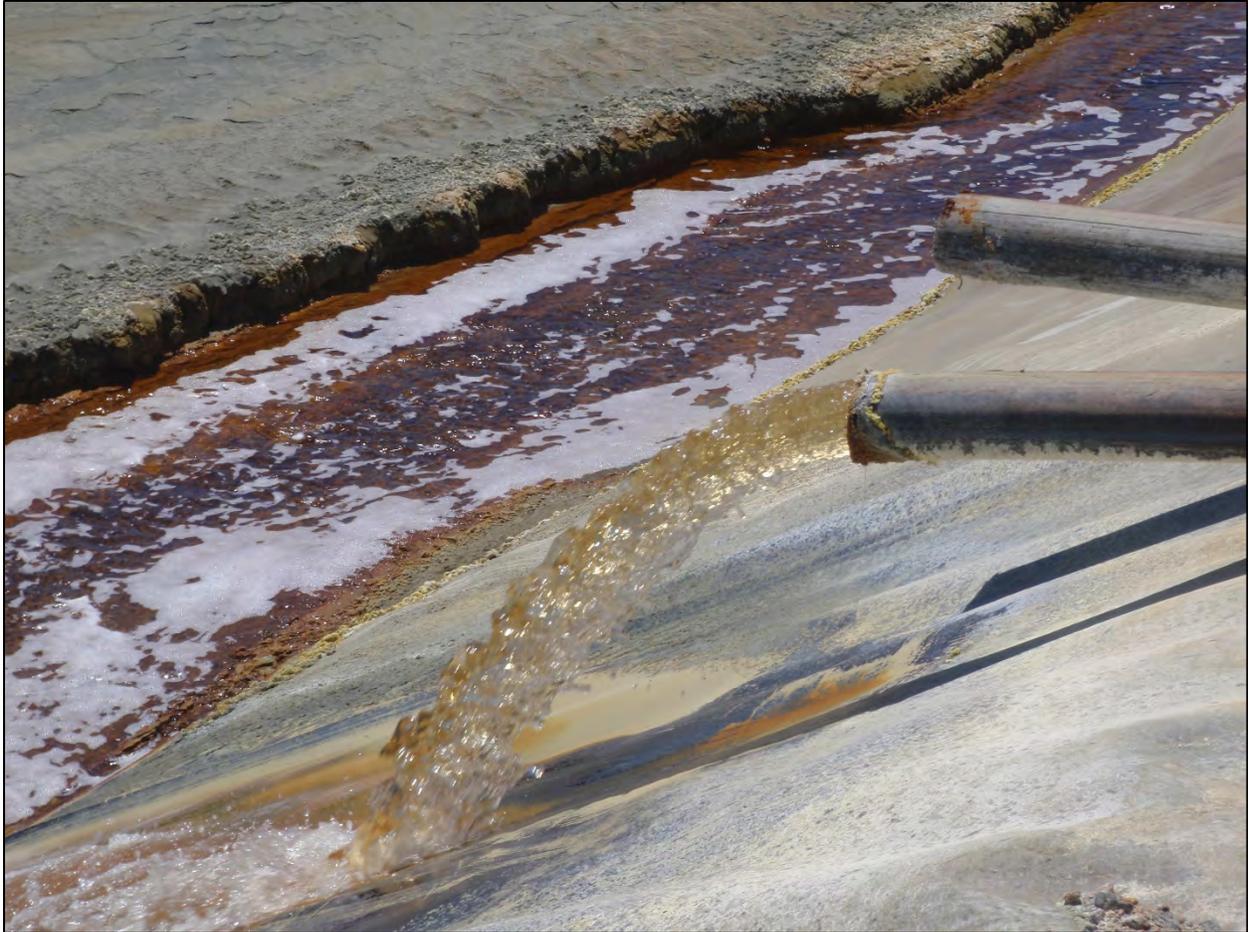
Figure 8b. A mixture of water and tailings with a solids content of 35% by mass is hydraulically discharged into the tailings pond from the crest of the Cobre dam at the Atalaya Mining Riotinto mine in Andalusia, Spain (see Fig. 7). Because of the lack of compaction, the loosely-packed tailings are susceptible to liquefaction (see Fig. 10). Photo taken by the author on June 21, 2019.

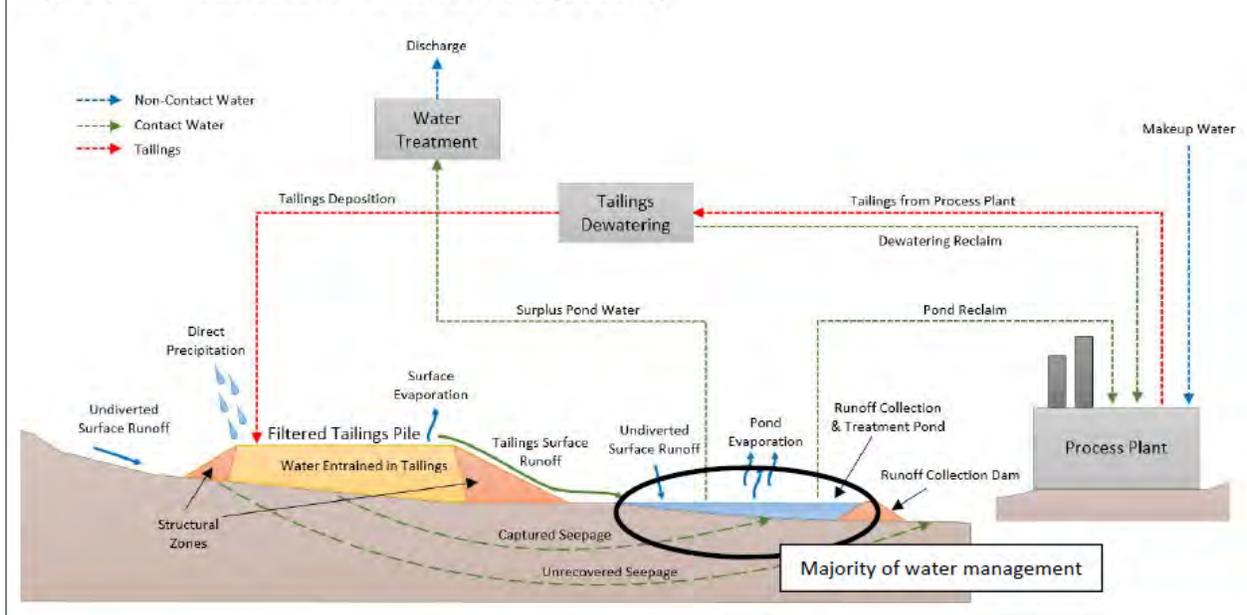
Figure 3.5 Schematic of a Filtered Tailings Facility

Figure 13. Current filter press technology does not consistently produce filtered tailings with the appropriate geotechnical water content for adequate compaction. Even if tailings do leave the filter presses with the appropriate water content, they can be rewetted by precipitation. The standard solution for filtered tailings stacks is to place the tailings that are too wet or too dry for adequate compaction in the center of the facility in a non-structural zone, in which the tailings are either uncompacted or lightly compacted. The tailings with the appropriate water content for adequate compaction are then placed on the periphery, where they can be compacted to form a structural zone. The structural zone serves the same function as a dam for the non-structural zone. Figure from Klohn Crippen Berger (2017).

It is important to point out that filtered tailings storage facilities have other possible failure mechanisms besides liquefaction. For example, surface runoff flowing over the structural zone could erode it away, thus exposing the uncompacted tailings that were behind the structural zone (see Fig. 13). Uneven settlement or failure of the foundation beneath the filtered tailings storage facility could cause failure of the entire structure. Finally, the structural zone (dam) could fail simply by sliding with no liquefaction or other flow behavior. According to Klohn Crippen Berger (2017), due to the typical low water content of filtered tailings, “Failure, if it occurs, would likely be local slumping and consequences would be restricted to the local area (or the distance equivalent to roughly 10 times the height [of the tailings dam]) ...” On the other hand, flow behavior of the tailings could develop if the tailings mixed with sufficient water after dam failure. The above quote continues, “... unless the material slumps into a water body ... When large water ponds are located downstream of high-density thickened/paste facilities, cascading failures are possible and should be accounted for when developing the risk profile of tailings failure management” (Klohn Crippen Berger, 2017). On the above basis, drainage and runoff collection ponds should be located sufficiently far downstream from the tailings storage facility and excessive accumulation of water in these ponds should be avoided (Klohn Crippen Berger, 2017; see Fig. 13).

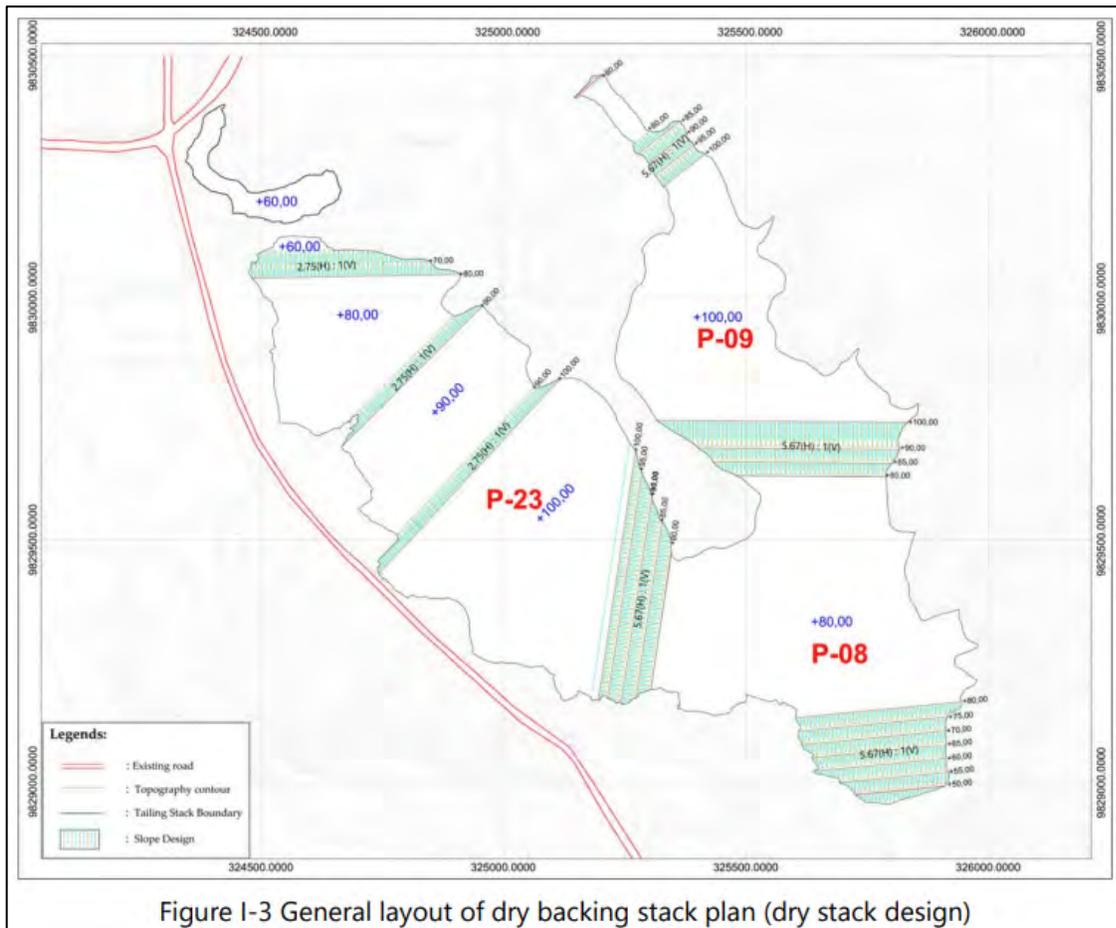
Figure I-3 General layout of dry backing stack plan (dry stack design)

At the end of its useful life, the DSTF for PT HPL will have a height of 57 meters, footprint of 195 hectares, and maximum capacity of 57.2 million metric tons or 25.8 million cubic meters of tailings (PT Halmahera Persada Lygend (2024); see Table 4). Thus, the target dry density (density of solid particles, not including water) is 2.22 metric tons per cubic meter, which is within the mining industry range of 1.9 to 2.6 metric tons per cubic meter with 2.0 metric tons per cubic meter as a typical dry density (Cacciuttolo Vargas and Pérez Campomanes, 2022). The DSTF at the PT HPL mine is being constructed in three stages, starting with P-23, then moving to P-09, and concluding with P-08 (see Fig. 21). The construction includes both temporary and permanent rockfill buttresses, which consist of coarse fragments of ultramafic rocks with a minor amount of soil, all of which is obtained from the mine site (PT Lapi ITB, 2022; see Fig. 22). The tailings are being stacked far higher than the tops of the rockfill buttresses (see Fig. 22). Thus, the rockfill buttresses do not actually serve the function of dams, since if the tailings liquefied, they could easily flow over the tops of the buttresses (see Fig. 22). The actual density and corresponding maximum capacity by mass will be discussed in the section “Obi Island: Imminent Catastrophic Failure,” along with a possible reason for the short heights of the buttresses.

Figure 21. The Dry Stack Tailings Facility (DSTF) at the PT HPL mine is being constructed in three stages, starting with P-23, then moving to P-09, and concluding with P-08. The rockfill buttresses are indicated by green stripes. See longitudinal sections of the three stages in Fig. 22. Figure from PT Lapi ITB (2022).

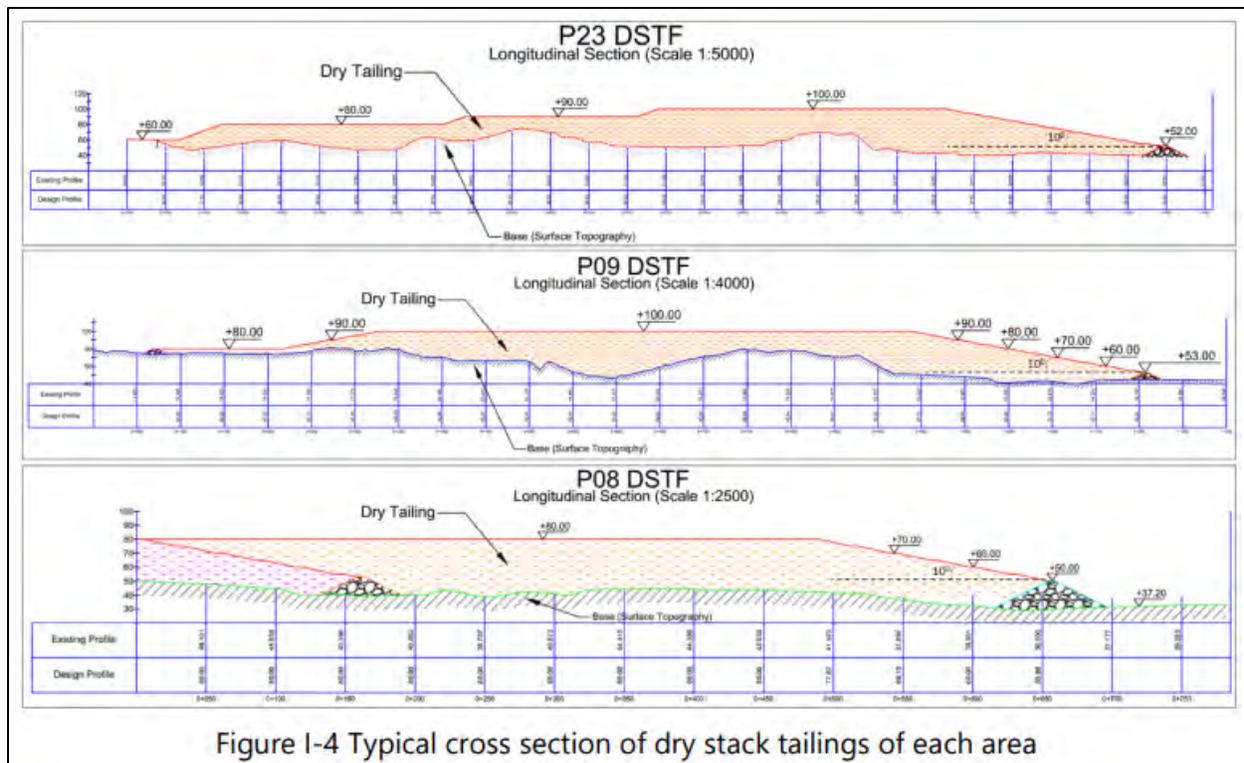
Figure I-4 Typical cross section of dry stack tailings of each area

Figure 22. The Dry Stack Tailings Facility (DSTF) at the PT HPL mine is being constructed in three stages, starting with P-23, then moving to P-09, and concluding with P-08. The maximum height will be 57 meters (see Table 1a). The tailings are being stacked far higher than the tops of the rockfill buttresses. Thus, the rockfill buttresses do not actually serve the function of dams. If the tailings liquefied, they could easily flow over the tops of the buttresses. See map views of the three stages in Fig. 21. Figure from PT Lapi ITB (2022).

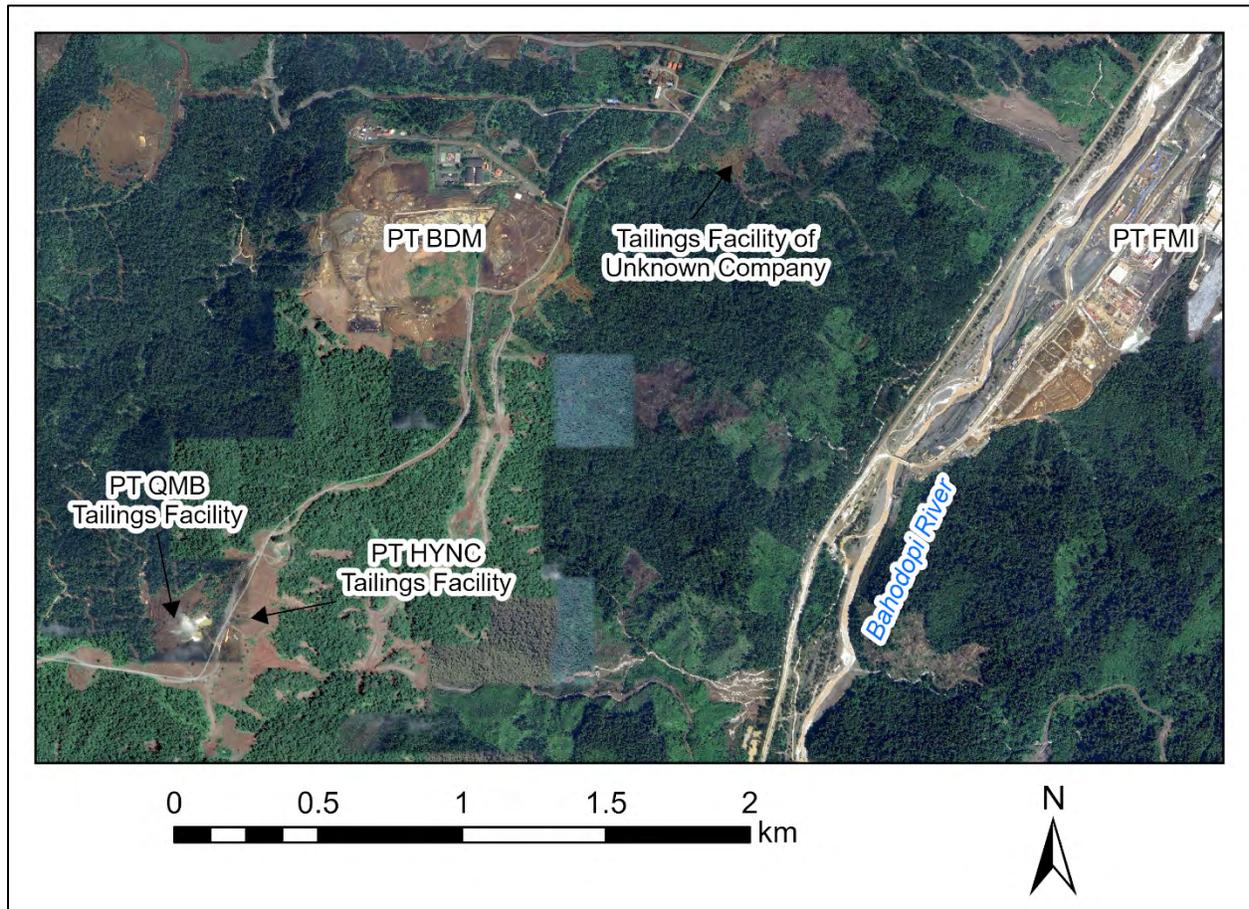
There are multiple filtered tailings storage facilities for the HPAL projects in the Indonesia Morowali Industrial Park with a total footprint of 600 hectares (Fisher and Grossl, 2023; Lee, 2023; see Table 4). According to mineworkers, filtered tailings storage facilities belonging to PT Huayue Nickel Cobalt (HYNC) and PT Qing Mei Bang (QMB) New Energy Materials are located at a site called KM8 or IMIP8 about 7.5 kilometers west of the Indonesia Morowali Industrial Park, at which the PT QMB tailings facility is northwest of the highway and the PT HYNC tailings facility is southeast of the highway (see Figs. 23-24). The combined footprint of the PT HYNC and PT QMB tailings facilities is less than 20 hectares, so a considerable footprint of tailings storage facilities must exist elsewhere on Sulawesi Island. Mineworkers have identified another location about two kilometers northwest of the PT HYNC/PT QMB tailings facilities as the site of a filtered tailings storage facility of an unknown company, which could be either PT HYNC or PT QMB, or potentially either PT ESG New Energy Material or PT Meiming New Energy Material, which began production in 2025 (see Table 1a). According to Fisher and Grossl (2023), “The tailings [for PT HYNC] are sent to a dry stack site – which is 7.5 kilometres away [apparently referring to the site KM8] ... Dry stack tailings site [for PT QMB] is even further than for PT Huayue, at around 10 to 15 kilometres from the HPAL operation.” It should be noted that even the location for the HPAL plant for PT Meiming New Energy Material within the Indonesia Morowali Industrial Park is unknown (see Fig. 23). The question as to whether PT QMB and PT HYNC have separate tailings facilities at the site KM8 or IMIP8 or whether they are the same facility, as well as company recognition that KM8 is the site of a tailings storage facility, will be discussed further in the section “Sulawesi Island: Ongoing Catastrophic Failure.”

Figure 24. Within the Indonesia Morowali Industrial Park (IMIP), only three filtered tailings storage facilities have been located, which are the tailings facilities for PT Qing Mei Bang (QMB) New Energy Materials, PT Huayue Nickel Cobalt (HYNC), and an unknown company. The three facilities occupy an area far less than the total footprint of 600 hectares (6 square kilometers) for all filtered tailings storage facilities in IMIP (see Table 4). A collapse of any one of the three facilities could potentially transport tailings to the Bahodopi River (see smaller-scale view with tailings pathway in Figs. 41a-b). The location of the filtered tailings storage facilities for PT HYNC and PT QMB is known locally as KM8 or IMIP8. It is not entirely clear as to whether the filtered tailings storage facilities for PT HYNC and PT QMB are actually separate facilities (see Figs.40a and 42a). PT BDM (Bintang Delapan Mineral) and PT FMI (Fajar Metal Industry) are not HPAL projects. PT BDM is a nickel-ore mine, while PT FMI produces nickel sulfide for electric batteries. Background is Google Earth imagery from January 7, 2020, and January 3, 2025. Indonesian version of map available in Yayasan Tanah Merdeka (YTM) (2025b).

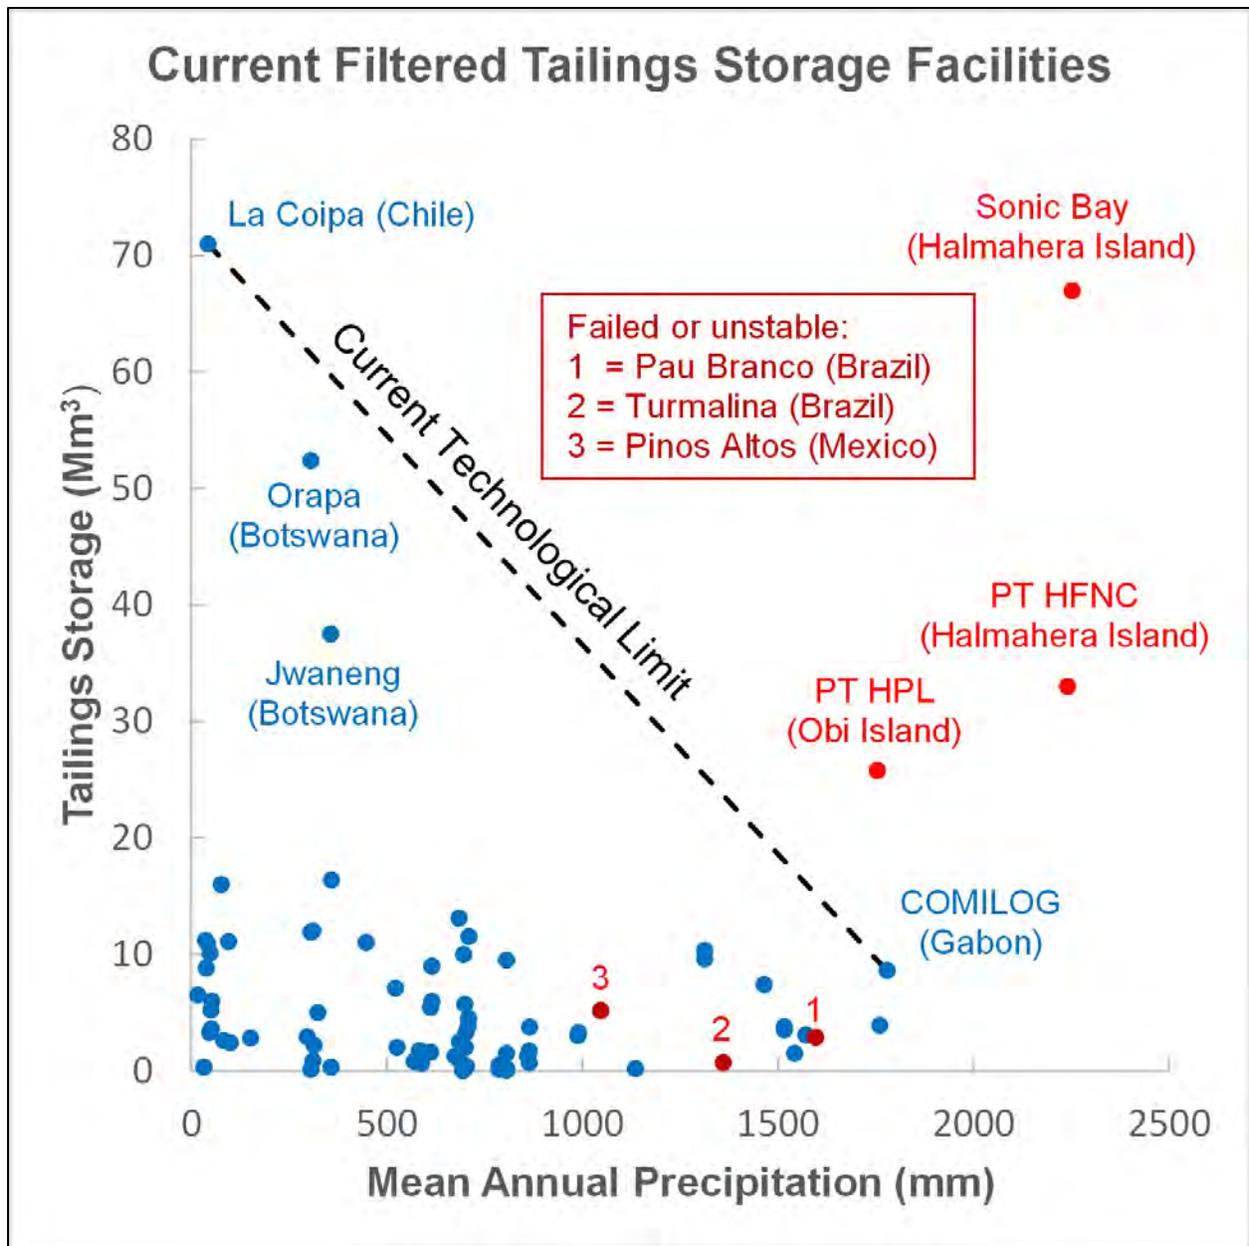
Figure 25a. The chief limitation on the size of filtered tailings storage facilities is the impact of precipitation. The current technological limit is constrained by a line connecting the filtered tailings storage facility at the La Coipa mine in Chile with tailings storage of 71 million cubic meters and mean annual precipitation of 43 mm and the filtered tailings storage facility at the COMILOG mine in Gabon with tailings storage of 8.6 million cubic meters and mean annual precipitation of 1779 mm. The mean annual precipitations of 2252, 2241, and 1754 mm, and tailings storage volumes of 67, 33, and 25.8 million cubic meters for the filtered tailings storage facilities at the Sonic Bay, PT HFNC, and PT HPL projects, respectively (see Table 4), place all three facilities well outside of the current technological limit. The mean annual precipitations of 1597, 1360, and 1046 mm, and tailings storage volumes of 2.85, 0.71, and 5.152 million cubic meters for the filtered tailings storage facilities at the Pau Branco, Turmalina, and Pinos Altos mines, respectively, show that construction within the current technological limit is not a guarantee of success. Data on existing filtered tailings storage facilities from Franks et al. (2021), UNEP et al. (2025) and Agência Nacional de Mineração (2025), and mean annual precipitation from Fick and Hijmans (2017).

The model of Fick and Hijmans (2017) was also used to assign mean annual precipitations of 2252, 2241, and 1754 mm to the sites of the filtered tailings storage facilities at the Sonic Bay, PT HFNC, and PT HPL projects, respectively. The exact locations for the sites of the filtered tailings storage facilities on Halmahera Island (PT HFNC and Sonic Bay) are not actually known, but the mean annual precipitations are based upon the best estimates by staff at Survival International. Combining the mean annual precipitations with tailings storage volumes of 67, 33, and 25.8 million cubic meters for the filtered tailings storage facilities at the Sonic Bay, PT HFNC, and PT HPL projects, respectively (see Table 4), places all three facilities well outside of the current technological limit (see Fig. 25a). The assignment of a storage volume of 33 million cubic meters for the tailings facility at the PT HFNC project was based on the assumption of a compacted tailings dry density of 2.0 metric tons per cubic meter (see Table 4). It is especially noteworthy that the sites for the two projects on Halmahera Island have mean annual precipitations that far exceed the rainfall for any existing filtered tailings storage facility, the wettest site being the COMILOG mine in Gabon with a mean annual precipitation of 1779 mm (see Fig. 25a).

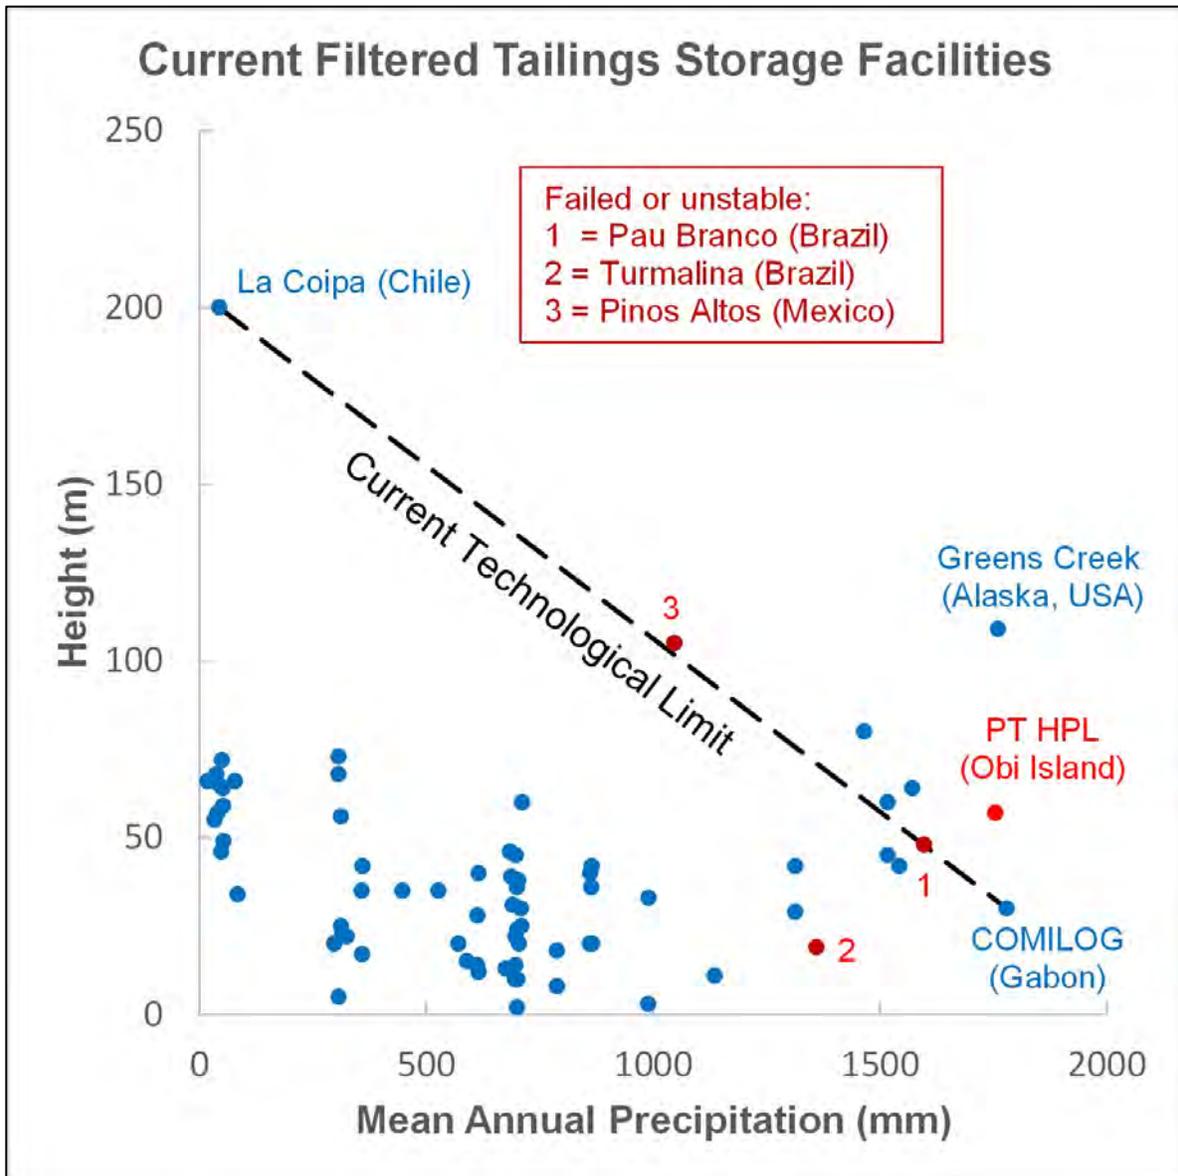
In a similar way, the current technological limit on height was constrained by a line connecting the La Coipa filtered tailings storage facility with a height of 200 meters and mean annual precipitation of 43 mm and the COMILOG filtered tailings storage facility with a height of 30 meters and mean annual precipitation of 1779 mm (see Fig. 25b). Although the filtered tailings storage facility at the Greens Creek mine in Alaska has a height of 109 meters at a mean annual precipitation of 1760 mm (see Table 6a), the throughput (tailings production rate) is only 1500 metric tons per day (see Table 6b). Therefore, the success of the Greens Creek facility is probably not relevant to the success of the Sonic Bay, PT HFNC, and PT HPL projects, which have throughputs of 28,356, 49,041, and 20,537 metric tons per day, respectively (see Table 4). It is curious that, with mean annual precipitations of 1597, 1360, and 1046 mm (Fick and Hijmans, 2017), and heights of 48, 19, and 105 meters for the filtered tailings storage facilities at the Pau Branco, Turmalina, and Pinos Altos mines, respectively (Agência Nacional de Mineração, 2025; UNEP et al., 2025), the heights of the Pau Branco and Pinos Altos facilities roughly met the current technological limit, although the height of the Turmalina facility was well below the limit. In any event, the mean annual precipitations of 1754 mm and height of 57 meters for the filtered tailings storage facility at the PT HPL mine (see Table 4) places the height of the facility 25 meters above the current technological limit (see Fig. 25b). Unfortunately, the Dry Stack Tailings Facility (DSTF) at the PT HPL project is the only filtered tailings storage facility in Indonesia with a known maximum height.

Figure 25b. At the present time, the chief limitation on the size of filtered tailings storage facilities is the impact of precipitation. Thus, the current technological limit is roughly constrained by a line connecting the La Coipa filtered tailings storage facility in Chile with a height of 200 meters and mean annual precipitation of 43 mm and the COMILOG filtered tailings storage facility in Gabon with a height of 30 meters and mean annual precipitation of 1779 mm. The height of the filtered tailings storage facility at the Greens Creek mine is not relevant since its tailings production rate had been only 750 metric tons per day, which increased to 1500 metric tons per day by 2022 (see Table 6b), as opposed to the planned tailings production rate of 20,537 metric tons per day at the PT HPL mine (see Table 4). The mean annual precipitations of 1754 mm and height of 57 meters for the filtered tailings storage facility at the PT HPL mine (see Table 1a) places the height of the facility 25 meters above the current technological limit. The mean annual precipitations of 1597, 1360, and 1046 mm, and heights of 48, 19, and 105 meters for the filtered tailings storage facilities at the Pau Branco, Turmalina, and Pinos Altos mines, respectively, show that the heights of the Pau Branco and Pinos Altos facilities roughly met the current technological limit, while the height of the Turmalina facility was well below the limit. Data on existing filtered tailings storage facilities from Franks et al. (2021), UNEP et al. (2025) and Agência Nacional de Mineração (2025), and mean annual precipitation from Fick and Hijmans (2017).

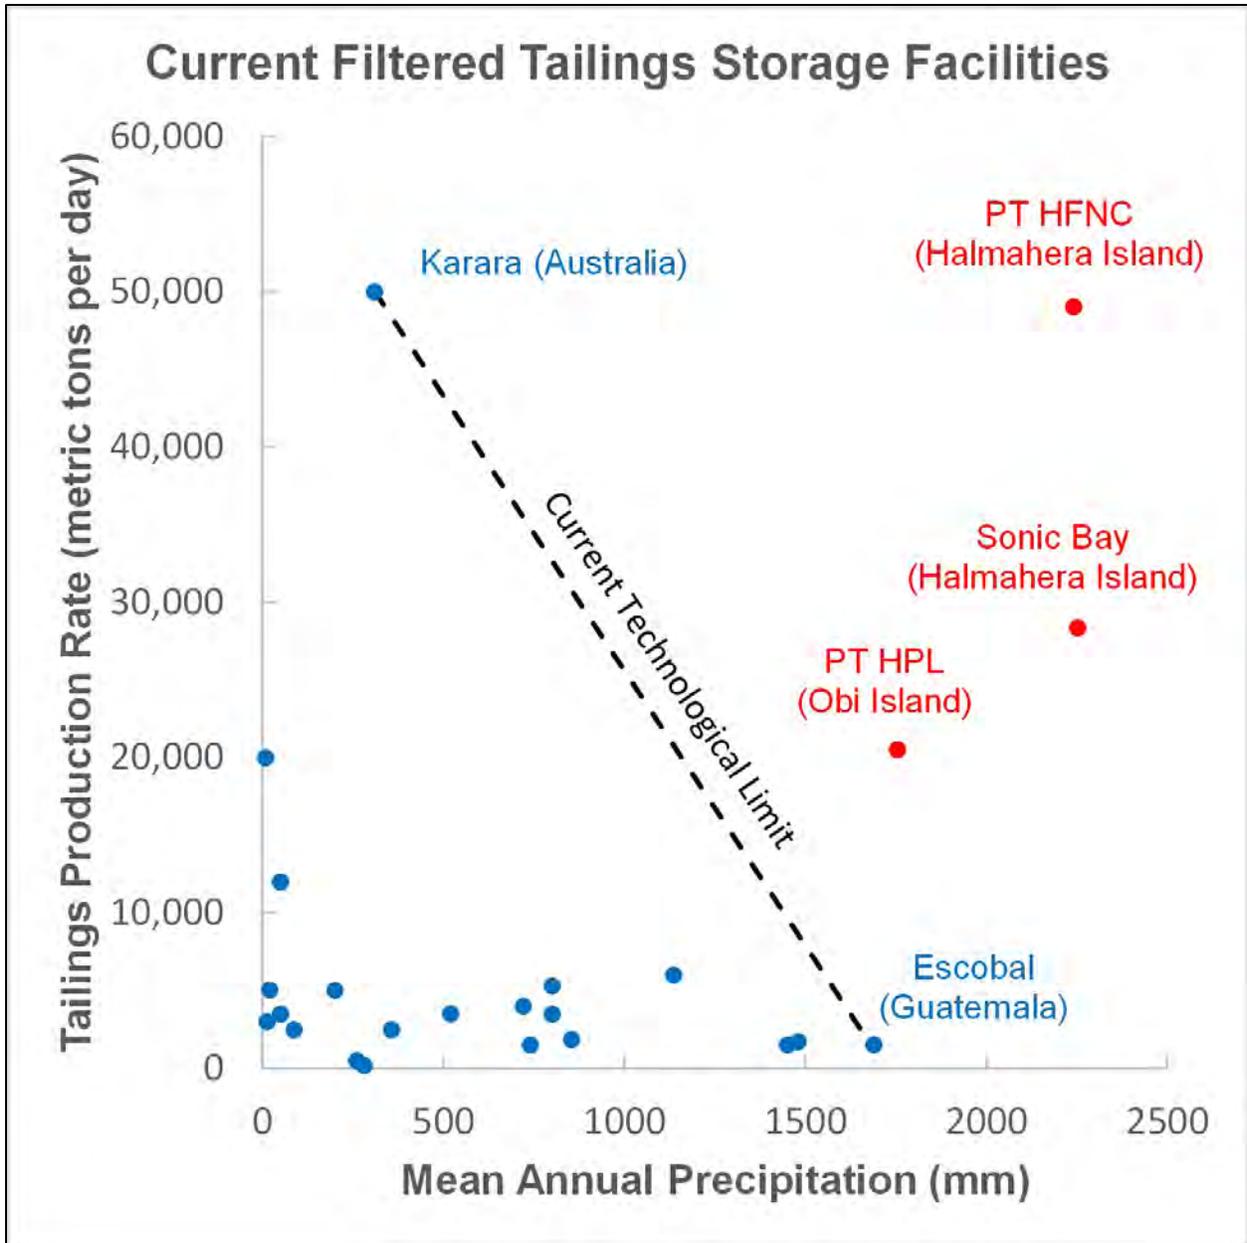
Finally, the current technological limit on throughput was constrained by a line connecting the Karara filtered tailings stack in Australia with a tailings production rate of 50,000 metric tons per day and mean annual precipitation of 310 mm and the Escobal filtered tailings stack in Guatemala with a tailings production rate of 1528 metric tons per day and mean annual precipitation of 1689 mm (see Fig. 25c). Thus far, the greatest known tailings throughput in a wet climate has been carried out at the Marlin mine in Guatemala with a throughput of 6000 metric tons per day at a mean annual precipitation of 1136 mm (see Table 6b). Using the mean annual precipitations of 2252, 2241, and 1754 mm, and tailings production rates of 28,356, 49,041, and 20,537 metric tons per day for the filtered tailings storage facilities at the Sonic Bay, PT HFNC, and PT HPL projects, respectively (see Table 4), as stated above, then places all three facilities far outside of the current technological limit (see Fig. 25c). In summary, the Sonic Bay, PT HFNC, and PT HPL projects are all clearly beyond current technological limits for storage volume, height, and throughput for a given precipitation rate.

Figure 25c. At the present time, the chief limitation on the size of filtered tailings stacks is the impact of precipitation. Thus, the current technological limit is constrained by a line connecting the Karara filtered tailings stack in Australia with a tailings production rate of 50,000 metric tons per day and mean annual precipitation of 310 mm and the Escobal filtered tailings stack in Guatemala with a tailings production rate of 1528 metric tons per day and mean annual precipitation of 1689 mm. The mean annual precipitations of 2252, 2241, and 1754 mm, and tailings production rates of 28,356, 49,041, and 20,537 metric tons per day for the filtered tailings storage facilities at the Sonic Bay, PT HFNC, and PT HPL projects, respectively (see Table 4), place all three facilities far outside of the current technological limit. Data on existing filtered tailings stacks from Klohn Crippen Berger (2017) and Cacciuttolo Vargas and Pérez Campomanes (2022). Mean annual precipitation from Klohn Crippen Berger (2017), Fick and Hijmans (2017), and Cacciuttolo Vargas and Pérez Campomanes (2022).

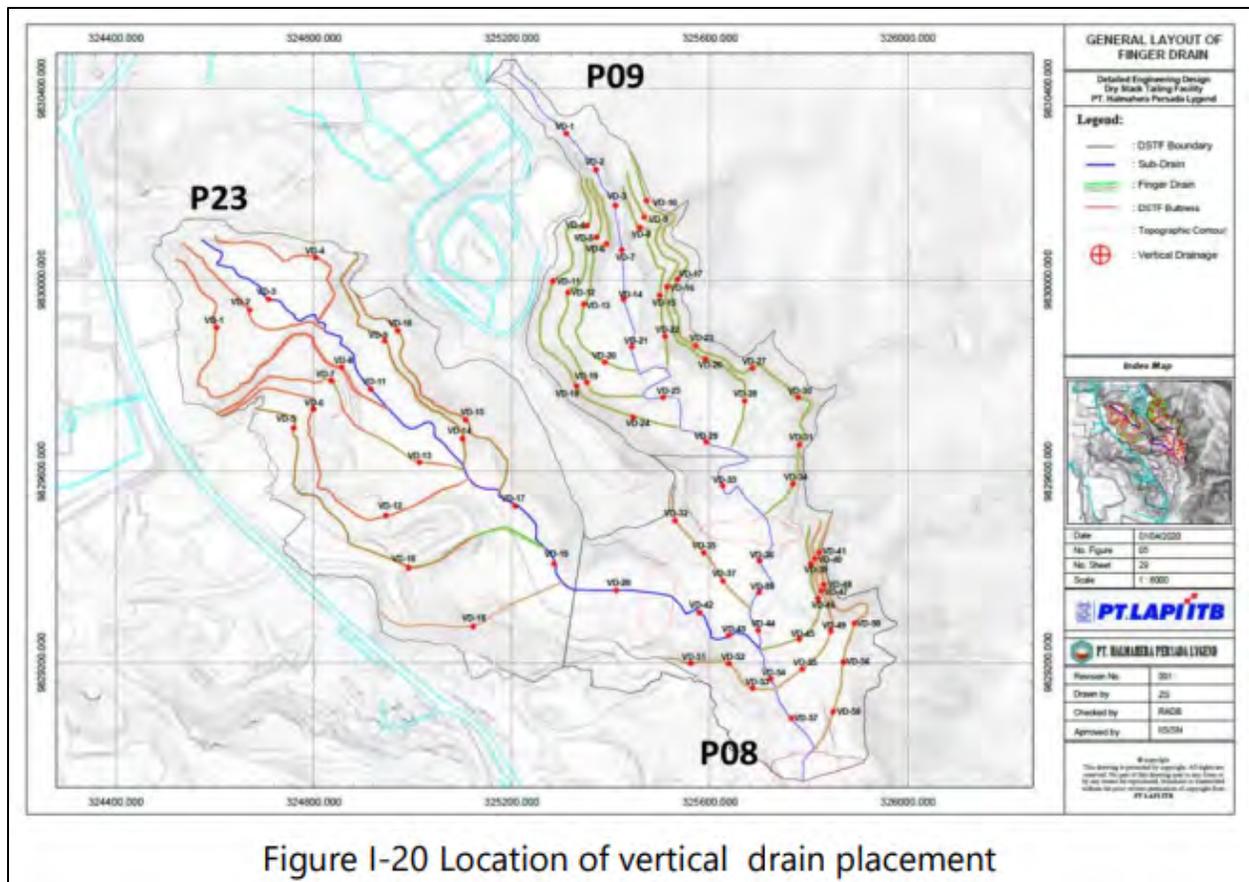
Figure I-20 Location of vertical drain placement

Figure 26. Although the Dry Stack Tailings Facility (DSTF) at the PT HPL mine had been operating for 1.5 years out of an anticipated lifetime of six years, SRK Consulting (2022a) noted that the drainage infrastructure had still not been completed. Moreover, SRK Consulting (2022a) could not understand how the drainage system was supposed to function. According to SRK Consulting (2022a), “[How] the discharge of P 23-SE and P09-SW drains away from the dry stack tailings facility is unclear. It was also noted that part of the drainage infrastructure was still under construction.” Figure from PT Lapi ITB (2022).

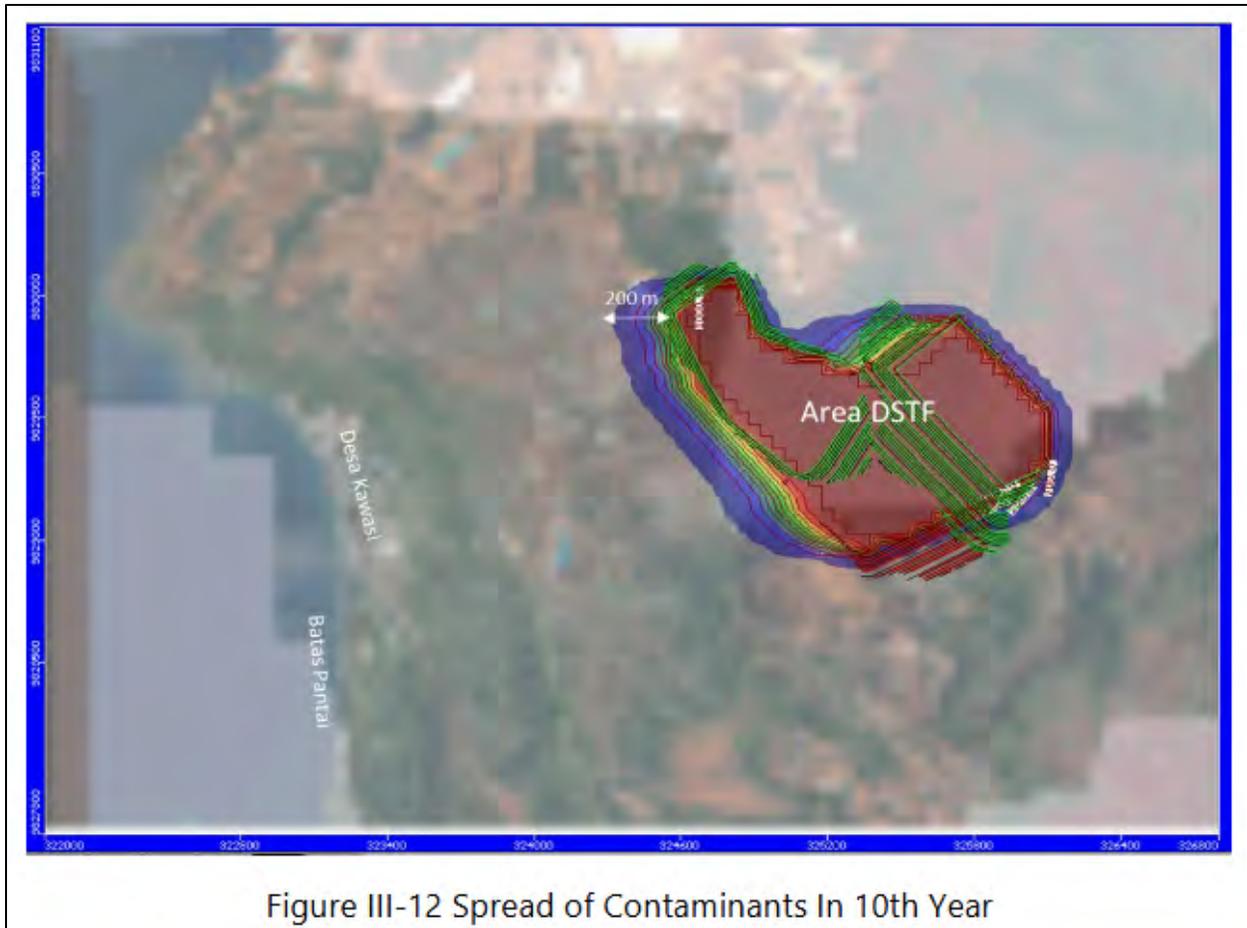
In a sense, groundwater contamination was built into the design of the Dry Stack Tailings Facility (DSTF). None of the available documents on the DSTF (Hatch, 2020; PT Lapi ITB, 2020, 2022; SRK Consulting, 2022a) mention the existence of a liner system, which would be the standard means of preventing groundwater contamination, together with appropriate drainage infrastructure both above and below the liner system. In fact, PT Lapi ITB (2020) predicted mean annual leakage to the underlying aquifer of 29,326 cubic meters per year with a daily peak of 82.86 cubic meters per day (see Figs. 27a-b). According to PT Lapi ITB (2020), “The generation of leachate is caused principally by water percolating through tailing deposited. Once in contact with tailings, the percolating water becomes contaminated, and if it then flows out of the tailing deposit it is termed leachate.” PT Lapi ITB (2020) further predicted rises in the water table within the DSTF of 31 meters due to the inability of the leachate from the DSTF to flow away fast enough into the underlying aquifer (see Fig. 28). Finally, PT Lapi ITB (2020) produced a series of maps predicting the “Spread of Contaminants” 10 years, 50 years, and 100 years after the opening of the DSTF (see Figs. 29a-c). The implication of the predicted high water table for

Figure 29a. A consulting report by PT Lapi ITB predicted the spread of potentially contaminated water that would leak from the Dry Stack Tailings Facility (DSTF) at the PT HPL mine into the underlying aquifer. Thus, the potential contamination of groundwater seems to have been implicit in the design of the facility. See spread after 50 years and 100 years, respectively, in Figs. 29b and 29c. Figure from PT Lapi ITB (2020).

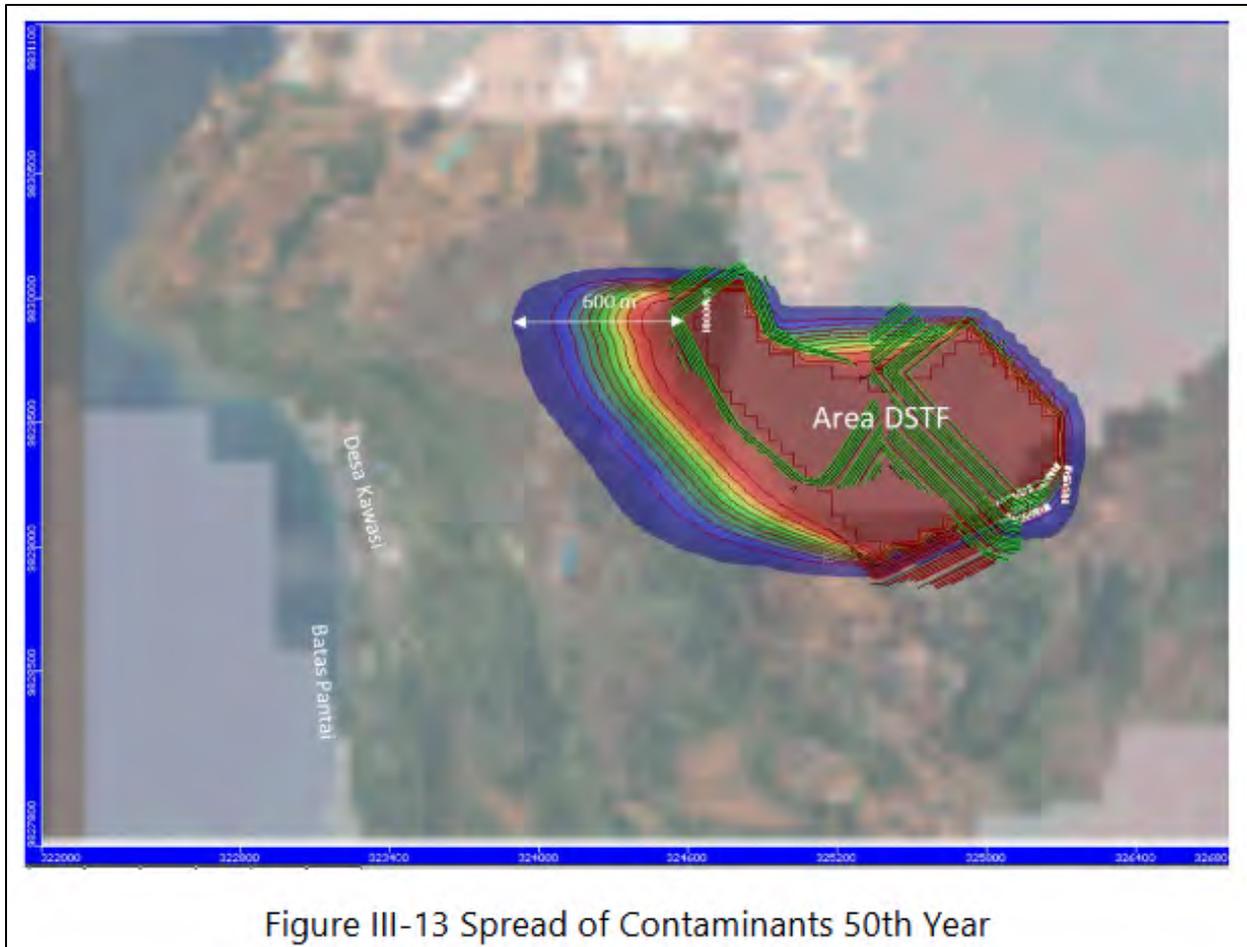
Figure 29b. A consulting report by PT Lapi ITB predicted the spread of potentially contaminated water that would leak from the Dry Stack Tailings Facility (DSTF) at the PT HPL mine into the underlying aquifer. Thus, the potential contamination of groundwater seems to have been implicit in the design of the facility. See spread after 10 years and 100 years, respectively, in Figs. 29a and 29c. Figure from PT Lapi ITB (2020).

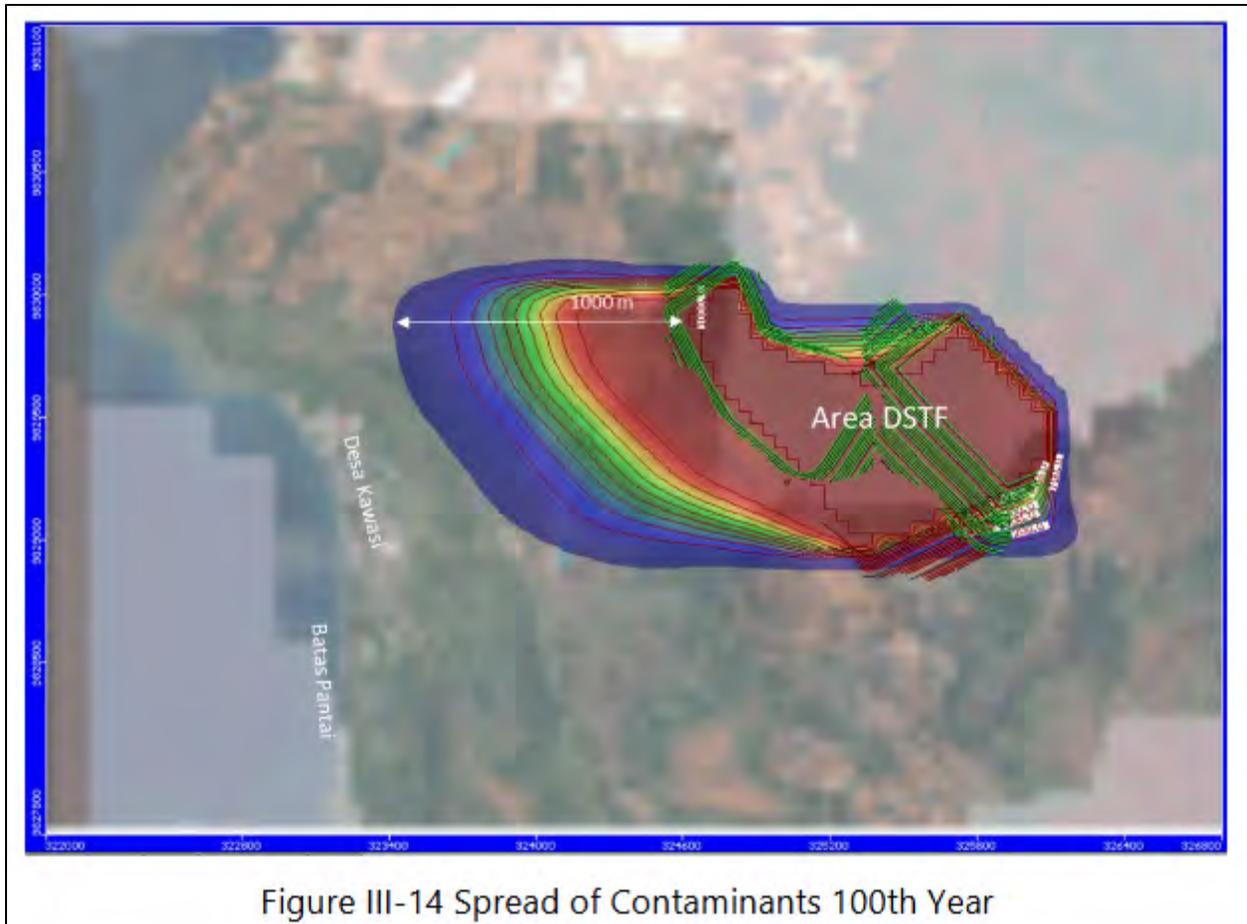
Figure 29c. A consulting report by PT Lapi ITB predicted the spread of potentially contaminated water that would leak from the Dry Stack Tailings Facility (DSTF) at the PT HPL mine into the underlying aquifer. Thus, the potential contamination of groundwater seems to have been implicit in the design of the facility. See spread after 10 years and 50 years, respectively, in Figs. 29a and 29b. Figure from PT Lapi ITB (2020).
