Filtered Tailings in Indonesia

The Catastrophic Failure of a Disruptive Technology

Technical Report: Steven H. Emerman, PhD, Malach Consulting

March, 2026

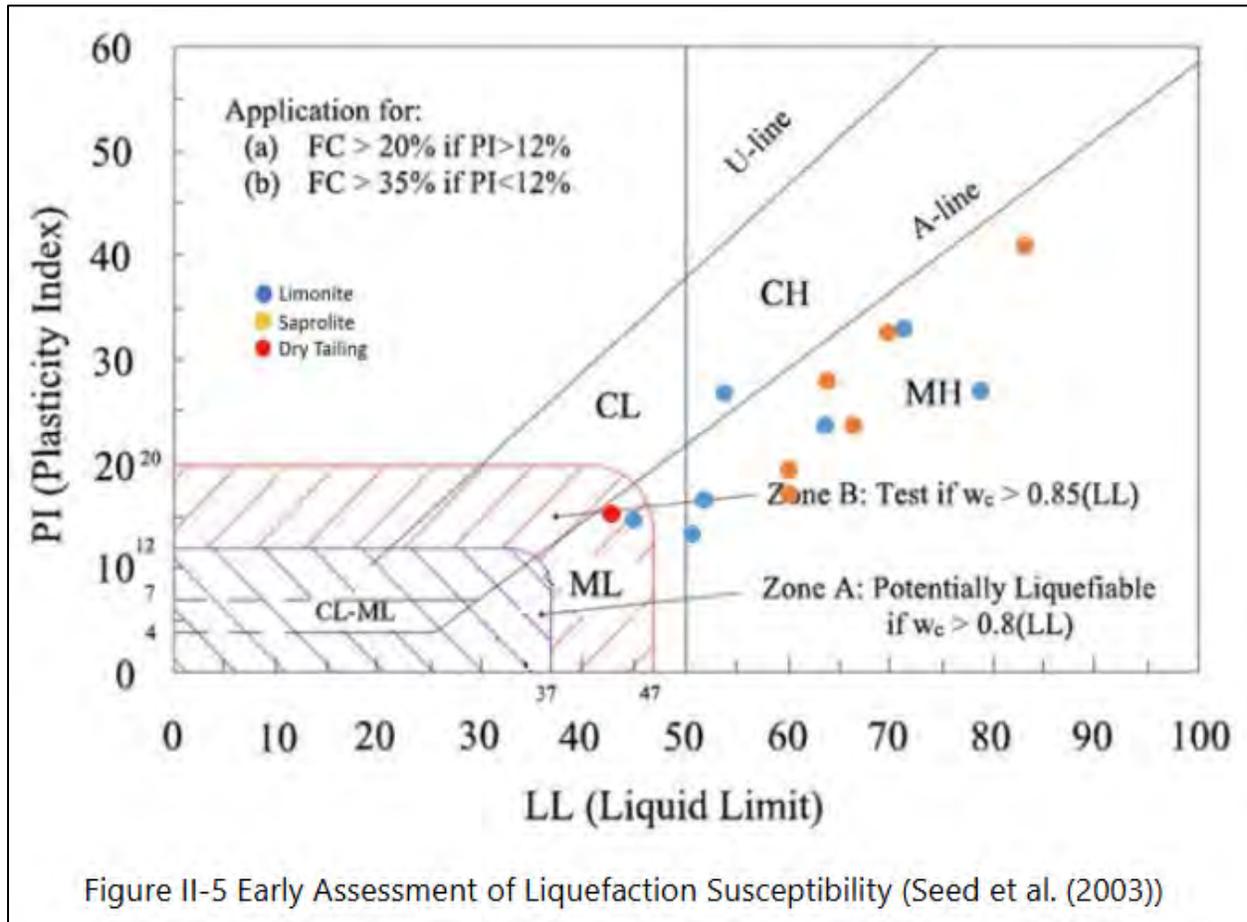
The consulting report by PT Lapi ITB (2020) further evaluated the susceptibility of the tailings to liquefaction based on an empirical relationship among the plasticity index (PI), the liquid limit (LL), and the geotechnical water content (w_c) of the tailings that was developed by Seed et al. (2003) (see Fig. 30a). According to PT Lapi ITB (2020), “Soils with $12 < PI \leq 20$, $37 < LL \leq 47$ and $w_c/LL > 0.85$ fall into zone B, are classified to be moderately susceptible to liquefaction and need further testing ... Based on this methodology, the dry tailing fall into zone B [and are] categorized as susceptible to liquefaction if the water content $> 35.45\%$.” According to SRK Consulting (2022a), the target geotechnical water content was 35%, so that susceptibility to liquefaction should be the normal condition. A consulting report by Hatch (2020) later in the same year assessed the liquefaction potential of the tailings based on a different empirical relationship between the plasticity index (PI) and the ratio of the geotechnical water content (w_c) to the liquid limit (LL) that was developed by Bray et al. (2004) (see Fig. 30b). According to

Hatch (2020), “It is observed that PT HPL’s Obi Project filtered tailings possess a moderate susceptibility to liquefaction and further testing was recommended.”

Figure 30a. According to a consulting report by PT Lapi ITB (2020), based on criteria determined by Seed et al. (2003), “Soils with $12 < PI \leq 20$, $37 < LL \leq 47$ and $w_c/LL > 0.85$ fall into zone B, are classified to be moderately susceptible to liquefaction and need further testing ... Based on this methodology, the dry tailing fall into zone B [and are] categorized as susceptible to liquefaction if the water content $> 35.45\%$.” The geotechnical water content (w_c) is the ratio of the mass of water to the mass of solid particles. The liquid limit (LL) is the geotechnical water content above which the mixture of water and solid particles behaves like a liquid, while the plastic limit (PL) is the geotechnical water content above which the mixture of water and solid particles behaves like a plastic. The plasticity index (PI) is the difference between the liquid limit and plastic limit, in which the limits are expressed as percentages. CL = Clay with low plasticity, ML = Silt with low plasticity, CH = clay with high plasticity, MH = silt with high plasticity. Figure from PT Lapi ITB (2020).

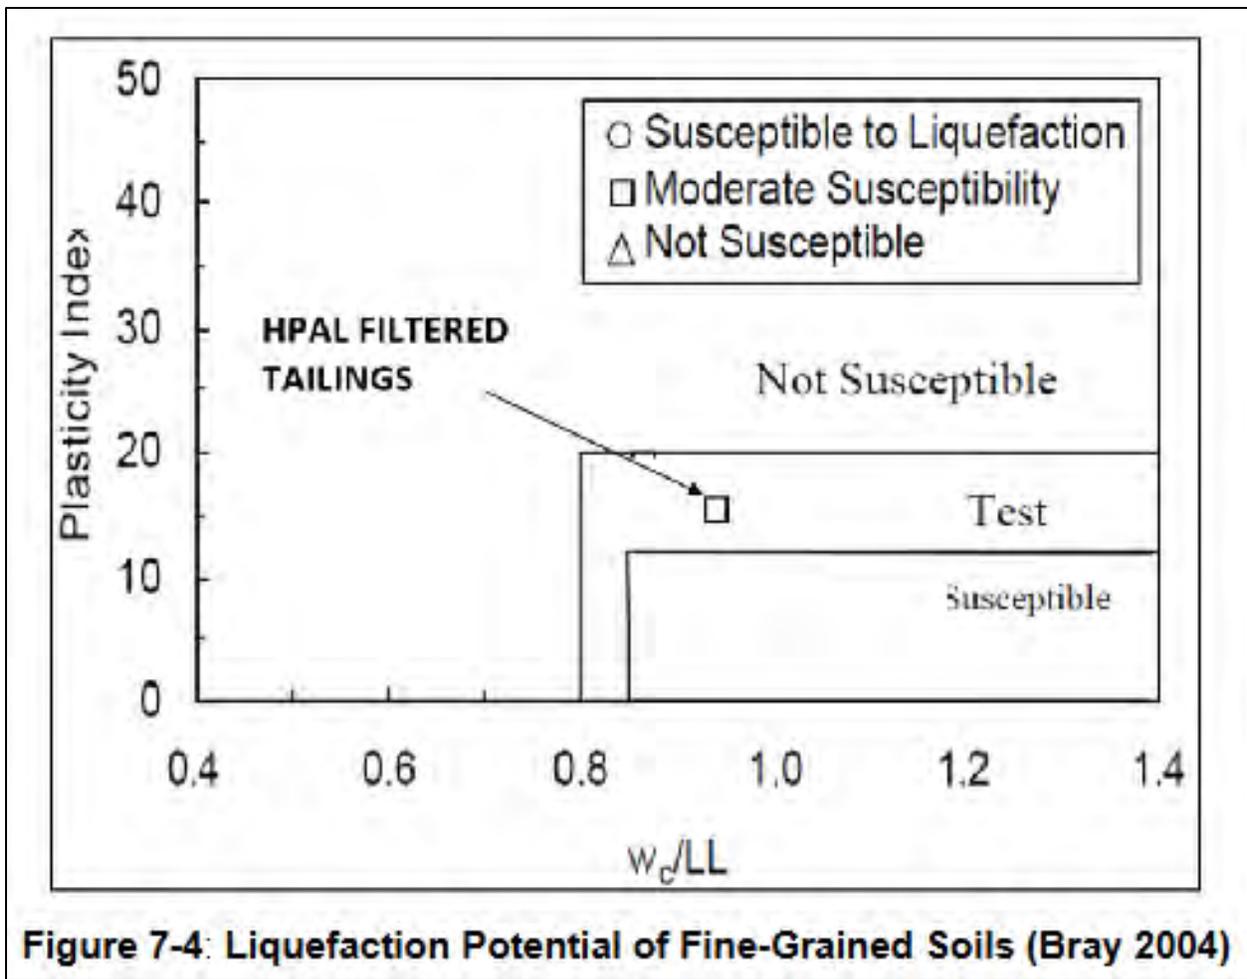
Figure 30b. According to a consulting report by Hatch (2020), based on criteria determined by Bray et al. (2004), “It is observed that PT HPL’s Obi Project filtered tailings possess a moderate susceptibility to liquefaction and further testing was recommended.” The criteria developed by Bray et al. (2004) depend upon an empirical relationship between the plasticity index and the ratio of the geotechnical water content (w_c) to the liquid limit (LL). The geotechnical water content is the ratio of the mass of water to the mass of solid particles. The liquid limit is the geotechnical water content above which the mixture of water and solid particles behaves like a liquid, while the plastic limit is the geotechnical water content above which the mixture of water and solid particles behaves like a plastic. The plasticity index is the difference between the liquid limit and plastic limit, in which the limits are expressed as percentages. Figure from Hatch (2020).

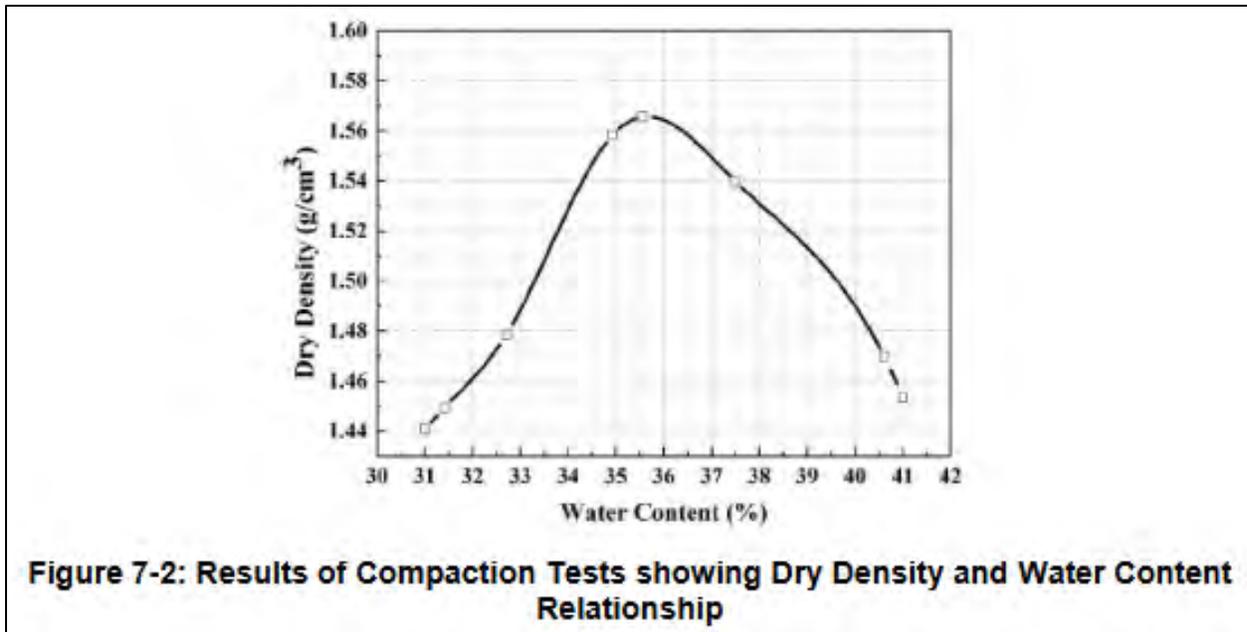
As a final point, the consulting report by Hatch (2020) showed, as expected, a strong dependence of the density of the compacted tailings on the geotechnical water content, with the maximum density achieved at an optimum water content of 35.6% (see Fig. 33), although Hatch (2020) also stated “The filtered tailings as designed has [have] 30 % in place moisture content.” The surprising observation was that the graph shows a maximum density of 1.566 metric tons per cubic meter at the optimum water content (see Fig. 33), which was stated as ~1.6 metric tons per cubic meter by Hatch (2020). By contrast, the design compacted density is 2.22 metric tons per cubic meter, based on the maximum capacity of DSTF of 57.2 million metric tons or 25.8 million cubic meters of tailings (PT Halmahera Persada Lygend (2024); see Table 4). PT Lapi ITB

Figure 33. A consulting report by Hatch (2020) showed a strong dependence of the dry density of the compacted tailings on the geotechnical water content with a maximum dry density of 1.566 metric tons per cubic meter (stated as ~1.6 metric tons per cubic meter by Hatch (2020)) achieved at an optimum water content of 35.6%. PT Lapi ITB (2020) stated that the maximum dry density measured by Hatch (2020) was “not credible,” and proposed an alternative value of 1.76 metric tons per cubic meter. SRK Consulting (2020a) and PT Halmahera Persada Lygend (2024) both assumed the much higher maximum densities of 2.20 and 2.22 metric tons per cubic meter, respectively, which are more typical for filtered tailings, but which suggests some confusion as to the correct way to measure density. Figure from Hatch (2020).

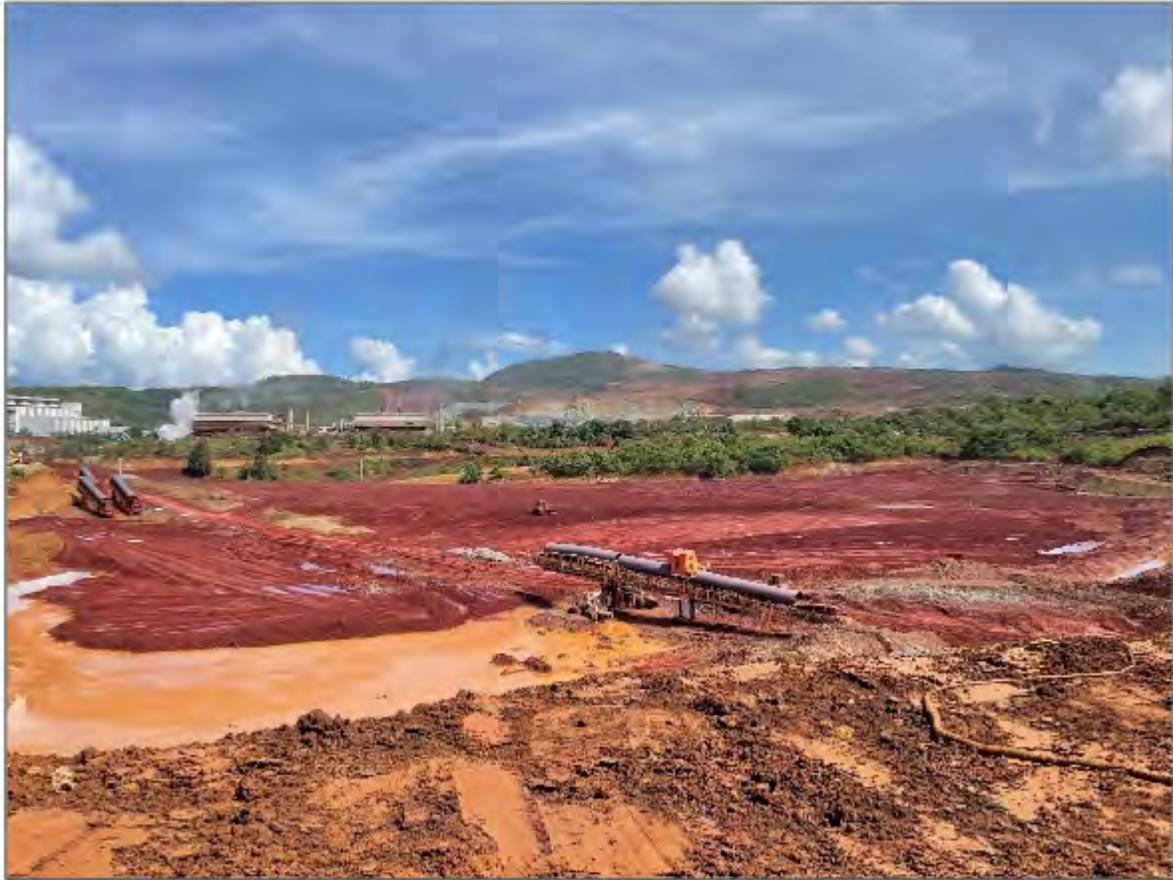
Figure 9-11: View of DSTF area with significant water ponding

Figure 35a. The first revision of the 2022 report by SRK Consulting (2022b) included a large photo with the heading “View of DSTF area with significant water ponding.” Surface ponding is a very serious problem for a filtered tailings storage facility because the ponded water can lead to erosion and washouts (gully formation) of the filtered tailings stack and because the ponded areas are not trafficable. Moreover, ponding raises the possibility that the entire stack might be saturated and liquefiable, while the surface water would promote flow behavior if a collapse did occur. According to SRK Consulting (2022b), “**During the site visit, some issues with water ponding and poor drainage appeared to be present (Figure 9-11)** ... The design considered that the compaction imposed on the tailings would be sufficient to prevent liquefaction; however, it is SRK’s opinion that given the height of the facility (57 m), the lack of quality control in the placement of tailings, **and the observed surface water issues,** further study is required to assess the risk for the tailings to exhibit contractive behaviour during undrained shearing” (emphasis added). A simple way to assess whether the entire stack might be saturated would be to inquire as to the persistence of surface ponding after the cessation of rainfall. SRK Consulting did not include information on the persistence of water ponding in their 2022 report. Photo from SRK Consulting (2022b). Photo from SRK Consulting (2022b).

Given the available information, it does not appear that SRK Consulting determined the cause or causes of the surface ponding. SRK Consulting did observe the significant ponding and poor drainage issues, but successive drafts of their report removed key language, minimizing the risks these issues pose to the DSTF. In the follow-up to Revision 1 (called Rev1_Draft) (SRK Consulting, 2022c), the large photo of surface ponding in Revision 1 (see Fig. 35a) was reduced to a one-quarter of its previous size (see Fig. 35b). The heading “View of DSTF area with significant water ponding” (SRK Consulting, 2022b; see Fig. 35a) was softened to the caption “View of DSTF area with water ponding issues” (SRK Consulting, 2022c; see Fig. 35b). Otherwise, the photo is identical between the two versions (compare Figs. 35a-b). The follow-up to Revision 1 still states, “**During the site visit, some issues with water ponding and poor drainage appeared to be present ...** The design considered that the compaction imposed on the tailings would be sufficient to prevent liquefaction, however it is SRK’s opinion that given the height of the facility (57 m), the lack of quality control in the placement of tailings, **and the observed surface water issues**, a further study is required to assess the risk for the tailings to have contractive behaviour during undrained shearing” (emphasis added) (SRK Consulting, 2022c). The above photo, caption, and quote in SRK Consulting (2022c) were unchanged

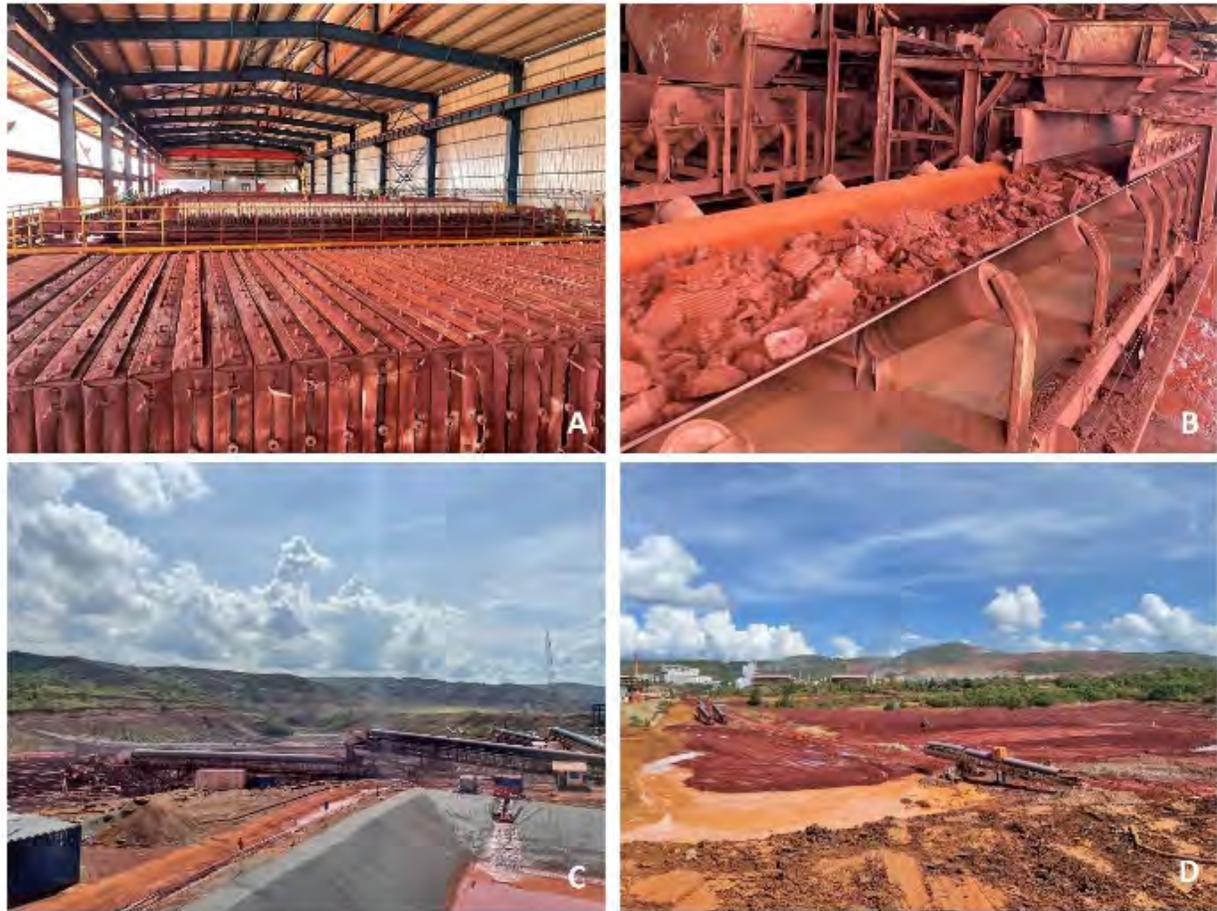
Figure 8-6: DSFT operation

Note: A: filter presses, B: Conveyor belt with filtered material, C: View of conveyors and earthmoving plant and D: View of DSTF area with water ponding issue

Figure 35b. The large photo with the heading “View of DSTF area with significant water ponding” in the first revision of the 2022 report by SRK Consulting (2022b) was made much smaller in a follow-up to the first revision (SRK Consulting, 2022c) and the caption was changed to “View of DSTF area with water ponding issues.” Otherwise, the photo is identical. The follow-up to the first revision still states, “**During the site visit, some issues with water ponding and poor drainage appeared to be present** ... The design considered that the compaction imposed on the tailings would be sufficient to prevent liquefaction, however it is SRK's opinion that given the height of the facility (57 m), the lack of quality control in the placement of tailings, **and the observed surface water issues**, a further study is required to assess the risk for the tailings to have contractive behaviour during undrained shearing” (emphasis added). The above photo, caption, and quote in SRK Consulting (2022c) are unchanged through Revision 8 (SRK Consulting, 2022e), except that “DSTF” was changed to “dry stack tailings facility” in the photo caption and “poor drainage” was changed to “drainage” in the quote. Photo from SRK Consulting (2022c).

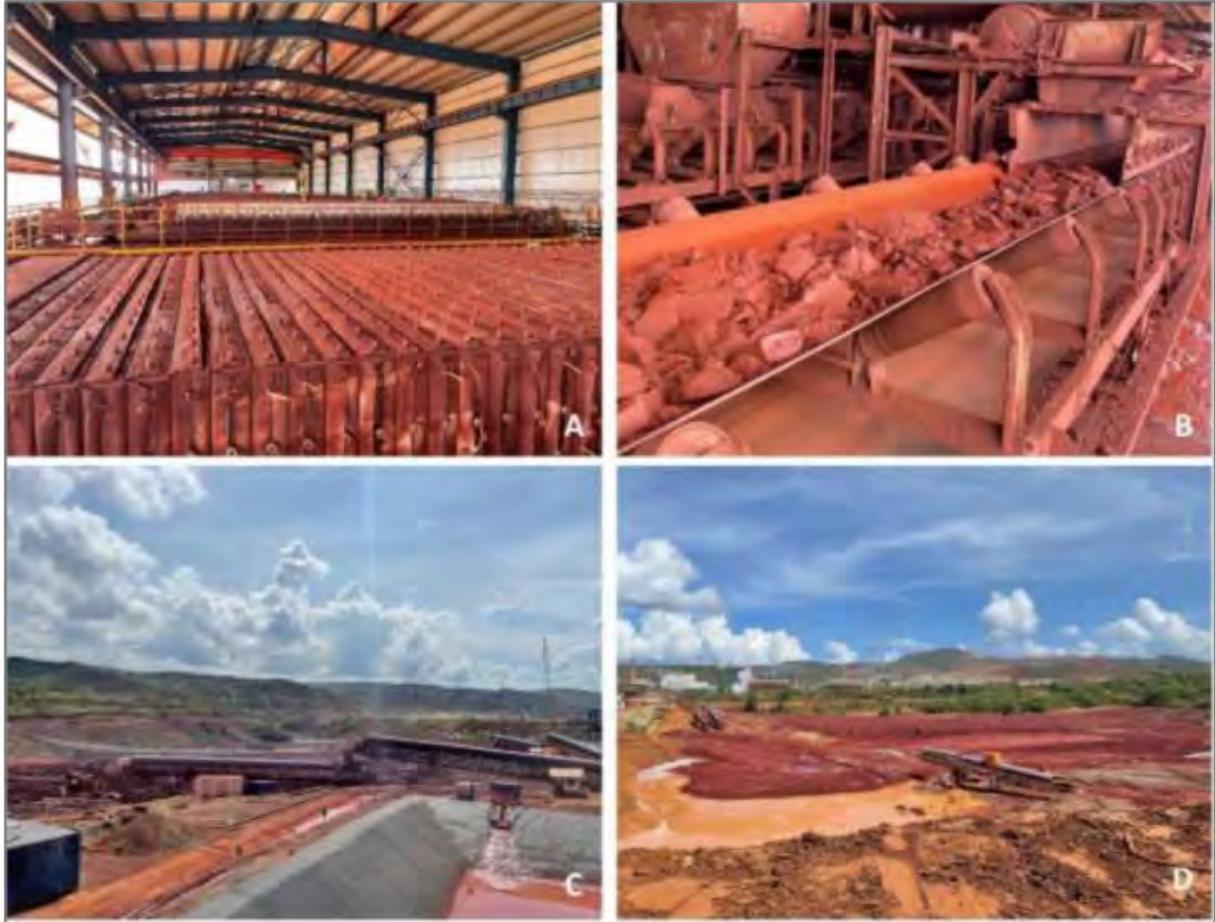
Figure 7-6: Dry stack tailings facility operation

Figure 35c. In Revision 8A, the photo caption of the previous revisions that stated, “View of DSTF area with water ponding issues” or “View of dry stack tailings facility area with water ponding issues” (see Fig. 35b) was changed to “View of dry stack tailings facility area” with no change in the photo. In the quote from Revision 8 that stated, **“During the site visit, some issues with water ponding and drainage appeared to be present ...** The design considered that the compaction imposed on the tailings would be sufficient to prevent liquefaction, however it is SRK’s opinion that given the height of the facility (57 m), the lack of quality control in the placement of tailings, **and the observed surface water issues,** a further study is required to assess the risk for the tailings to have contractive behaviour during undrained shearing” (emphasis added) (SRK Consulting, 2022e), the sentence “During the site visit, some issues with water ponding and drainage appeared to be present” was removed, as well as the phrase “and the observed surface water issues,” which actually left the last sentence grammatically incorrect. The photo, caption, and quote were unchanged through the final revision (SRK Consulting, 2022a), except that the quote was fixed to be grammatically correct: “The design considered that the compaction imposed on the tailings would be sufficient to prevent liquefaction; however, it is SRK’s opinion that given the height of the facility (57 m) and the lack of quality control in the placement of tailings, further study is required to assess the risk for the tailings to exhibit contractive behaviour during undrained shearing.” Photo from SRK Consulting (2022f).

The significant change occurred in the transition from Revision 8 (SRK Consulting, 2022e) to Revision 8A (SRK Consulting, 2022f). In Revision 8A, the photo caption of the previous revisions that had stated “View of DSTF area with water ponding issues” (SRK Consulting, 2022c; see Fig. 35b) or “View of dry stack tailings facility area with water ponding issues” (SRK Consulting, 2022e) was changed to “View of dry stack tailings facility area” (SRK Consulting, 2022e; see Fig. 35c) with no change in the photo. Thus, the observation of surface ponding was eliminated entirely. In the quote from Revision 8 that stated, “**During the site visit, some issues with water ponding and drainage appeared to be present** ... The design considered that the compaction imposed on the tailings would be sufficient to prevent liquefaction, however it is SRK's opinion that given the height of the facility (57 m), the lack of quality control in the placement of tailings, **and the observed surface water issues**, a further study is required to assess the risk for the tailings to have contractive behaviour during undrained shearing” (emphasis added) (SRK Consulting, 2022e), the sentence “During the site visit, some issues with water ponding and drainage appeared to be present” was removed, as well as the phrase “and the observed surface water issues,” which actually left the last sentence grammatically incorrect. Thus, all mention of the observation of surface ponding, as well as the significance of surface ponding, was removed from Revision 8A (SRK Consulting, 2022e). The full quote in Revision 8A states, “The design considered that the compaction imposed on the tailings would be sufficient to prevent liquefaction; however it is SRK's opinion that given the height of the facility (57 m), the lack of quality control in the placement of tailings, a further study is required to assess the risk for the tailings to have contractive behaviour during undrained shearing” (SRK Consulting, 2022e). Figs. 35d-e shows the Track Changes version of Revision 8A (SRK Consulting, 2022g) that clarifies the critical deletions that were made in the transition from Revision 8 to Revision 8A.

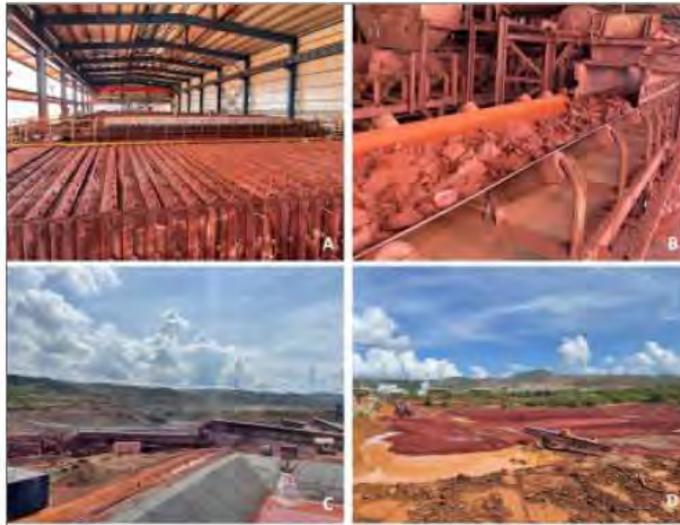
Figure 7-6: Dry stack tailings facility operation

Figure 35d. The Track Changes version that compares Revision 8A with Revision 8 clarifies the changes that were made. First, the phrase “with water ponding issue” was removed from the photo caption. See additional change in Fig. 35e. Photo with changes from SRK Consulting (2022g).

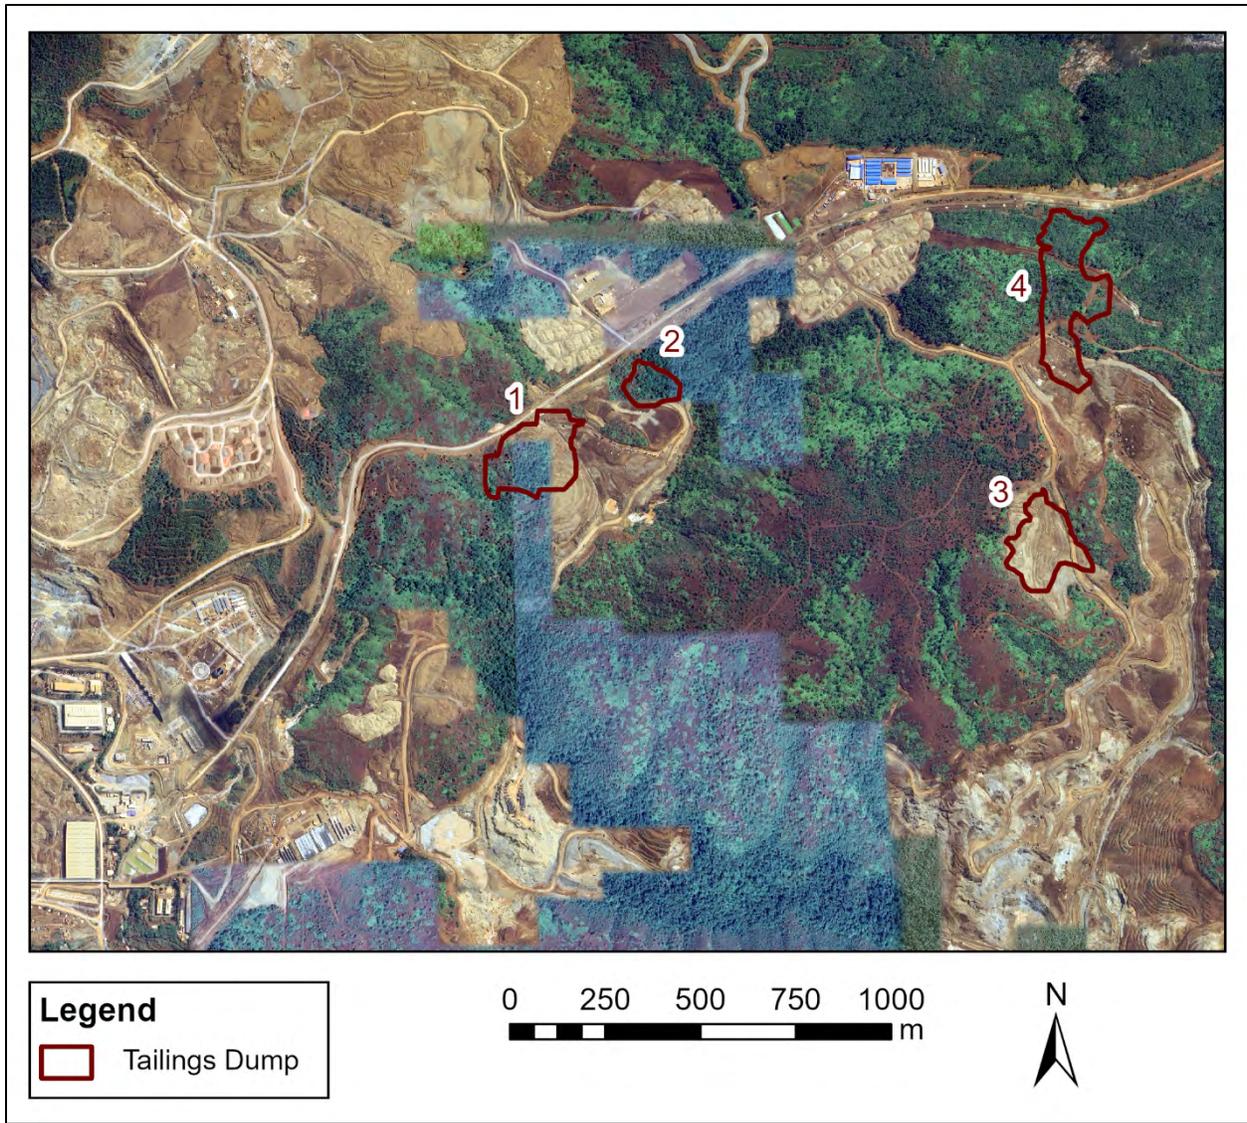
Figure 37. Harita Nickel and PT TBP (2023) discussed four filtered tailings storage facilities that were distinct from the PT HPL Dry Stack Tailings Facility (DSTF). Numbering of filtered tailings storage facilities is by the author. A map in Harita Nickel and PT TBP (2023) labels each of the facilities as “WD Tailings Dump” and also labels Tailings Dump #1 as “Karo Disposal Tailings Dump.” According to Harita Nickel and PT TBP (2023), the factor safety of Tailings Dump #1 was 1.045, so that the facility was on the cusp of catastrophic failure. Harita Nickel and PT TBP (2023) recommended that no additional tailings be placed in Tailings Dump #1, but made no recommendations regarding the safety of mineworkers, even though Tailings Dump #1 is only several hundred meters upslope from considerable mining infrastructure. Tailings dumps traced from map in Harita Nickel and PT TBP (2023). Background is Google Earth imagery from August 6, 2023.

Harita Nickel and PT TBP (2023) drew particular attention to one filtered tailings storage facility, referred to as the “Disposal Tailing Dam Karo” (Tailings Dump #1 in Fig. 37). According to Harita Nickel and PT TBP (2023), the filtered tailings storage facility was on the cusp of catastrophic failure with a static factor of safety of only 1.045 (see Fig. 39). The recommendation of Harita Nickel and PT TBP (2023) was that “*Kegiatan dumping di area disposal ini tidak direkomendasikan untuk dilanjutkan kembali*” [Dumping activities in this disposal area are not recommended to be continued]. The memo continued with recommendations regarding the repair of the filtered tailings storage facility, but it is disappointing that there were no recommendations regarding measures to be taken to protect mineworkers, despite the fact that Tailings Dump #1 is only several hundred meters upslope from considerable mining infrastructure (see Fig. 37).

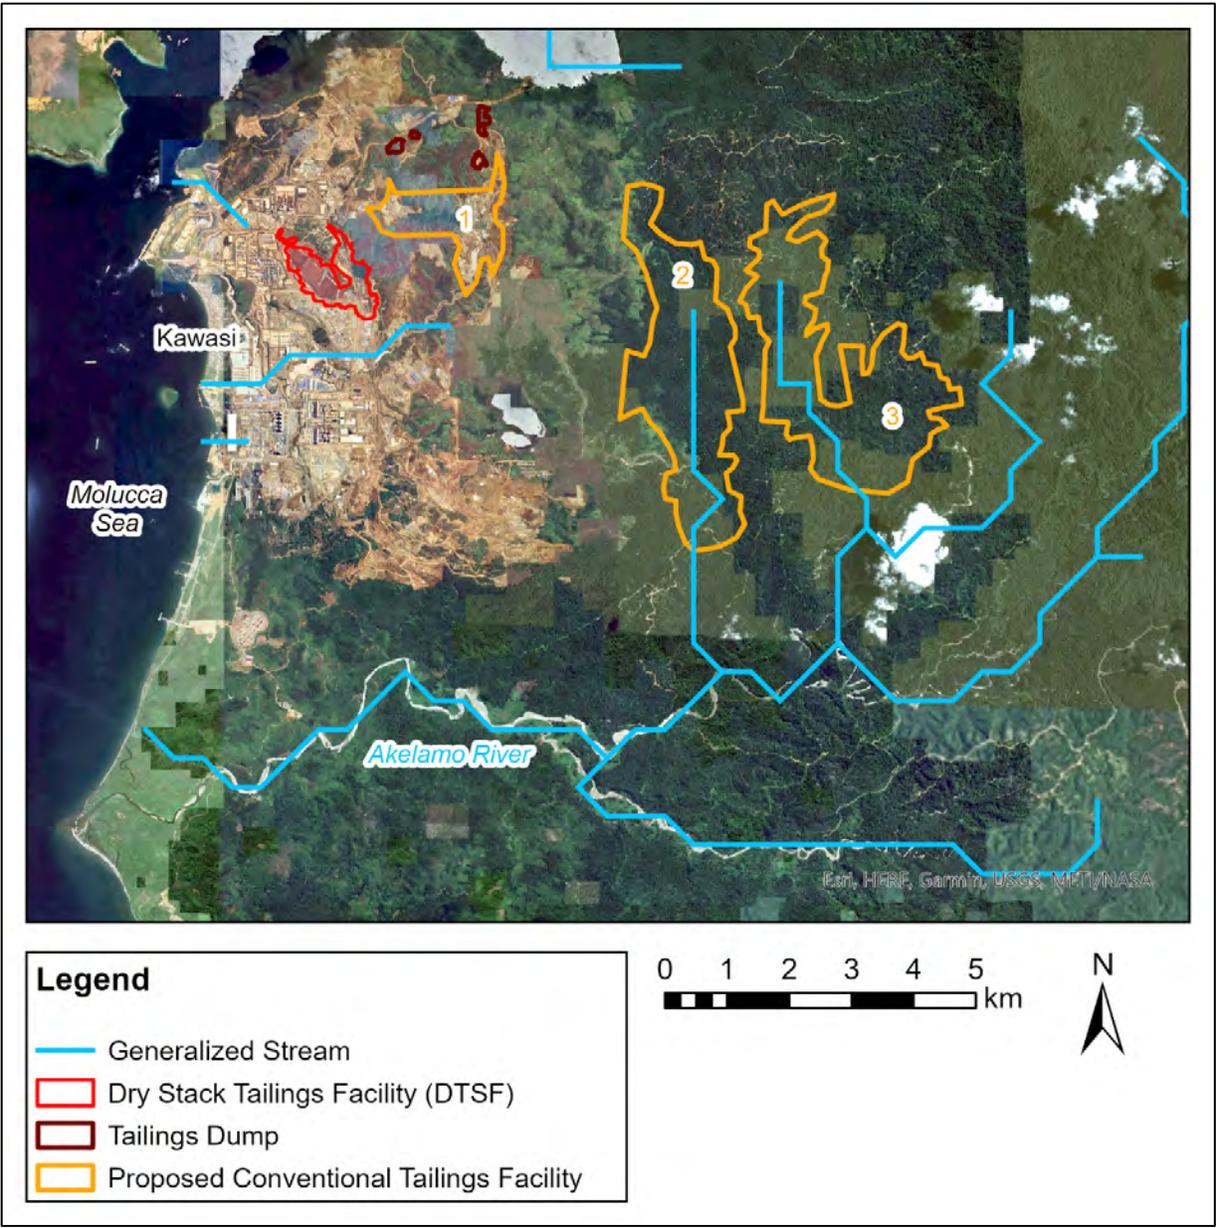
Figure 38. PT Halmahera Persada Lygend (HPL) is considering the construction of three conventional tailings facilities to store additional tailings after the Dry Stack Tailings Facility (DSTF) reaches full capacity in mid-2027. With a combined footprint of 1556 hectares, the conventional tailings storage facilities would cover eight times the area of the existing DSTF. SRK Consulting (2022a) refers to the conventional tailings storage facilities as Residue Storage Facilities (RSF) and denotes the proposed facilities as RSF 1, RSF 2, and RSF 3. As of December 2022, the conventional tailings storage facilities were already in the permitting phase. The presence of RSF 2 and RSF 3 at the headwaters of the Akelamo River indicates that a tailings dam failure could contaminate the entire Akelamo River Basin. See Figs. 34 and 37 for smaller-scale views of the DSTF and the tailings dumps, respectively. Generalized streams from HydroSHEDS (2025) with name of river from Yasya et al. (2024). DSTF, tailings dumps, and proposed conventional tailings facilities traced from maps in PT Lapi ITB (2022), Harita Nickel and PT TBP (2023), and SRK Consulting (2022a), respectively. The outlines of the proposed conventional tailings facilities are approximate since the outlines are obscured by numerous labels in the map in SRK Consulting (2022a) (see Fig. 47). Background is Google Earth imagery from December 31, 2020, and August 6, 2023.

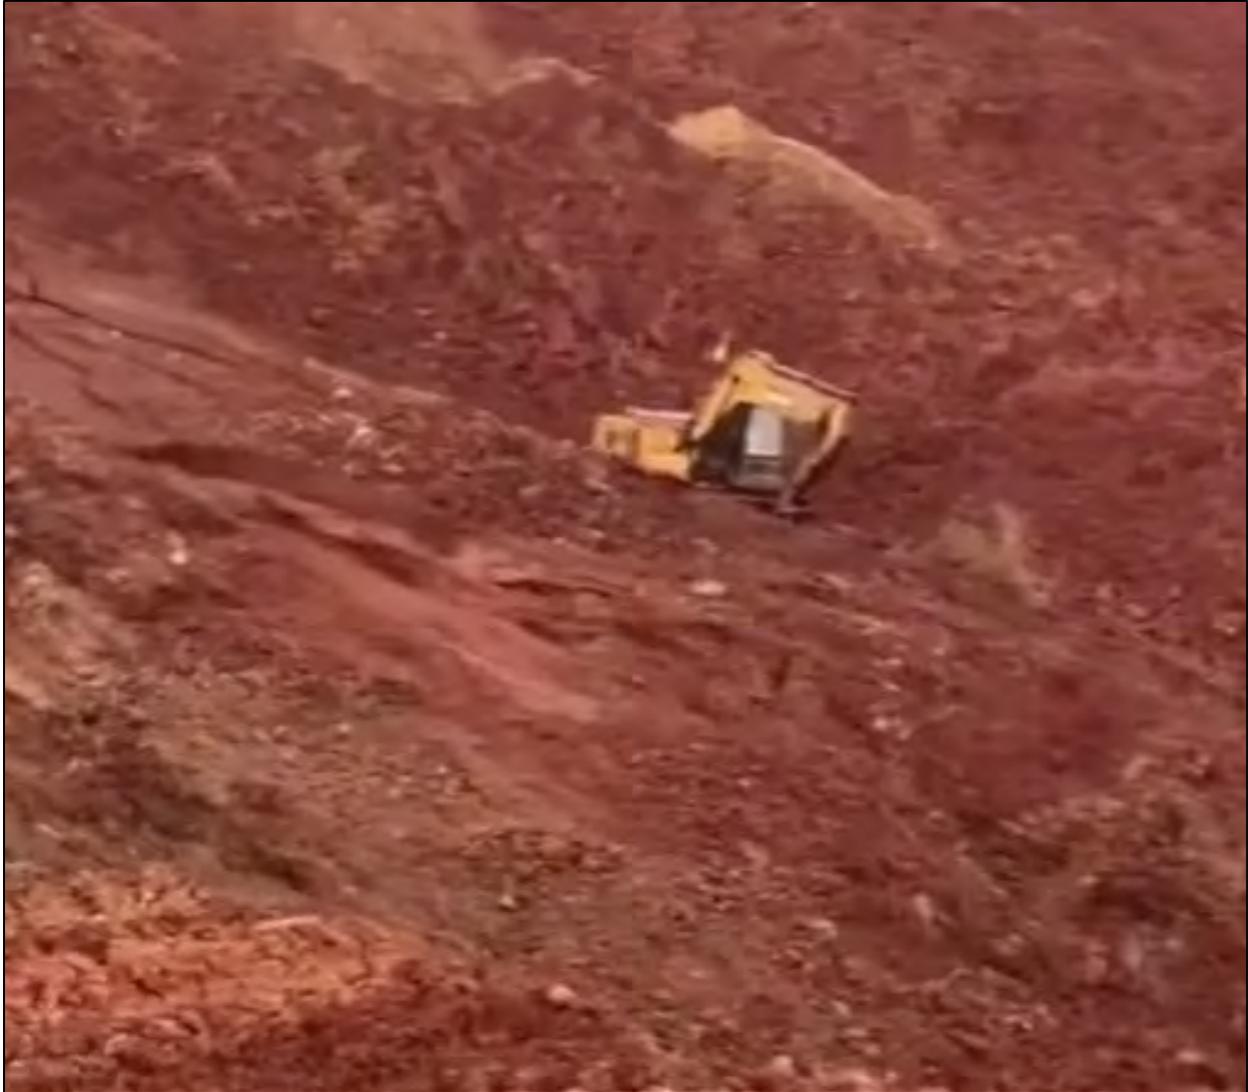
Figure 45. A bulldozer was engulfed by a landslide at a filtered tailings storage facility of the Indonesia Morowali Industrial Park (see Figs. 3 and 23) in September 2023. Still image at 0:03 from Kuli Tambang Random [Random Mineworker] (2023).

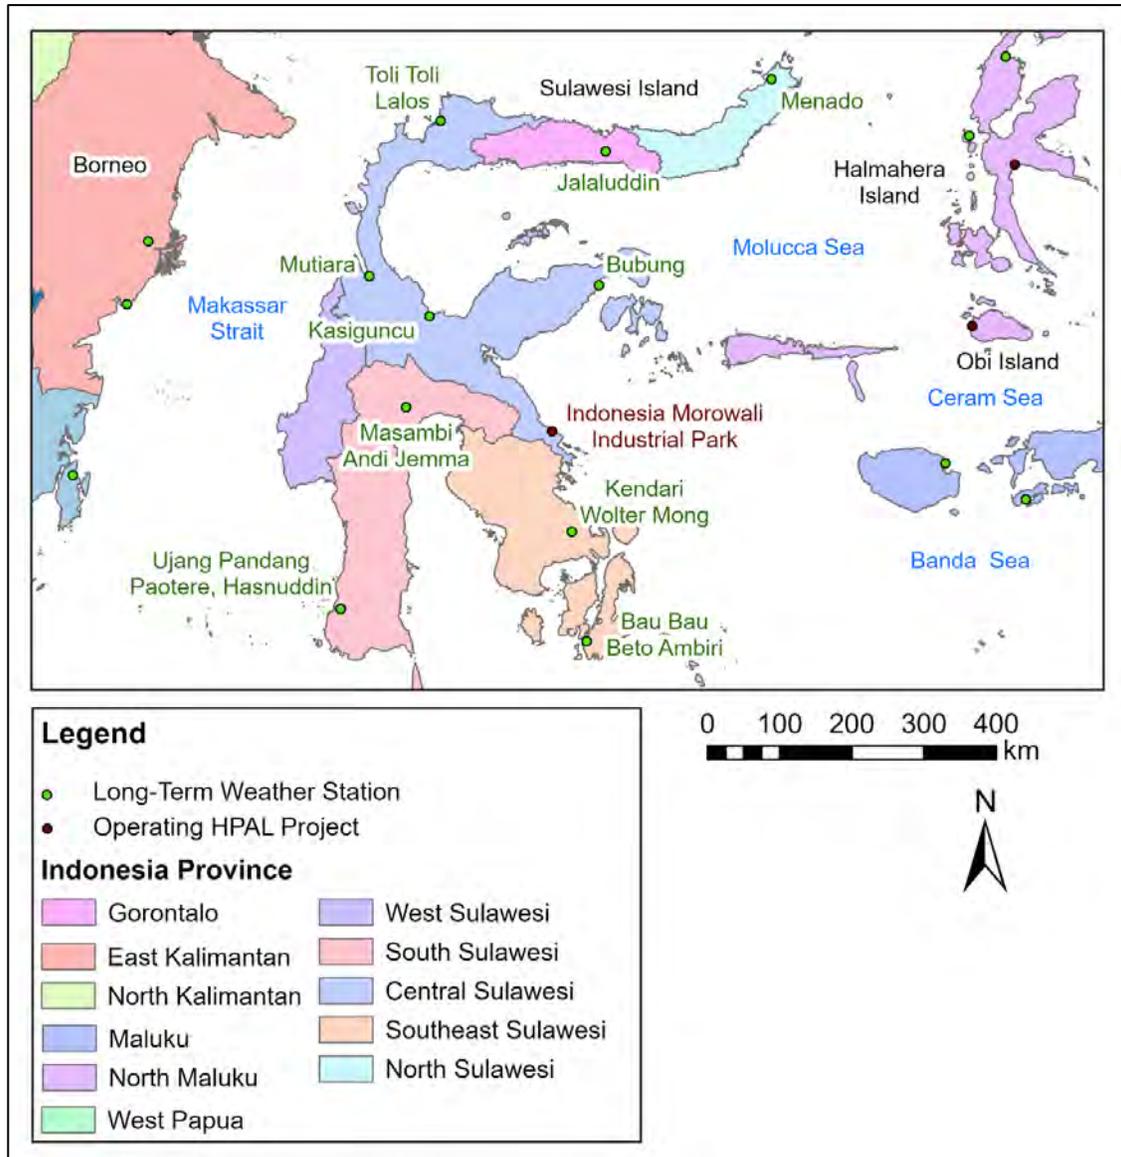
Figure 46. There are 11 long-term weather stations on Sulawesi Island, with the closest to the PT HYNC/PT QMB filtered tailings storage facility at the Indonesia Morowali Industrial Park (see Figs. 23-24) being Kendari Wolter Mong at a distance of 143 kilometers (see Table 7). Although PT QMB blames the landslide on March 21, 2025, that resulted in three fatalities (see Figs. 42a-c) on a precipitation event that was “beyond human control,” the magnitude of the 50-year event at the site of the fatal accident must be very poorly known. Long-term weather stations from NOAA (2025).
